A Management Plan for Historic Bridges in Virginia: The 2017 Update

Final Report VTRC 18-R6

FINAL REPORT
A MANAGEMENT PLAN FOR HISTORIC BRIDGES IN VIRGINIA:
THE 2017 UPDATE

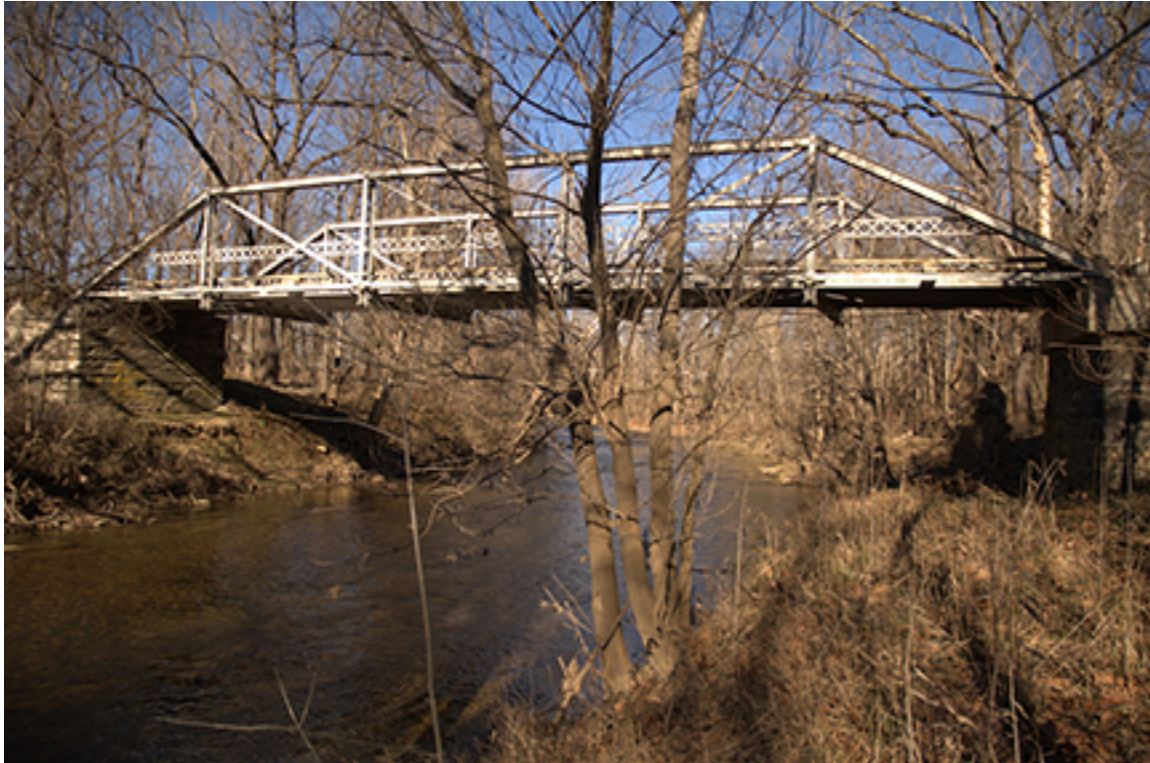
Figure B16. Augusta County Structure No. 6027

Current Historic Structures Task Group Observations and Recommendations: The current inspection report indicates that this structure is in poor condition. Previous repairs are in accordance with Recommendation 1 in the 2001 Management Plan. The task group reiterates the

recommendations of (continued) repair and maintain for vehicular use, with subsequent preventive maintenance as needed (Recommendation 1), in the 2001 Management Plan, with Recommendation 2 (repair and maintain for adaptive use and transfer ownership on-site if a suitable recipient can be identified) as a possible second option.

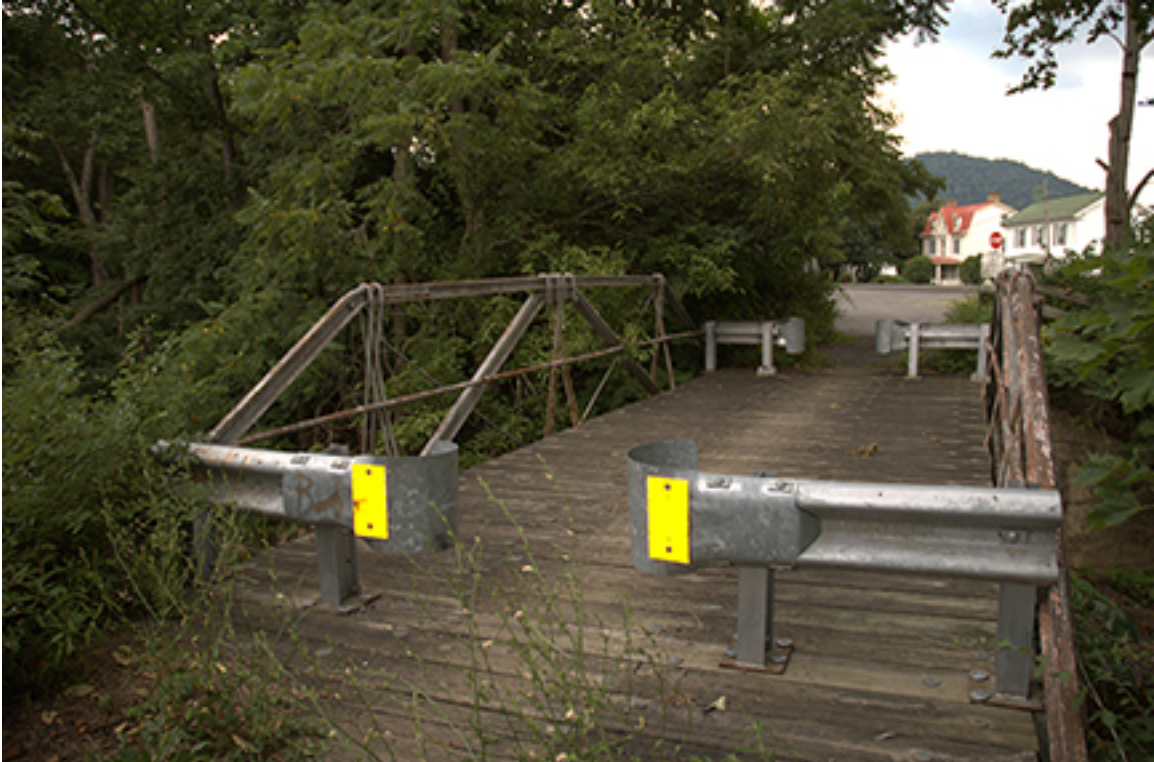
Figure B19. Highland County Structure No. 6034

Condition: The current inspection report indicates that this structure is in fair-to-poor condition. Highland County Structure No. 6034 was closed to vehicular traffic in 1994, after which the structure was rehabilitated to serve as a foot and bicycle bridge (this use allows pedestrians and cyclists to avoid the primary traffic on Rt. 250). Preventive maintenance is undertaken on an as-needed basis. The bridge was cleaned, redecked, wire brushed, and painted at the time that it was closed to vehicular traffic. There are currently some areas of rust on the truss members. The abutments (masonry, faced with concrete) exhibit some areas of cracking and spalling and are periodically subject to slight, but repairable scour. A tree is growing against the upstream abutment. Some of the truss members are loose and require tightening.

- There is severe rust and section loss on floor beams.
- Floor beam hanger rods are bent.
- Several stringers (2 and 3) are not bearing on Floor Beam 1.

- The rubble masonry abutments are covered with concrete, which is delaminating (up to 8 to 9 inches in some areas) and exhibiting active cracking and efflorescence.

Current Historic Structures Task Group Observations and Recommendations: The current inspection report indicates that this structure is in fair to poor condition. Planned repairs are in accordance with the Recommended Treatment in the 2001 Management Plan. The task group reiterates the recommendations of repair and maintain for continued adaptive use, with subsequent preventive maintenance as needed, in the 2001 Management Plan. The task group strongly supports making repairs to this important structure in the near future. Surviving Lane

vehicular traffic and concurs with its current adaptive use. The recommended management option for this structure consists of normal preventive maintenance and repairing and maintaining for continued adaptive use when necessary. Immediate repair recommendations are to remove the tree growing against the abutment, address the scour problem, and repair or reinforce the deteriorated abutment. Loose truss members should be tightened.

- Vegetation encroaching on the structure should be removed.
- The truss elements of the bridge need repair and painting.
- The abutments will require repair soon.

trusses are rare: only four are known to be extant. If the county is willing to coordinate with VDOT for a transportation enhancement grant. VDOT could assist the county with the submittal and administration of such a grant.

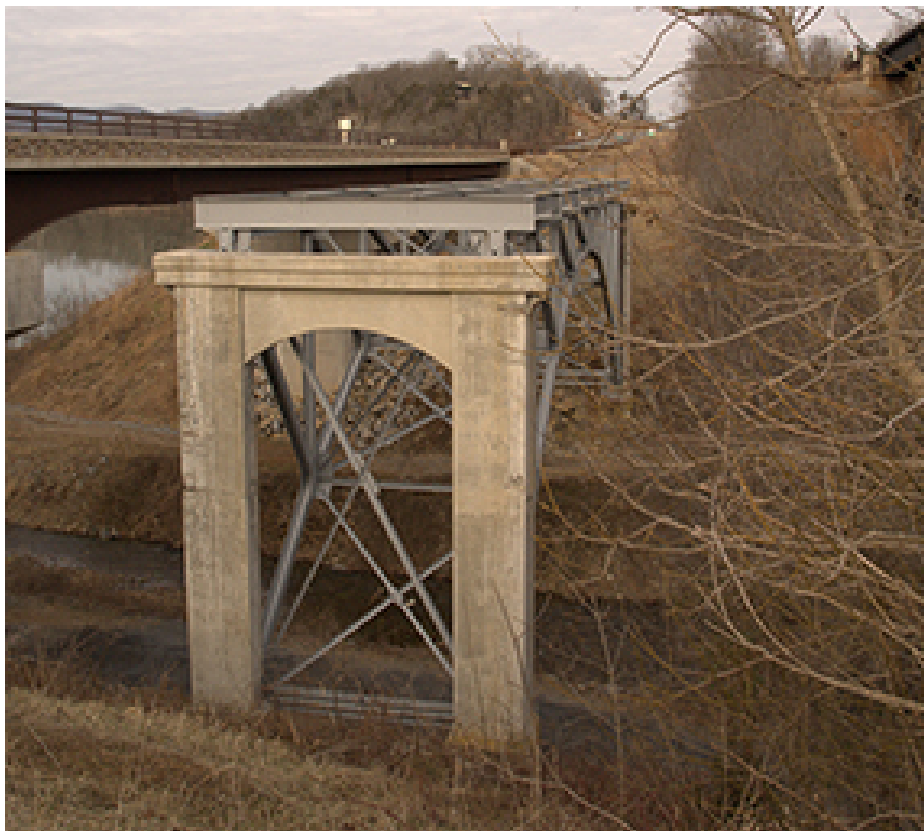
Figure B20. Page County Structure No. 9001 (formerly No. 1990)

- Per the original and amended memoranda of agreement, the deck of the original bridge was removed to expose the metal arch truss; the approaches have been removed. The structure is now preserved as a landscape feature and an historical exhibit and is also utilized for paint system evaluation by the district structure and bridge office. It is closed to all traffic / public access.

Current Historic Structures Task Group Observations and Recommendations: Currently, the terms of the original and amended memoranda of agreement are being followed. Along with its use as a landscape feature and an historical exhibit, the bridge is serving an additional purpose in paint system evaluation. The task group supports the fulfillment of the memoranda of agreement and the continued use of the structure for paint system evaluation.

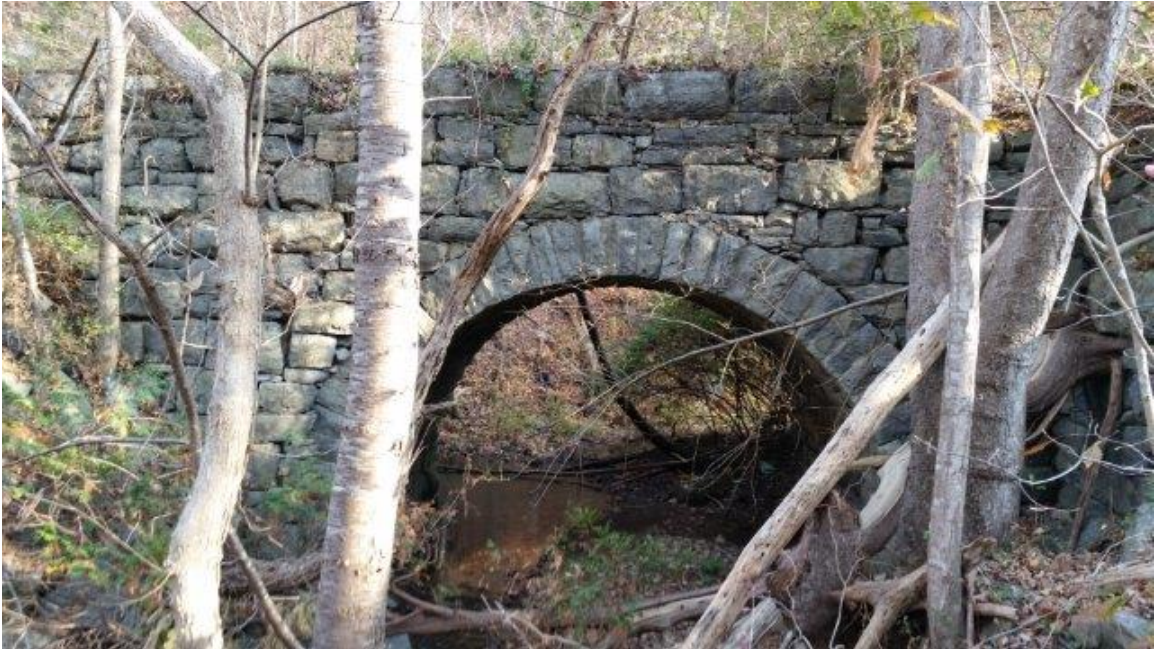
Figure B23. Southwest Turnpike Company Bridge, Wythe County

Current Historic Structures Task Group Observations and Recommendations: The task group reiterates the recommendations of repair and maintain for adaptive use, with subsequent preventive maintenance as needed, in the 2001 Management Plan.

- Some small trees and other vegetation encroaching on the bridge are being removed.
- Insertion of grouted anchors to prevent further movement of the structure should be considered.
- If the bridge is no longer in use, transferring ownership to Wythe County, if there is interest in acquiring the bridge on the part of the county, could be considered as an option.
- Transportation enhancement grants, noted as a potential funding source under *Recommended Treatment* in the 2001 Management Plan, are no longer available to DOTs.

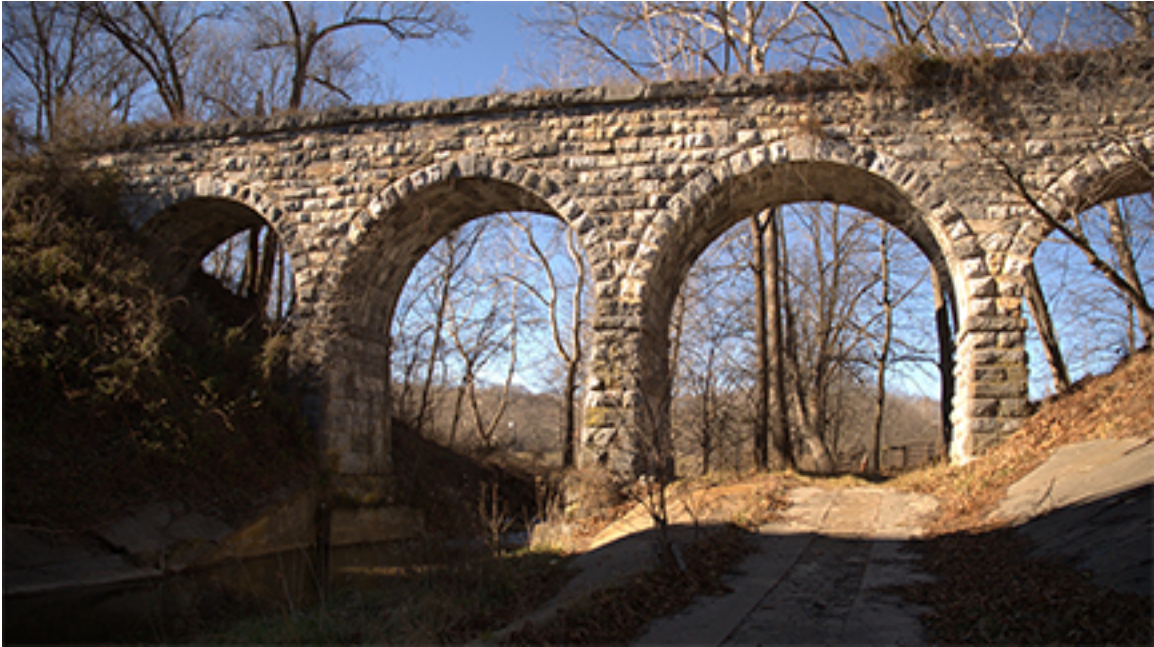
Figure B29. Augusta County Structure No. 6997 (Valley Railroad Bridge)

Current Historic Structures Task Group Observations and Recommendations: The task group reiterates the majority of the recommendations under *Recommended Treatment* (excluding the recommendation to pursue a transportation enhancement grant) in the 2001 Management Plan. The task group defers further recommendations pending the results of the district structure and

bridge office's assessment of drainage and masonry repair issues for this structure. However, the task group notes their strong support for maintaining this structure in good condition.

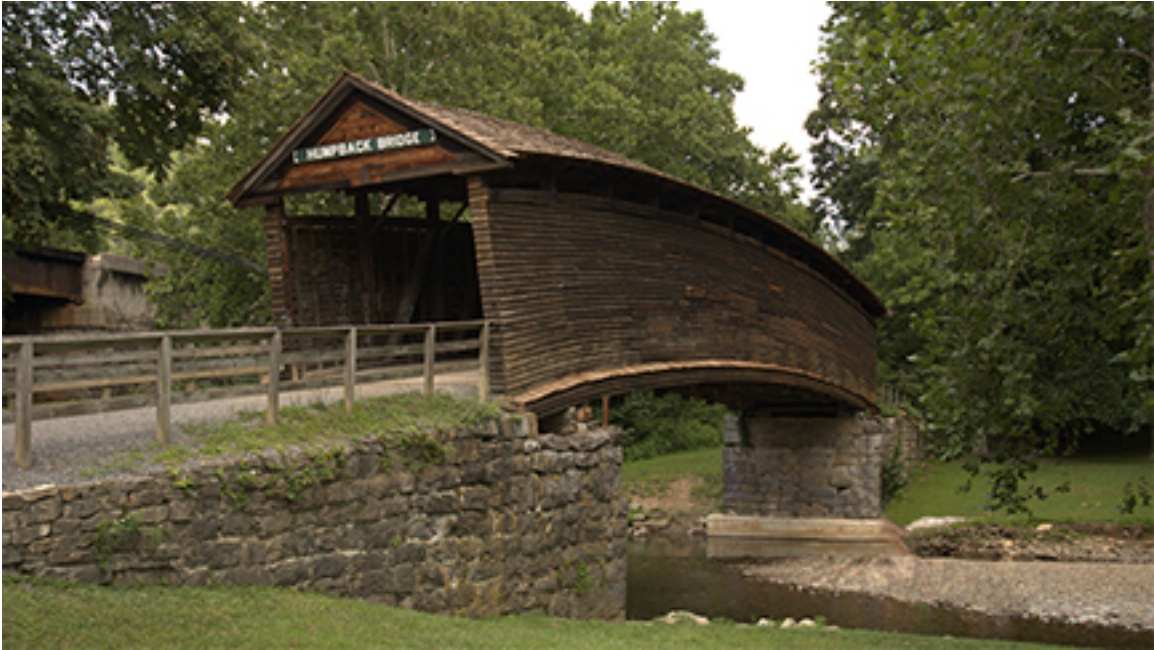
Figure B34. Alleghany County Structure No. 9007 (Humpback Bridge)

Current Historic Structures Task Group Observations and Recommendations: Previous rehabilitation and repairs are in accordance with Recommendation 1 in the 2001 Management Plan. The task group reiterates the recommendations of (continued) repair and maintain for continued adaptive use, with subsequent preventive maintenance as needed, in the 2001

Management Plan. The feasibility of stream restoration techniques should be explored: these would keep the channel from migrating in normal flow. (The channel is fairly stable at present.)

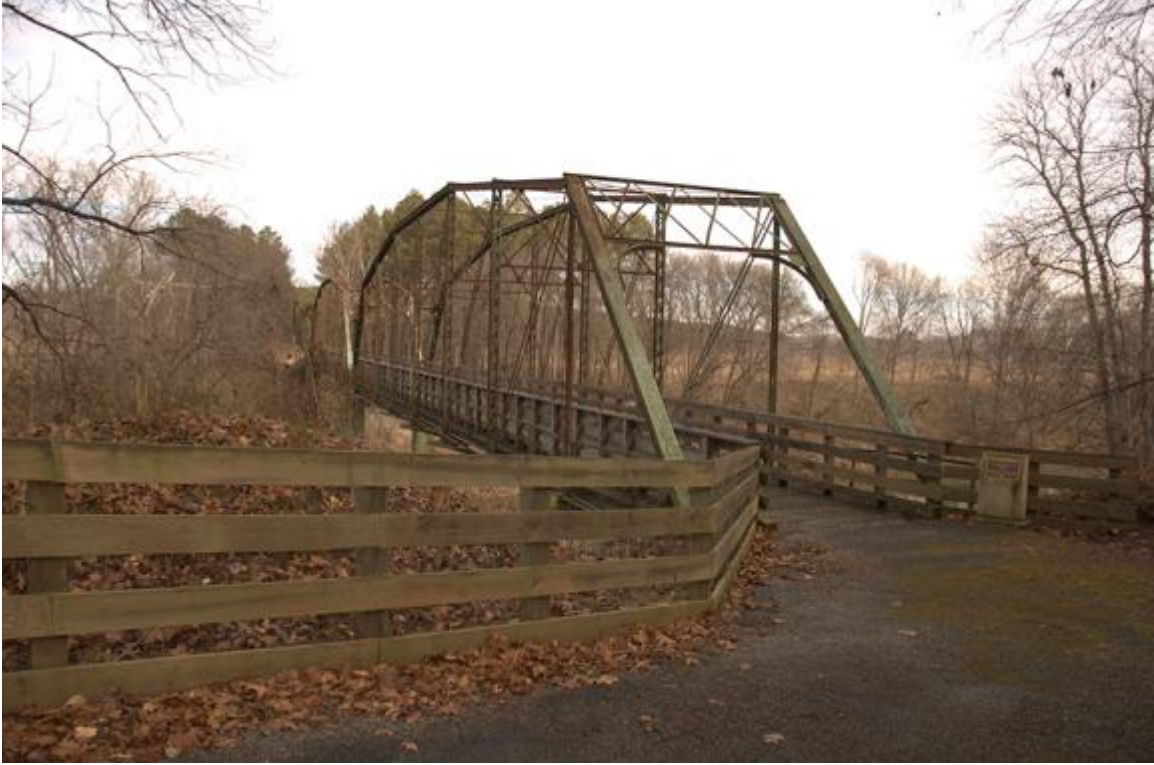
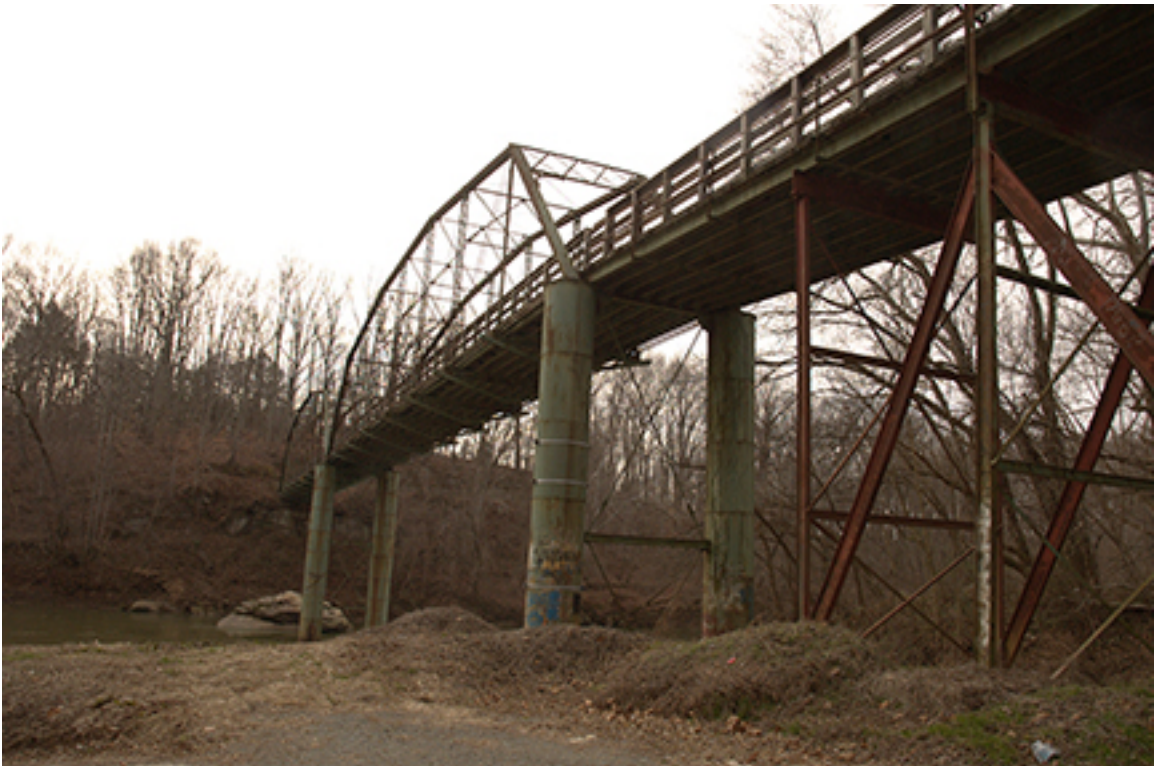
Figure B36. Charlotte County Structure No. 6902

- The 2015 inspection disclosed additional deterioration in the steel, and the Lally columns are failing.
- The bridge was determined unsafe even for inspection access. The district structure and bridge office has closed the bridge completely.
- Section 106 review is ongoing with stakeholders.

Figure B37. Charlotte County Structure No. 6902, Showing Lally Columns

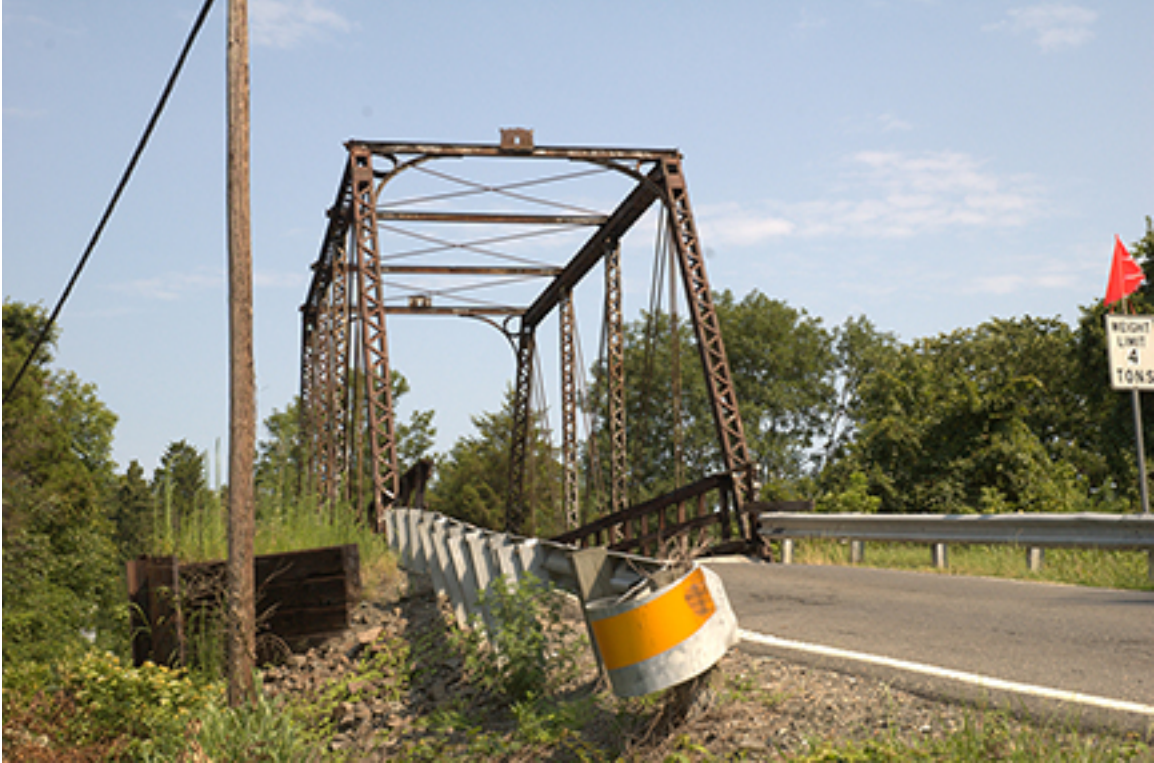
Figure B40. Prince William County Structure No. 6023 (Shown Prior to Disassembly)

- The bridge is currently disassembled, and the elements are being analyzed.
- Section 106 review is ongoing with stakeholders.
