Premature Failure of Concrete Patching: Reasons and Resolutions

Final Report VTRC 19-R14

FINAL REPORT

The performance of concrete patches in continuously reinforced concrete pavement in Virginia varies from less than 1 year to many years. The purpose of this study was to determine the causes of premature repair failure in continuously reinforced concrete pavement.

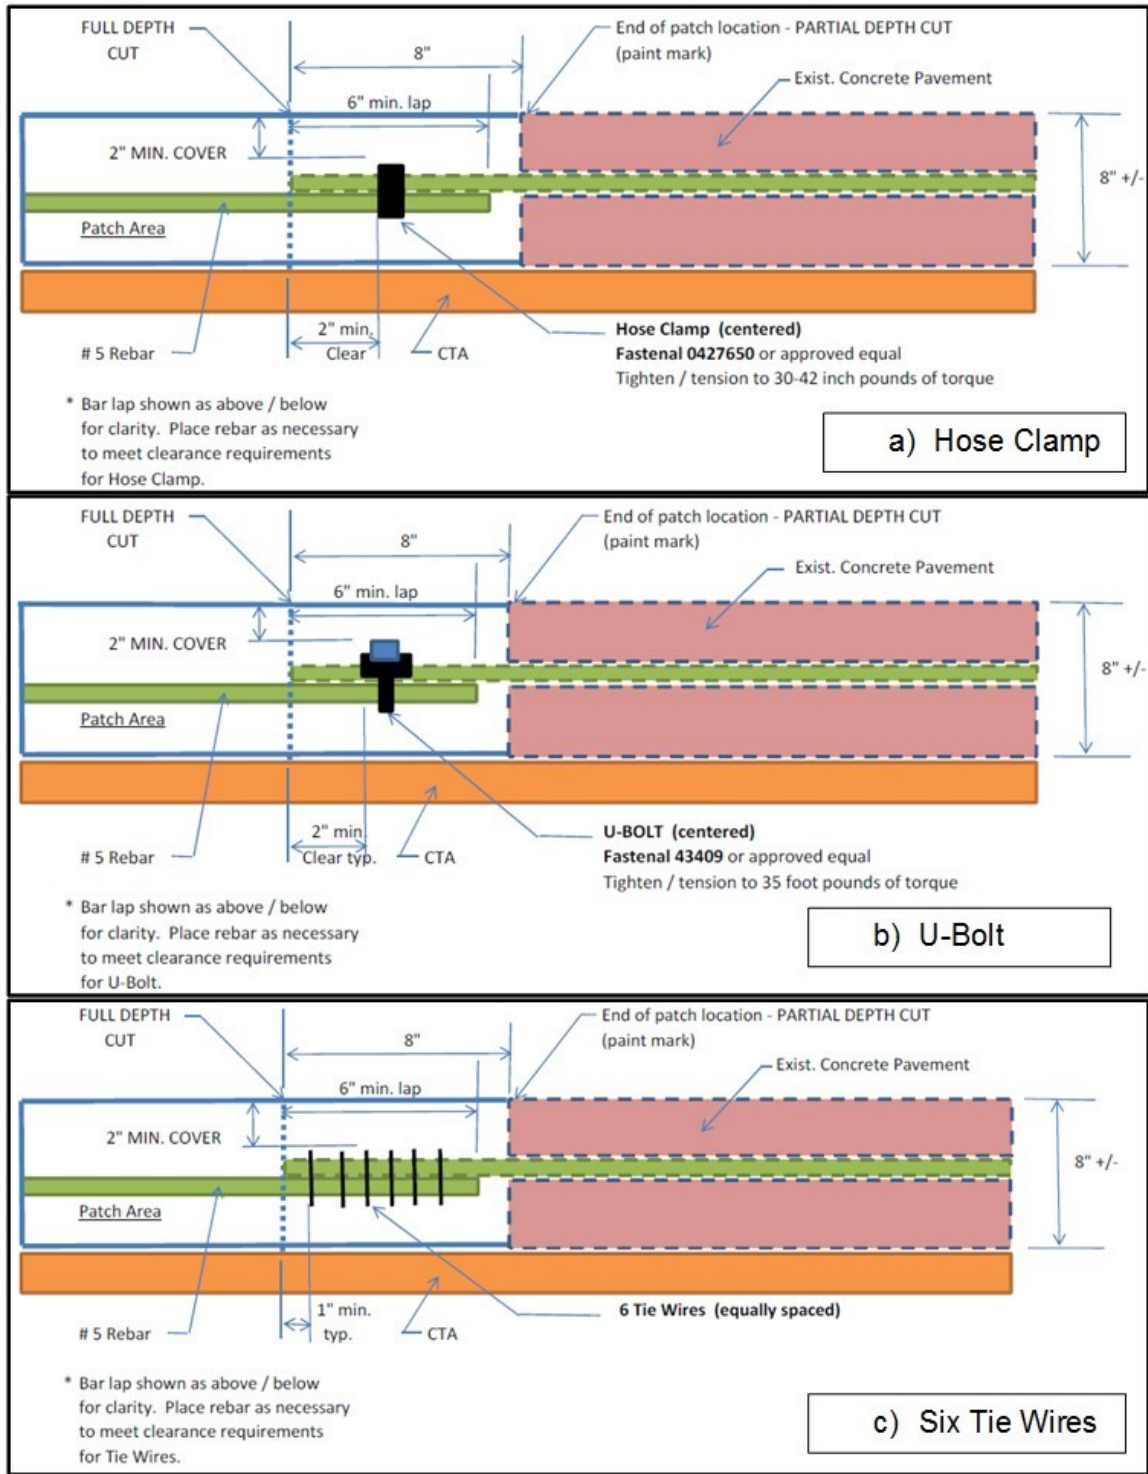
In addition to the current practice of reestablishing the continuity of the reinforcement, three new reinforcement connection (splicing) details as shown in Figure 2 were tried in the I-85 patching work to determine their effect with regard to the construction of the patches and to provide sites for future performance evaluation. These connections included hose clamps, U-bolts, and six tie wires. Current VDOT patching practice uses only two tie wires with an 18-in overlap, which provides continuity through the development length concept. The experimental mechanical connections were designed to reduce the required development length, which would reduce the quantities of concrete removal and patching material.

Figure 2. Alternative Splicing Methods: a) hose clamp; b) U-bolt; c) 6 tie wires

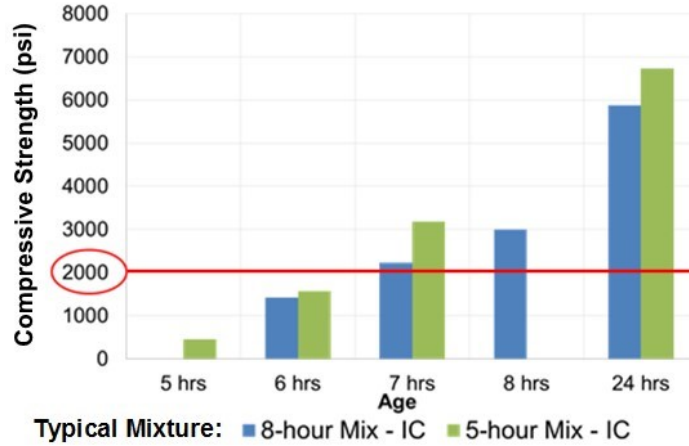
All Type IV patches observed for this project were constructed with high cement contents (e.g., 800 lb for 5-hour mixture and 752 lb for 8-hour mixture) so they could achieve the 2,000 psi compressive strength needed to be opened to traffic in 5 to 8 hours. Typical mixtures are described in Table 2 along with an improved, more durable mixture. The 5-hour and 8-hour mixtures were used in the I-85 patching project. Similar ingredients were collected from the respective plant, and mixtures were prepared in the laboratory. Figure 8 shows the typical early age compressive strength of these patching mixtures. All cylinders in the laboratory were cured in an insulated chamber to simulate field patching conditions where loss of heat is prevented because of the mass of concrete in a patch. Although the 8-hour mixture achieved the required 2,000 psi strength in 8 hours, the 5-hour mixture did not gain a similar strength in 5 hours. Figure 9 shows the early age compressive strength of improved high early strength patching mixtures that achieved the required 2,000 psi strength in 6.5 hours and hence were named 6.5-hour mixtures. Figure 10 shows the cracking typical of the high early strength mixtures being used. It is believed that a primary cause of the premature deterioration of the patches is the cracking in these mixtures.

Figure 8. Early Age Compressive Strength of a Typical (VDOT) High Early Strength Patching Mixtures Prepared in the Laboratory. IC = insulated curing.

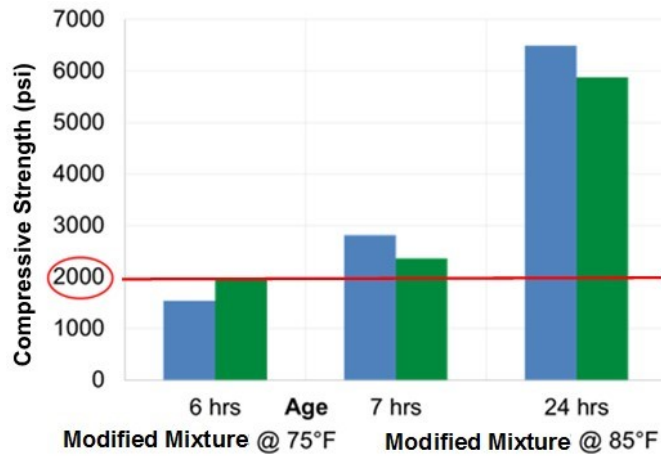
Figure 9. Early Age Compressive Strength of Improved High Early Strength Patching Mixtures Prepared in the Laboratory. Blue = mixing water temperature of 75 °F; green = mixing water temperature of 85 °F; both insulated cured.

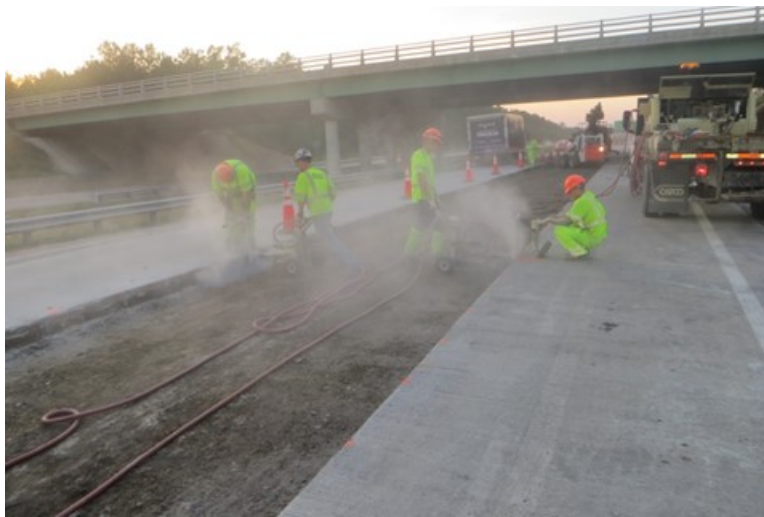
On the second night, June 10, only two patches were placed. The first (Batch 1B) was 381 ft 10 in long, and the second (Batch 2B) was 8 ft 8 in long. Figure 13 shows work being done on the longer patch. The first patch (Batch 1B) was under the overpass and did not appear to be in distress, but it was placed so that better quality exposed concrete to maintain the clearance would be present when the rest of the patch areas would be overlaid with asphalt. Core samples from the placement on the second night were taken from only the second smaller patch since the purpose of the first large patch was mainly to maintain the clearance under the bridge deck rather than to correct the damaged concrete pavement. Three cores each were taken on the north and south sides of the second, shorter patch at varying distances in the transverse and longitudinal directions.

Figure 13. Longer of Two Patches on SR 288 Constructed on 6/10/14

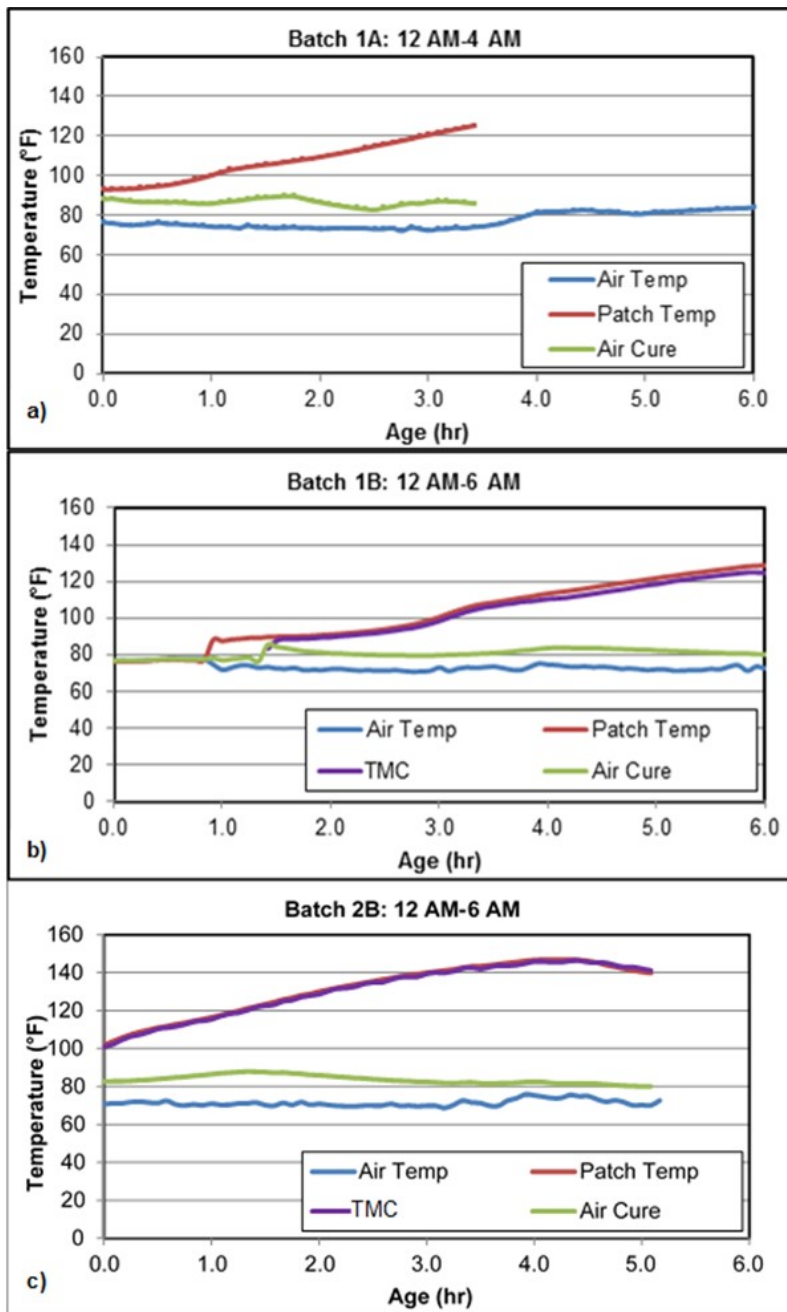
The temperature progression for the first few hours (4 to 6) was collected at three locations: (1) at mid-depth of the patching, (2) in the TMC molds, and (3) in the AC molds. Figure 14 shows the temperature behavior of the concrete patches during the first 5 or 6 hours after placement, detailing temperature fluctuations of the actual patches, air, and cylinders. On the first night, June 9, the generator used to heat the TMC molds for the second batch ran out of gas and was restarted at approximately 4 A.M., when this was discovered. Therefore, the temperature of the second patch on the first night was not available. All three plots show that the patch temperature was much higher compared to the air temperature for the first 6 hours. The TMC mold was able to match the actual patch temperature in the mold. On the other hand, the temperatures of the AC cylinders mostly followed the air temperature and were about 10 °F to 15 °F above it. This difference in curing temperature would also influence the strength gain, as explained later.

Figure 14. Temperature Variation With Time for Patches, Surrounding Air, and TMC and Air Cured Cylinders on SR 288. TMC = temperature matched cure.

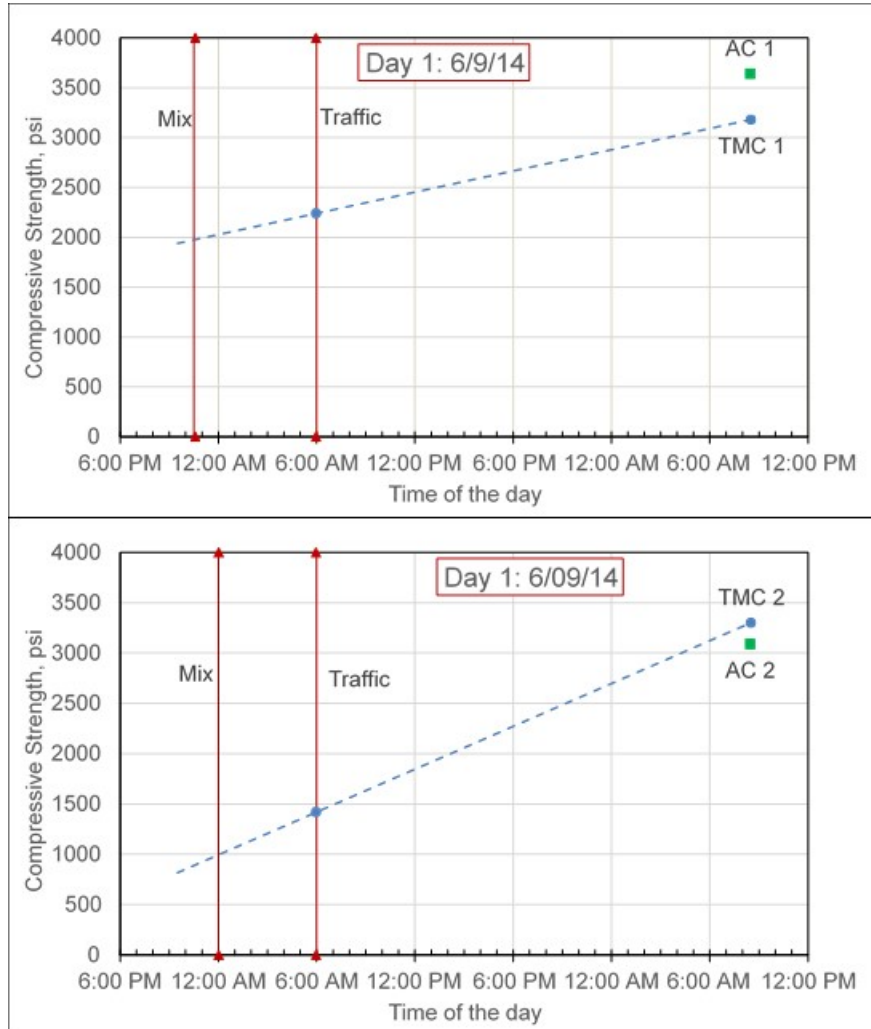
All patches were opened to traffic around 6 A.M. Figures 15 and 16 show the strength gain of the AC and TMC cylinders along with the time of mixing and opening to traffic. During the second night, the AC cylinders were tested right after opening to traffic. It is obvious from Figure 16 that the strength of the AC cylinder did not represent the actual strength of the patch, so using the strength of the AC cylinder for opening to traffic would be grossly inaccurate. The high temperature, hence the high strength, in the TMC cylinder indicates the feasibility of using the maturity method for estimation of strength for opening to traffic. The low value for TMC Cylinders 2A (last patch of the first night) was likely due to the generator stopping and the TMC cylinder not maintaining the temperature in the patch. In addition, the chloride permeability of the concrete cylinder specimens from the first night was measured at the age of 6 months and was above 6000 C, indicating poor durability.

Figure 15. Compressive Strength Development for TMC and AC Cylinders From Patches on SR 288: Day 1 (first day of observation). TMC = temperature matched cured; AC = air cured.

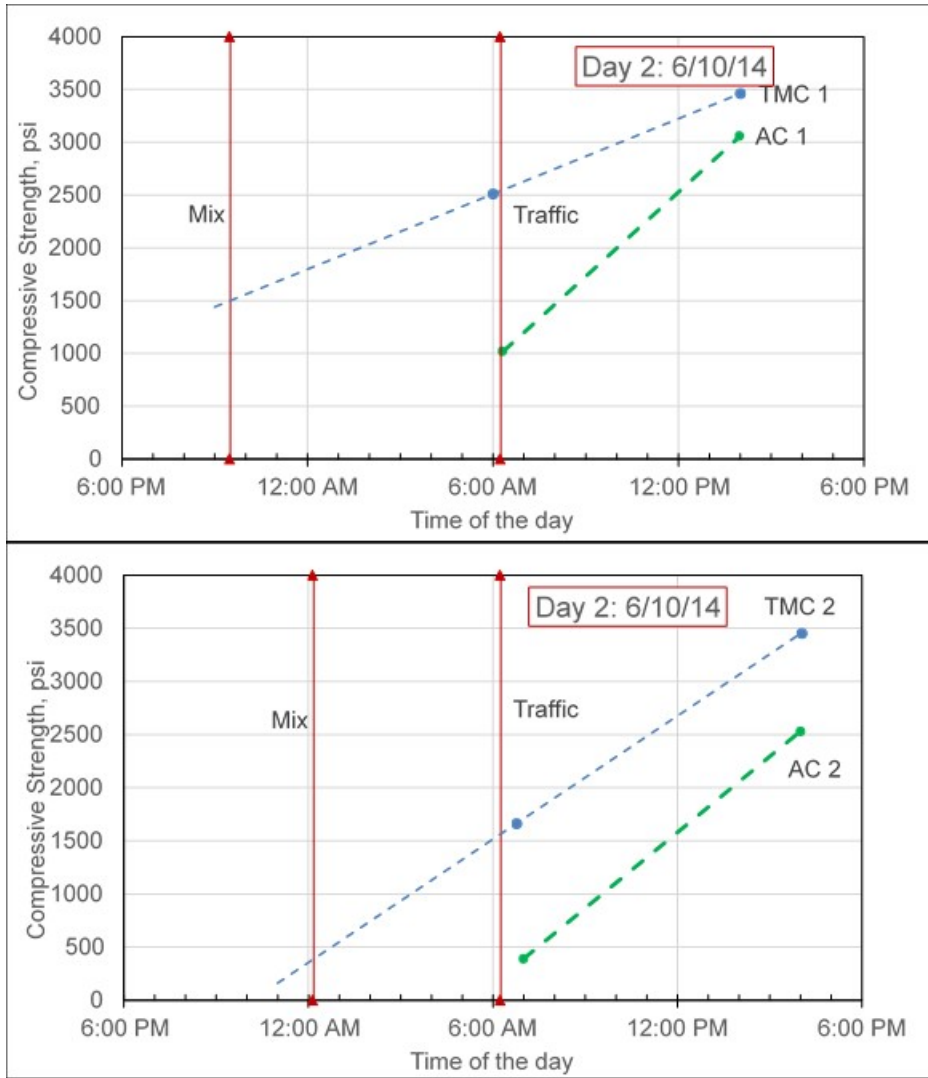
Figure 16. Compressive Strength Development for TMC and AC Cylinders From Patches on SR 288: Day 2 (second day of observation). TMC = temperature matched cured; AC = air cured.

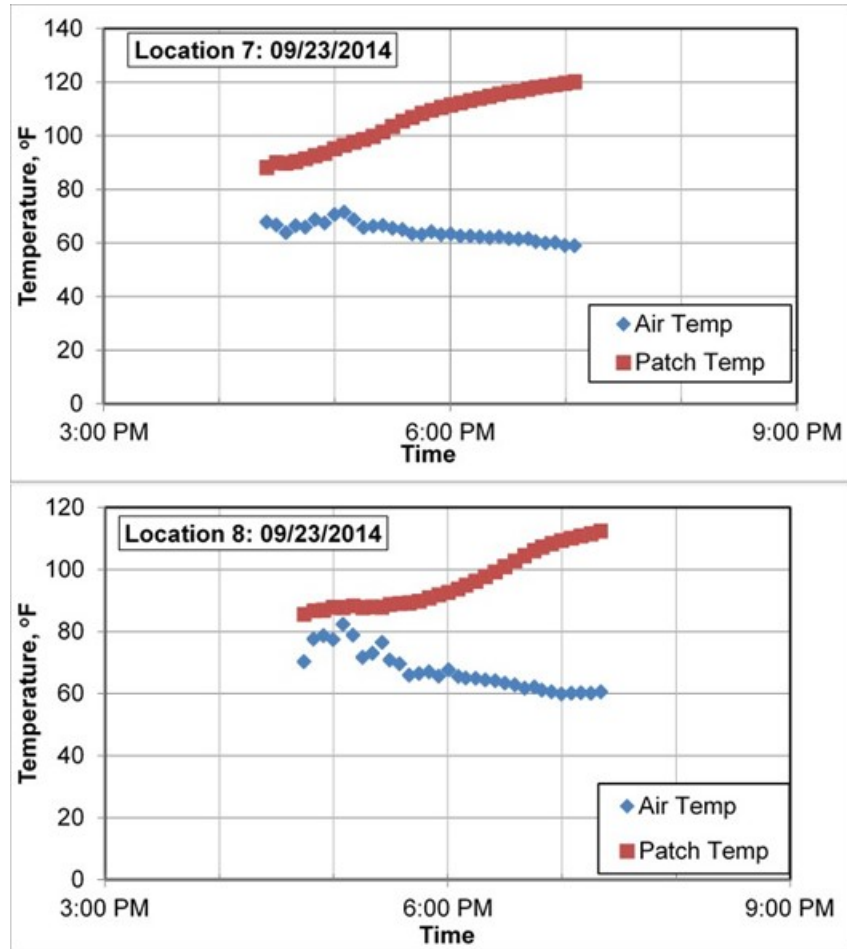
There was a big difference in the temperature of the air and the patches, as shown in Figure 17; as a consequence, the AC cylinder had a much lower early strength than the actual patch would have. Compressive strengths for TMC and AC cylinders as a function of age are shown in Table 9 and Figure 18. TMC strengths were in compliance with VDOT's specification except for that for Patch 2PL, which had a 6.0-hour TMC strength of 400 psi.

Figure 17. Temperature Variation With Time for Patches and Surrounding Air on US 58

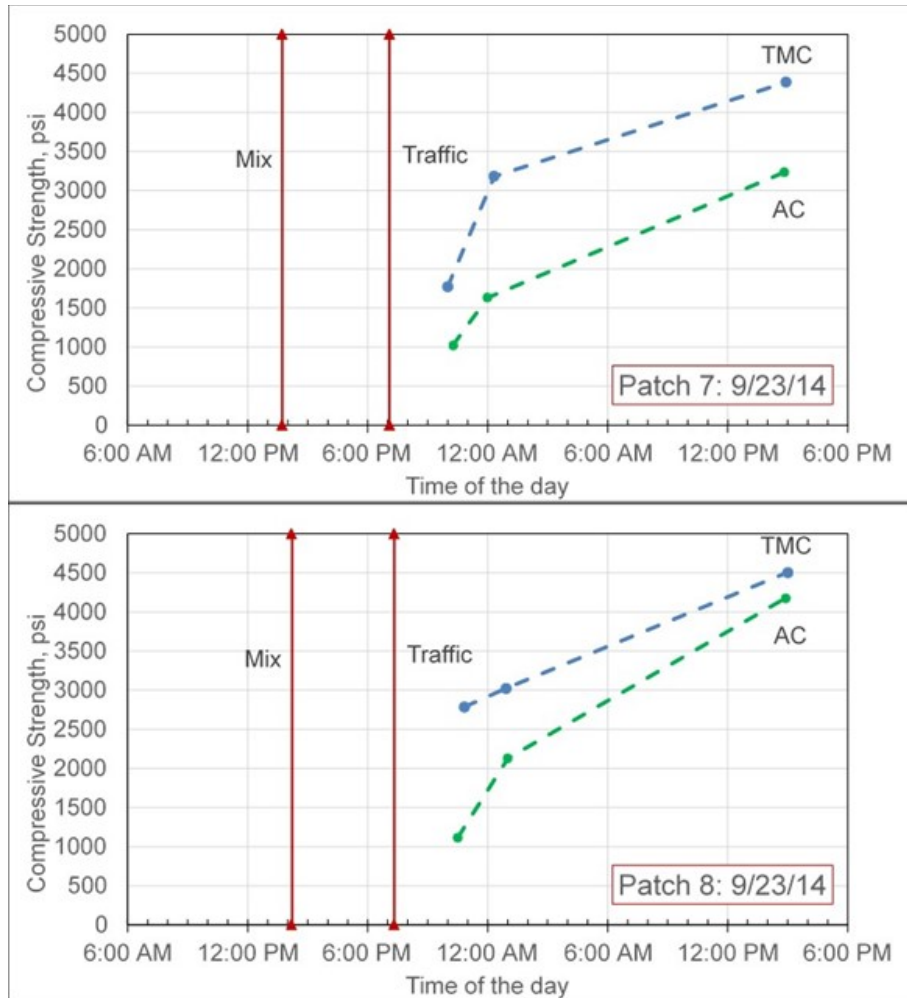
Figure 18. Comparison of Compressive Strength for AC and TMC Cylinders for Patches on US 58. The actual time of opening to traffic was not available and is estimated. AC = air cured; TMC = temperature matched cured.

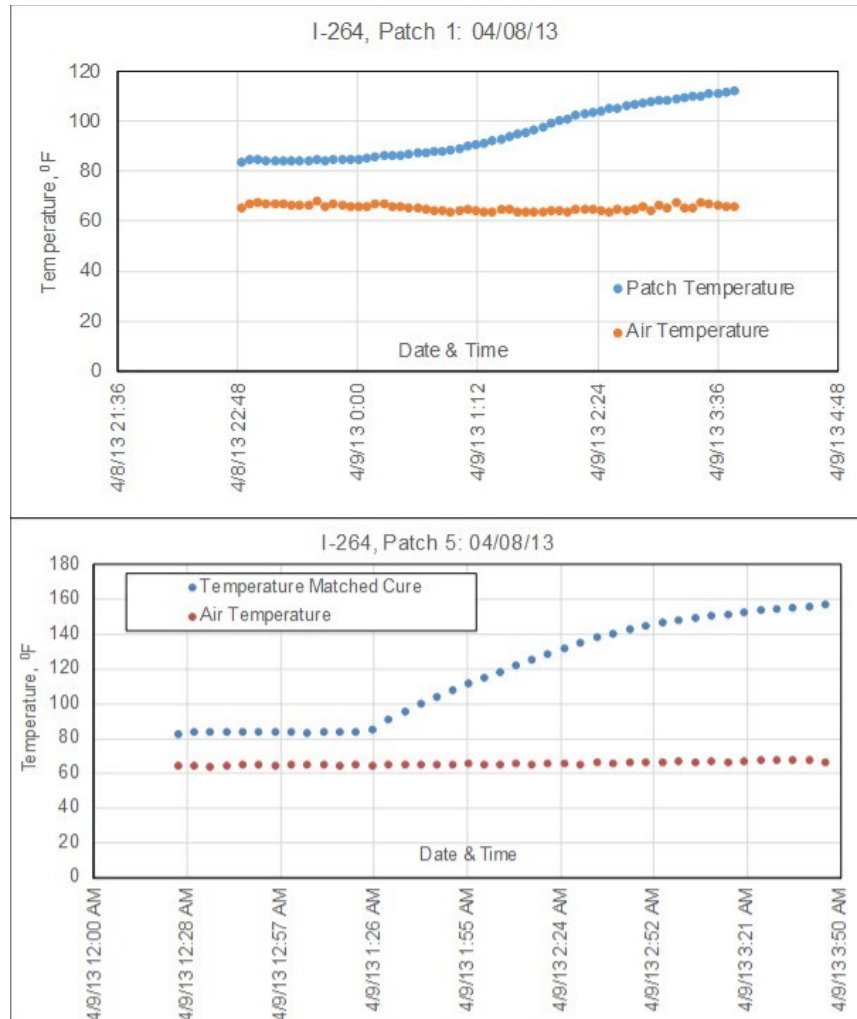
Similar to other patch areas, two patches were monitored on I-264: the first and last batches of a night's work. This was the first project evaluated for this study. This jointed concrete pavement patching was selected because no CRCP projects were available at the start of the study. Only the early age strength behavior of the high early strength patching mixture was investigated. Again, it was also a rich mixture with 800 lb of cement; fresh concrete properties were determined for the first and last patch, which exhibited slumps of 1 in and 3 in, respectively, and air contents of 3.0% and 7.2%, respectively. VDOT No. 57 stone was used for the coarse aggregate. The early age concrete temperatures in the patches and the surrounding air temperatures were recorded for a few hours, and there was a big difference between them, as shown in Figure 19. Eight cylinders (4 by 8 in) were prepared onsite from each patch: four were TMC, and the others were AC. The compressive strengths of the TMC and AC cylinders were determined at different ages and are shown in Table 10 and Figure 20. The results suggest that the mixture satisfied the specification requirement of 1,750 psi at 5 hours in the patch but not in the AC cylinders, since they did not maintain the same temperature as the actual patches.

Figure 19. Temperature Variation With Time for Patches, Surrounding Air, and TMC Cylinders on I-264. TMC = temperature matched cured.

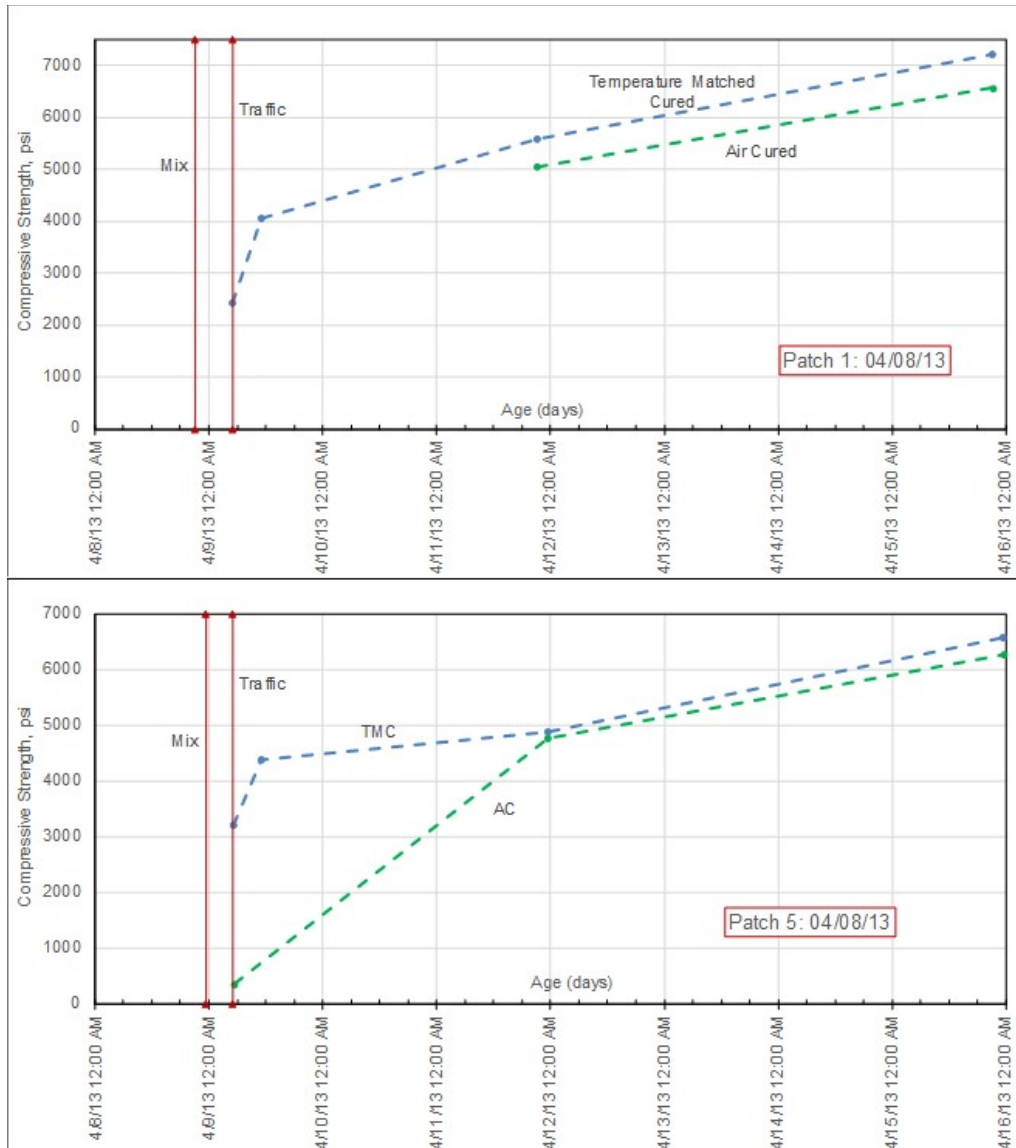
Figure 20. Comparison of Compressive Strength for AC and TMC Cylinders for Patches on I-264. AC = air cured; TMC = temperature matched cured.

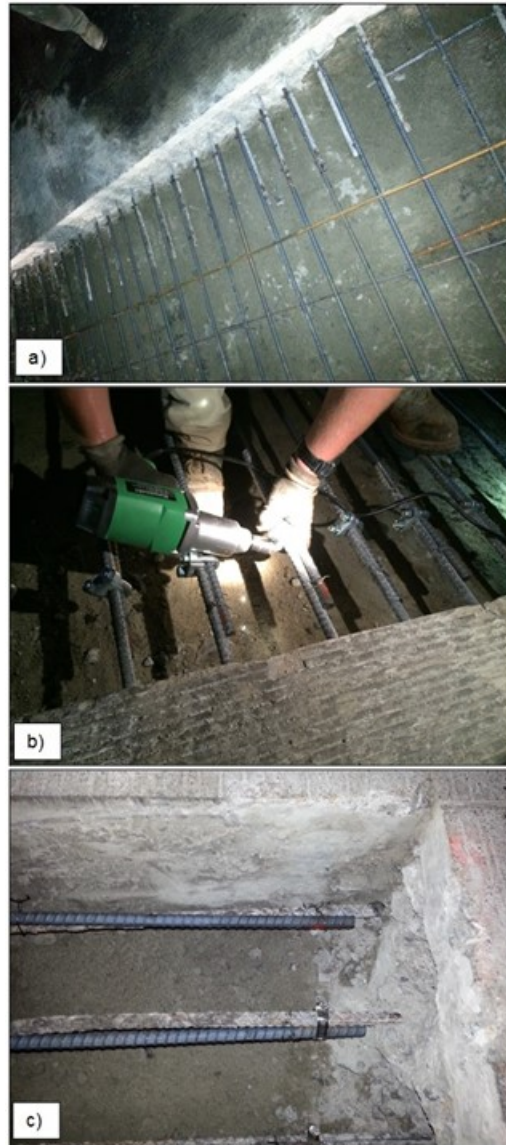
The hose clamps and U-bolts were tried on SR 288 to determine the feasibility of using these alternatives. Because of the concern that the ties do not provide a fixed continuity for the reinforcement, for the first patch on the first night, June 9, 2014, U-bolts were used for tying the reinforcement; hose clamps were attached in the second patch, as shown in Figure 21, but the splice lap length was not changed.

Figure 21. Splicing of Steel in Patches on SR 288: a) conventional method, 18-in overlap with 2 tie wires; b) U-bolts in first patch on the night of 6/9/14; c) hose clamps in second patch on the night of 6/9/14

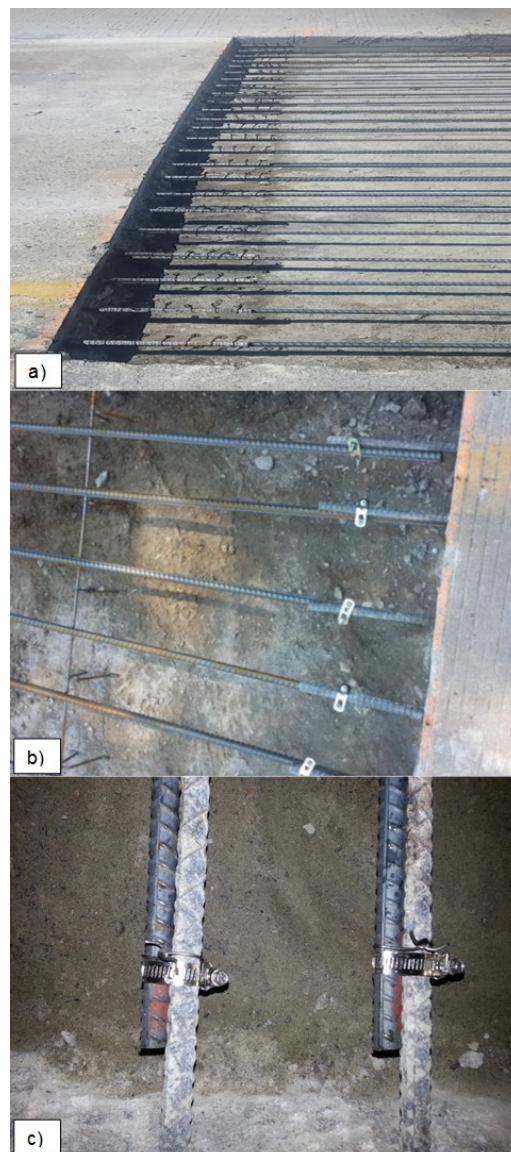
These trial installations (two locations) on SR 288 were done successfully and did not raise any concern. So experimental installations of all three splicing techniques were done as part of the I-85 patching project. The new splice connections on I-85 are shown in Figure 22 and included six tie wires (Figure 22a), U-bolts (Figure 22b), and hose clamps (Figure 22c). The contractor did not have a problem installing the new connections, although some required more time and material than others. For example, six tie wires required more time and materials

Figure 22. Splicing of Steel in Patches on I-85: a) 6 tie wires; b) 1 U-bolt; c) 1 of 2 hose clamps
