Experimental and Analytical Evaluation of Residual Capacity of Corrosion-Damaged Prestressed Concrete Bridge Girders

Via Department of Civil and Environmental Engineering Virginia Tech

Final Report VTRC 21-R6

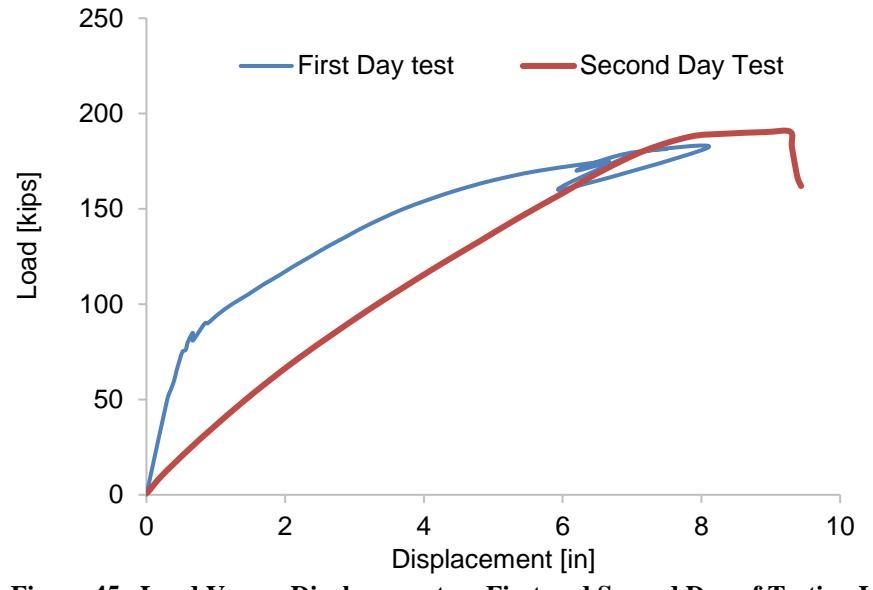
Figure 45. Load Versus Displacement on First and Second Day of Testing I-Beam 7

The load-deflection plot is shown in Figure 45 for first day and second day. For the first day test, a slight change in the slope of the line can be seen at around 80 kips, confirming the

first cracking load determined visually. For the second day test, at around 190 kips the loaddeflection curve begins to plateau, indicating the strands were yielding.

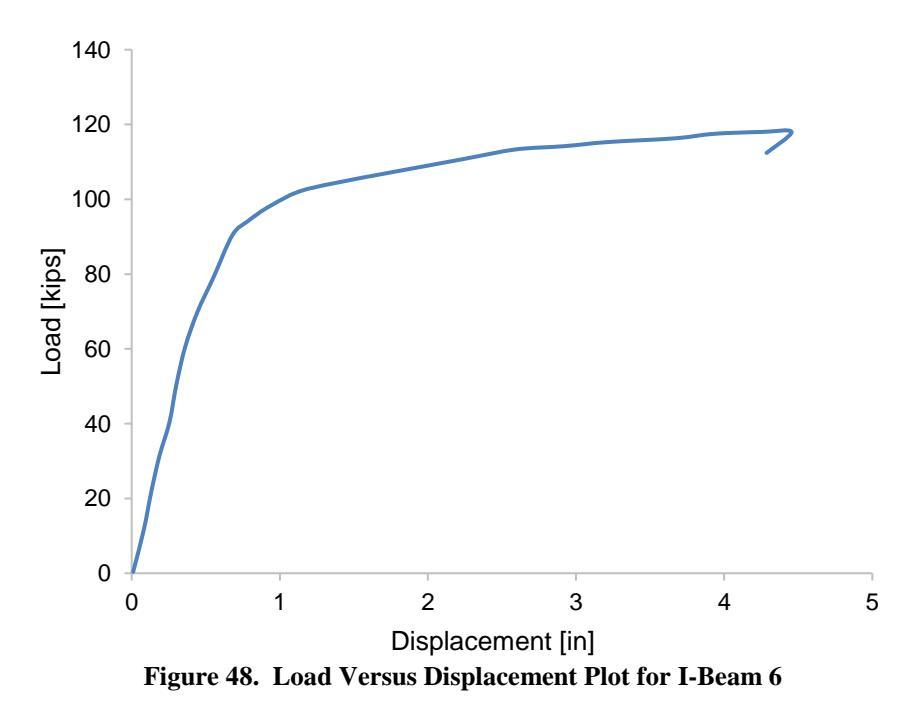
I-Beam 6 failed at an applied load of 118 kips and a deflection of 4.46 in, due to crushing of the top flange. The load versus deflection plot is shown in Figure 48. The first crack was visually observed at 50 kips; however, there was no noticeable change in the slope of the load displacement plot at that load.

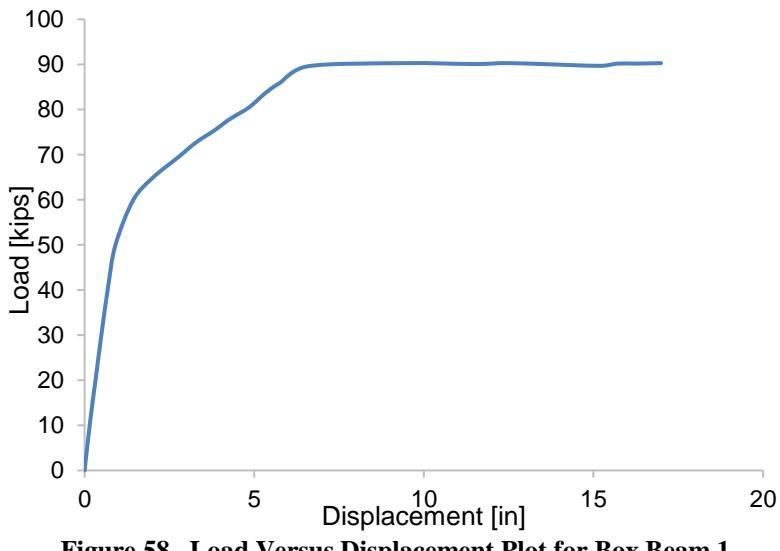
Figure 58. Load Versus Displacement Plot for Box Beam 1

First cracking was observed at a load of 50 kips. After cracking, the researchers applied additional load in 5-kip increments up to 70 kips, after which, the beam was no longer closely inspected, out of concern for safety. Also, after 70 kips, displacement control was used with 0.25-in increments. The test was terminated at 90.3 kips, when the deflection reached 16.99 in without any increase in load. This can be seen in the load versus deflection plot in Figure 58. The large deflection at the ultimate load can be seen in Figure 59.

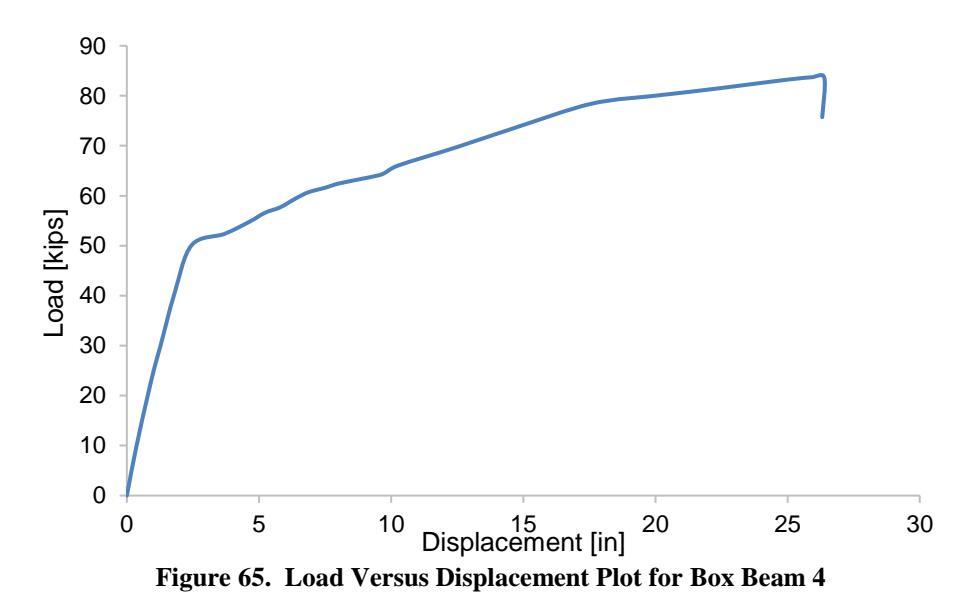
First cracking was visually observed at a load of 45 kips, as confirmed by the change in slope of the load-deflection plot in Figure 65. During the test and at high deflection, considerable water began leaking from the void in the beam. At that point, the load was held constant, and buckets were used to collect the leaking water. After a load of 65 kips, the beam was no longer closely inspected, due to safety concerns. The beam failed when the corroded strands ruptured at an applied load of 83.8 kips. Unfortunately, there was some difficulty with the data collection system before approximately 52 kips of applied load. Thus, strain measurements were not recorded. Additionally, deflection readings were taken manually after 52 kips of applied load, thus the deflection data in the second part of the test was not as accurate as in the previous tests.

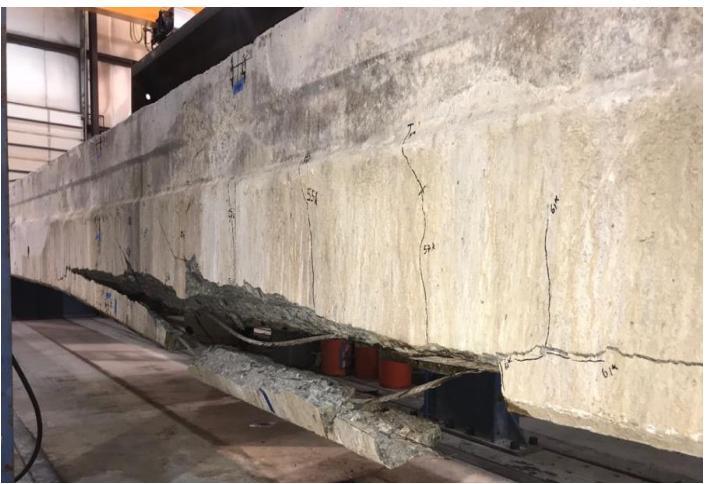
Figure 67. Box Beam 4 East Side after Testing

Figure 66 shows a horizontal crack along the east side of the beam prior to testing. Upon examination after the test, strands along that side did not show significant corrosion, but the strands had yielded (see Figure 67). Figure 68 shows the condition of the west side before testing. It can been seen that the edge strands in the lowest level had severe corrosion, possibly exacerbated by the water that had been trapped in the beam. Figure 69 and Figure 70 show the condition of the west side of the box beam after testing. After the bottom concrete cover had spalled off, it was apparent that the three outermost bottom layer strands were severely corroded.

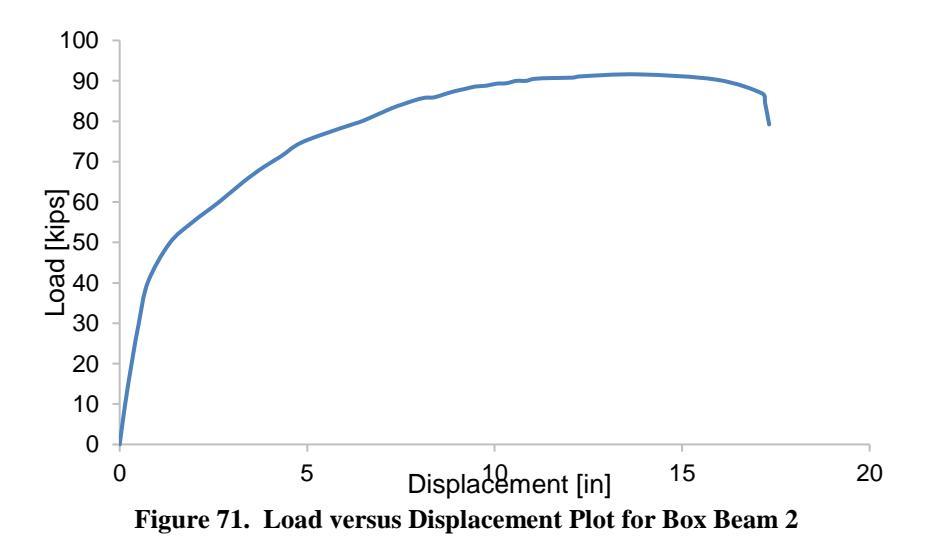
safety purposes, the beam was no longer closely inspected after 65 kips of applied load. Figure 71 presents the load-versus-displacement plot, and Figure 72 shows the top flange crushing.

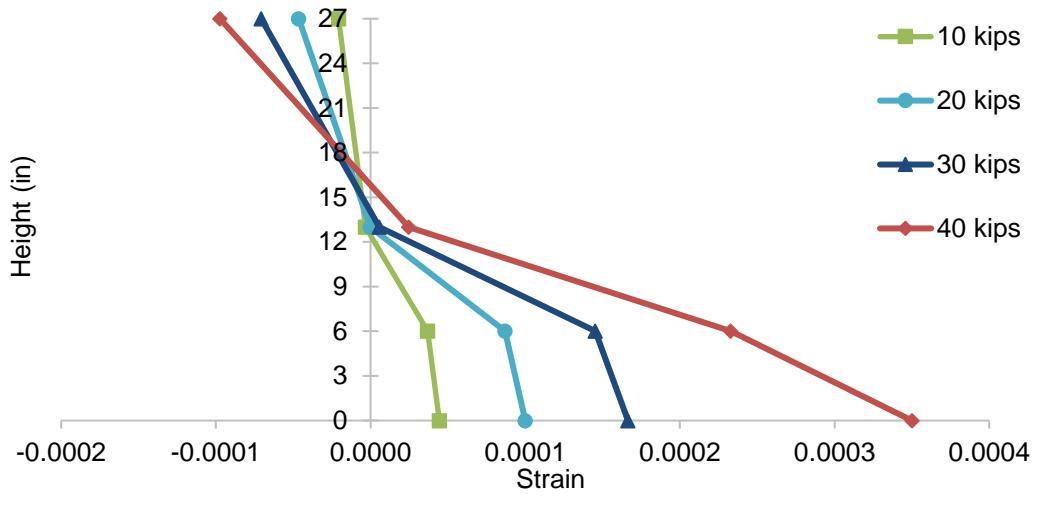
Figure 73. Mid-span Strain Versus Height of Box Beam 2

Based on strain measurements through the depth of the beam at mid-span from loads of 10 kips to 30 kips, the neutral axis was 13.5 in from the bottom of the beam (see Figure 73). The neutral axis based on calculation was also 13.5 in, identical to the neutral axis determined from measurements. Note that the height to the neutral axis increased at 40 kips, indicating that there may have been some microcracking that was not visible to the naked eye. Also note in Figure 71, the change in slope of the load-deflection plot occurred near 40 kips, which also indicated that cracking occurred before it was visually identified at 49 kips. Note that the measurements from the strain gages became erratic shortly after first cracking. Thus, Figure 73 only contains data up to that point.

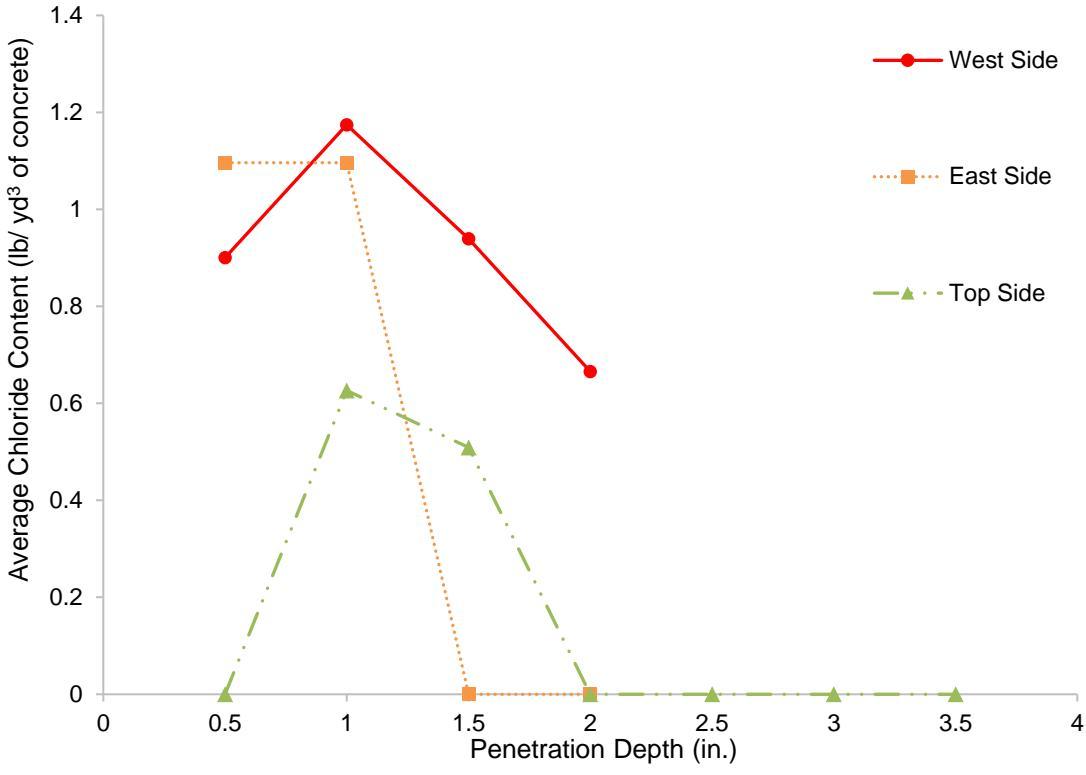
Figure 81. Results of Chloride Testing for Box Beam 2

The results of chloride content testing for Box Beam 2 are shown in Figure 81. Figure 16 shows the locations of the extracted samples on Box Beam 2. As can be seen in the graph, overall, the west side had the highest chloride content at 1.0 in depth. The second highest chloride content was the east side at 0.5 in and 1.0 in. For the top section, the chloride content was the lowest compared to the other parts of the concrete. For all of the sections, as a general trend, the chloride content decreased gradually with depth of the sample.

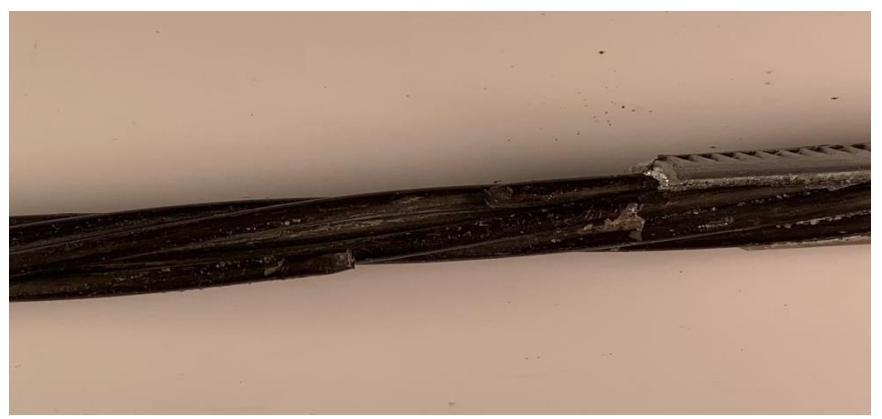
Figure 83. Strand Taken from I-Beam 7 after Testing

Table 10 shows the yield and ultimate tensile strengths of the prestressing strands that were extracted from the end of each beam. As specified in the plans, 7/16-in, stress-relieved grade 270 strands were used in all of the beams. Figures 82 through 93 show the stress-strain relationships and photographs of the prestressing strands. In the plots of stress-strain behavior, the tensile tests results are compared to the stress-strain model which was used in the calculation of the capacity of the beams. The condition of the strands varied from beam to beam. Some of them were heavily damaged, such as the strand from I-beam 6 and all box beams, while strands from I-beam 3 were in a good condition. I-Beam 7 strand had light damage.

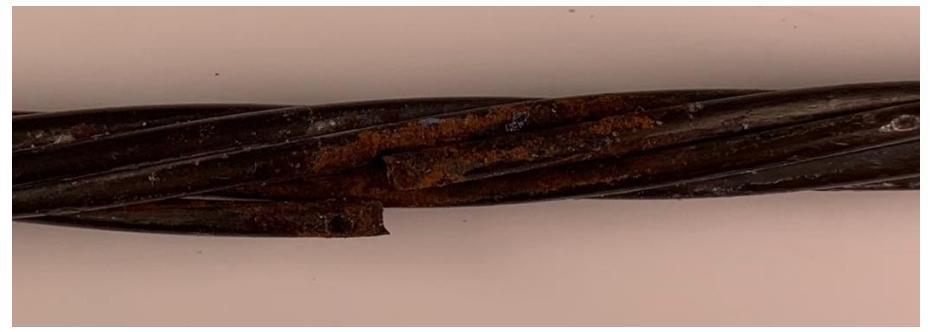
Figure 85. Strand Taken from I-Beam 6 after Testing

All the tensile tests were very similar to the stress strain model, prior to yield, except for the strand from Box Beam 4. The strands extracted from I-beam 6 and all three box beams failed to reach a strain of 0.02, because of their heavy corrosion. The stress-strain behavior of the strand from I-beam 3 was identical to the stress strain model, because it did not show any signs of damage. The strand from I-beam 7 did not achieve the expected ultimate strain, but also had light corrosion on its surface.

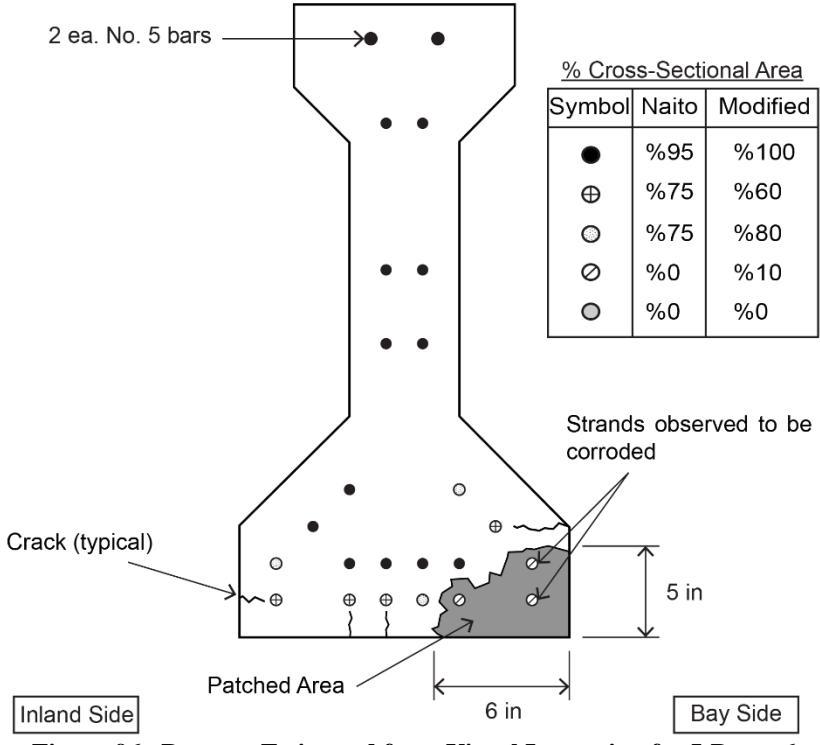
Figure 96. Damage Estimated from Visual Inspection for I-Beam 6

The strength for this beam was calculated using two methods to account for the damage: the recommendations of Naito et al. (2010), and the modified method. The damage inferred from the pre-test visual inspection is presented in Figure 96. The calculations were performed with the tested deck concrete strength of 2900 psi and the beam concrete strength of 6100 psi. The haunch at mid-span was 1.5 in. The tested strength of this beam was 1393 k-ft. The calculations using strain compatibility and the AASHTO method are presented in Table 12. Based on the damage maps, two out of six strands in the first lower level were in a patched area, and the other two had longitudinal cracks. Additionally, one strand out of six in the second lower level was in the patched area.

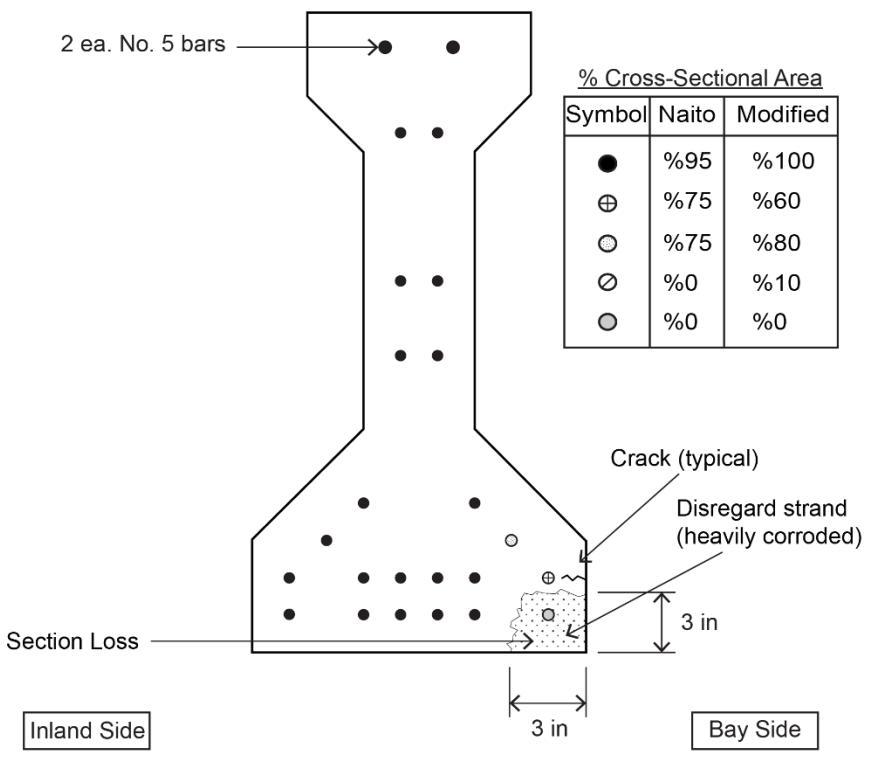
Figure 98. Damage Estimated from Visual Inspection for I-Beam 3

Naito et al. (2010) and the modified method were used to account for the damage in I-Beam 3 (see Figure 98). Prior to testing, there was one exposed strand in the first lower level. The deck concrete strength was 3500 psi and the beam concrete strength was 5600 psi. The haunch at mid-span was 1.5 in. The tested strength of this beam was 1873 k-ft. The effective

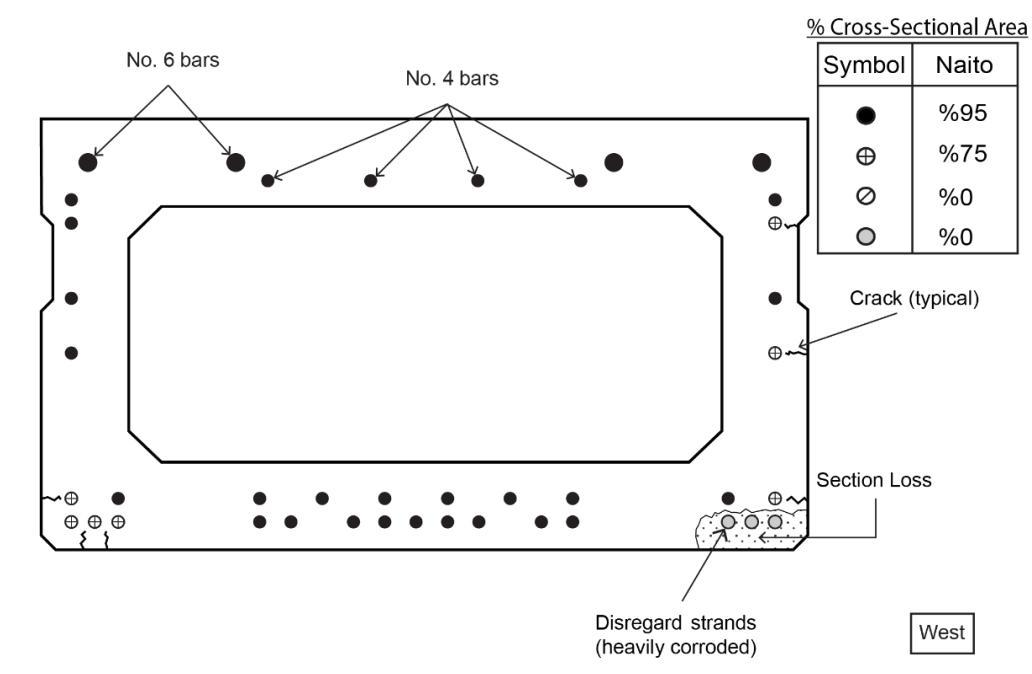
Figure 99. Damage Estimated from Visual Inspection for Box Beam 1

The cross-sectional area of the strands in Box Beam 1 to be used for calculations were assumed using the recommendations of Naito et al. (2010). Based on visual inspection, three exposed strands in the first lower level were heavily corroded (see Figure 99). Those assumptions, along with the tested concrete strength of 7250 psi, resulted in estimated flexural strengths that were within about 1% the actual strength determined from load testing. The total moment on the beam during testing, including self-weight, was 1269 k-ft. Using strain compatibility, the calculated flexural strength was 1253 k-ft, while the capacity at ultimate using the AASHTO method was slightly lower at 1251 k-ft. Note that the effective prestress calculated from the observed 50-kip cracking load and the Naito et al. (2010) recommendations was 128 ksi, which was about 18% below the AASHTO-based effective prestress.

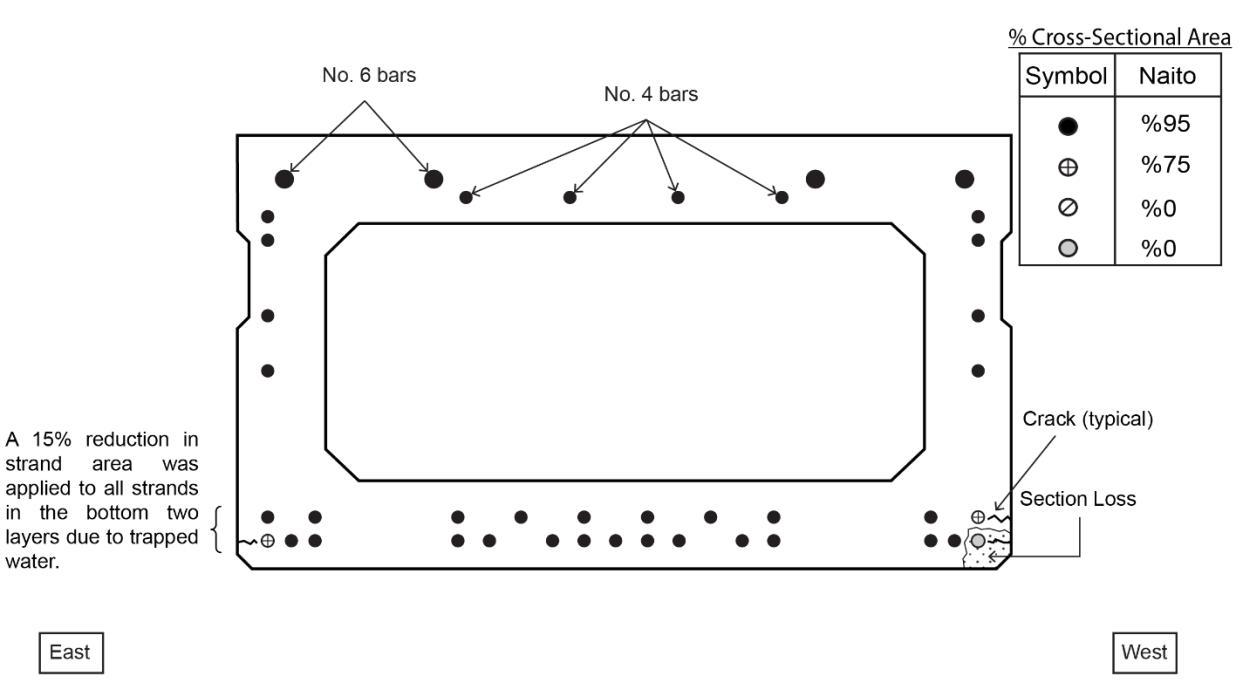
Figure 100. Damage Estimated from Visual Inspection for Box Beam 4

Box Beam 4 had different conditions than the other two box beams, with water trapped in the beam leading to a lower strength. The recommendations of Naito et al. (2010) were used with a small modification to account for the trapped water, where a 15% reduction was applied on top of the Naito reductions to the two lower strands levels (see Figure 100). This percentage reduction gave reasonable calculated results. Based on the compressive test, the concrete strength was 6250 psi. The tested strength of this beam was 1196 k-ft. The calculations using strain compatibility and the AASHTO method are presented in Table 14. Note that the actual cracking load of 50 kips resulted in an effective prestress equal 167 ksi. On the other hand, the effective prestress calculated from the AASHTO method was 156 ksi. This latter value for effective prestress was used in the strain compatibility calculation method for flexural strength.

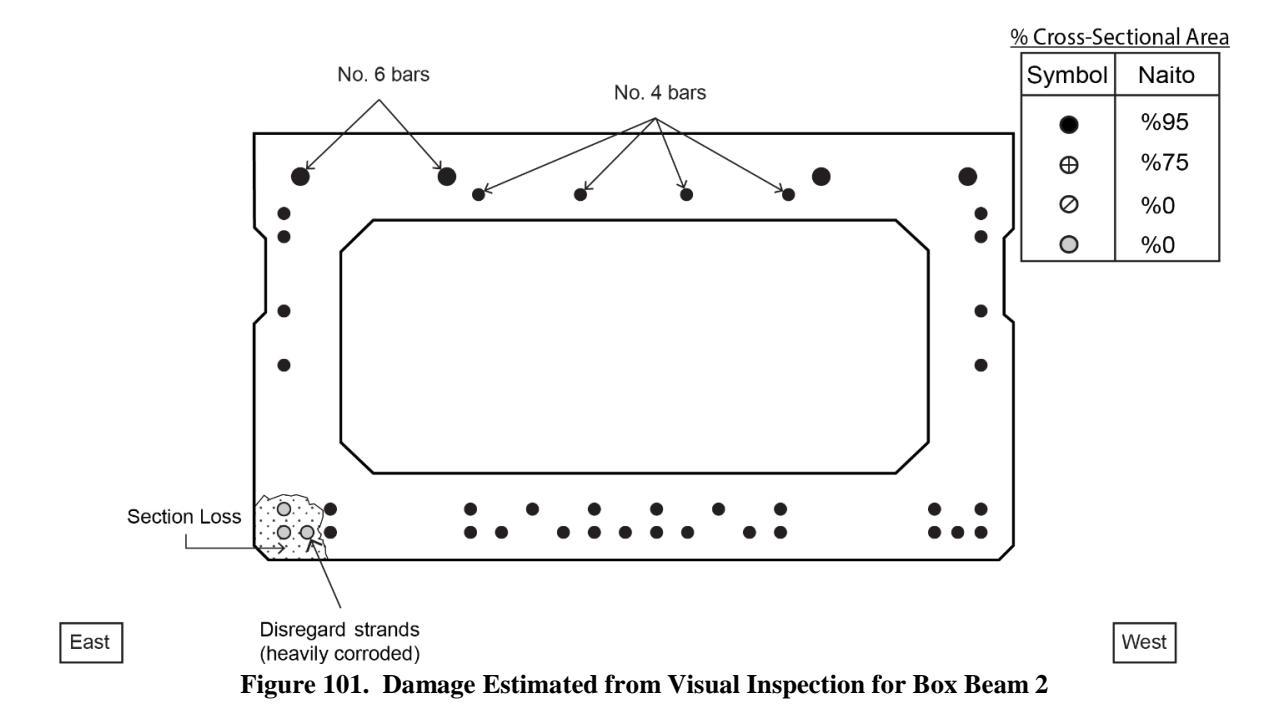
The residual capacity for Box Beam 2 was calculated using the recommendations of Naito et al. (2010) to estimate the remaining cross-sectional area of the strands. Three exposed strands were disregarded in the calculation of the flexural strength (see Figure 101). The concrete strength used in the calculation was 7100 psi which was obtained from compression tests of extracted cores. The tested strength of this beam was 1284k-ft. Following the strain compatibility method, the flexural strength was calculated to be 1292 k-ft. Using the AASHTO method resulted in a moment equal to 1289 k-ft. Based on the actual cracking load (49 kips), the effective prestress calculated was 146 ksi. On the other hand, the effective prestress calculated from the AASHTO method was 156 ksi.
