## Experimental and Analytical Evaluation of Residual Capacity of Corrosion-Damaged Prestressed Concrete Bridge Girders

**Final Report VTRC 25-R18**

### **EXPERIMENTAL AND ANALYTICAL EVALUATION OF RESIDUAL CAPACITY OF CORROSION-DAMAGED PRESTRESSED CONCRETE BRIDGE GIRDERS**

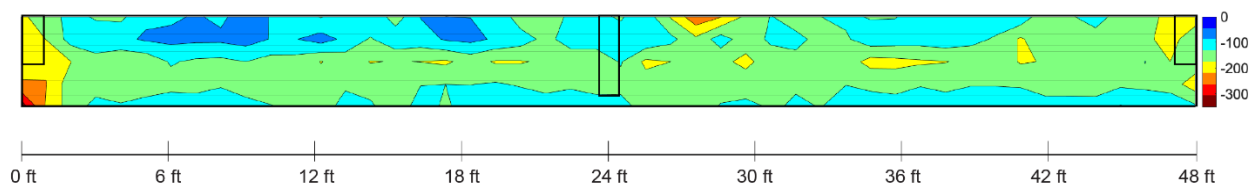
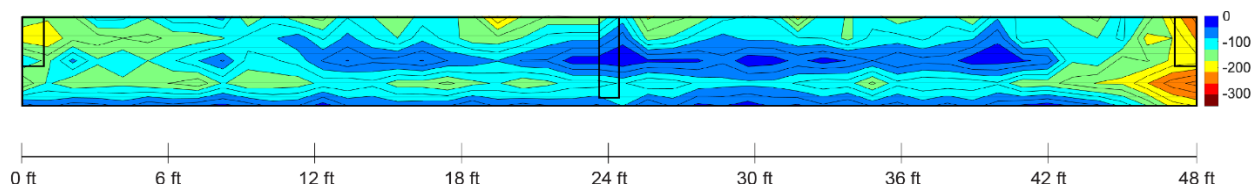
**Figure 33. Half-Cell Potential Results for I-Beam 7 - Good Condition - Bay Side (mV)**

**Figure 34. Half-Cell Potential Results for I-Beam 7 - Good Condition - Inland Side (mV)**

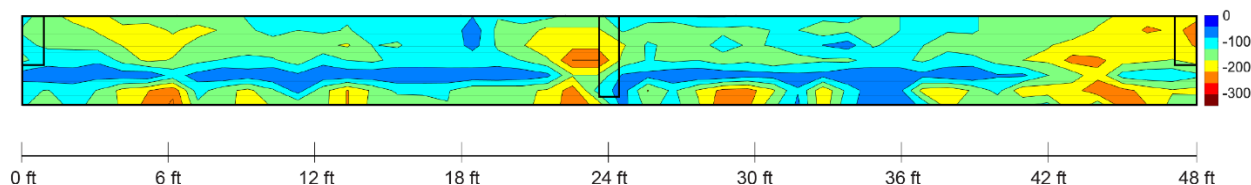
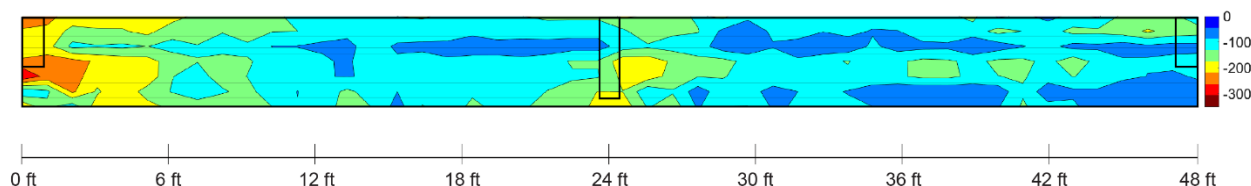
As discussed in the Methods section, half-cell corrosion mapping was used to identify the possibility of active corrosion in the girders. Unfortunately, for I-Beam 3, which was in poor condition, the half-cell potential data could not be retrieved from stored files, and no back-ups had been made. For the good condition I-Beam 7, the half-cell did not show any indication of corrosion, which matched the visual damage maps. For I-Beam 6, which was considered to be in medium condition, visual inspections indicated active corrosion along much of the bottom flange of the bay side of the beam. The half-cell also indicated possible corrosion along the bay side bottom flange and near the ends of the beam.

**Figure 35. Half-Cell Potential Results for I-Beam 6 - Medium Condition - Bay Side (mV)**

**Figure 36. Half-Cell Potential Results for I-Beam 6 - Medium Condition - Inland Side (mV)**

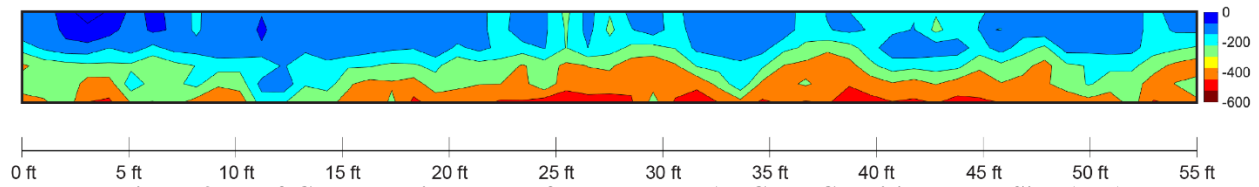
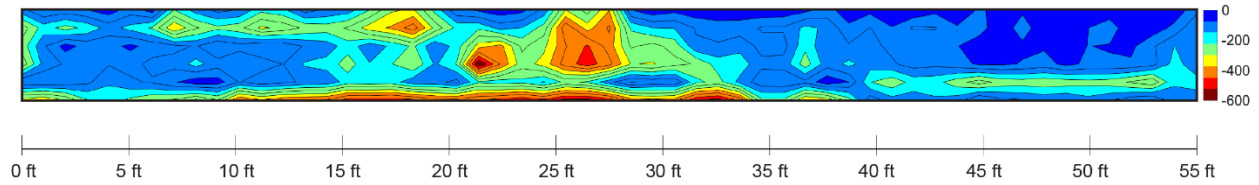
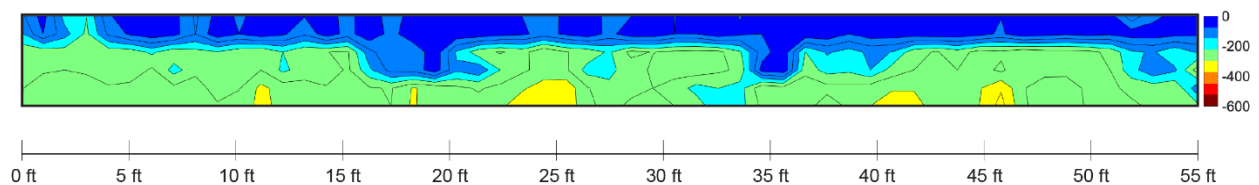
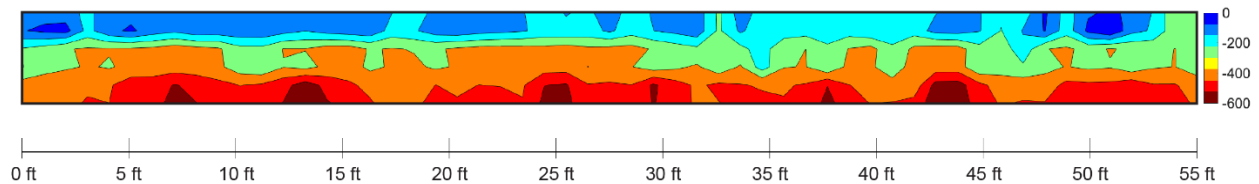
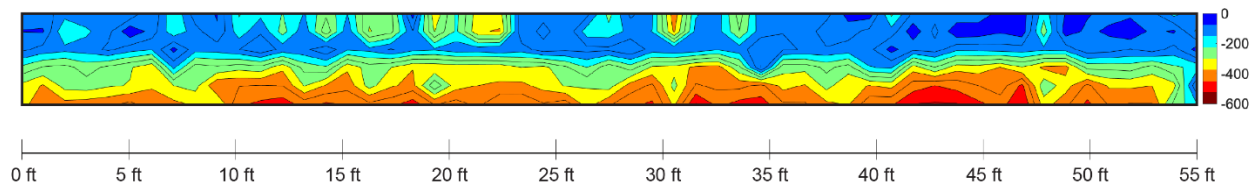
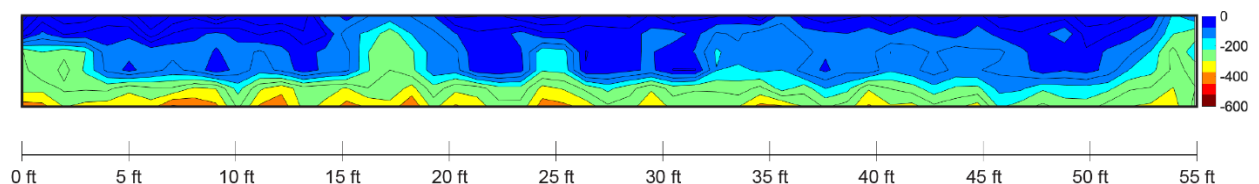
All of the Aden Road box beams showed high potential for corrosion along the bottom edge of the beams. These results for the box beams are in agreement with the visual inspection, which indicated considerable spalling, delamination and exposed, corroded strands.

**Figure 41. Half-Cell Potential Results for Box Beam 2 – Bad Condition - East Side (mV)**

**Figure 42. Half-Cell Potential Results for Box Beam 2 – Bad Condition - West Side (mV)**

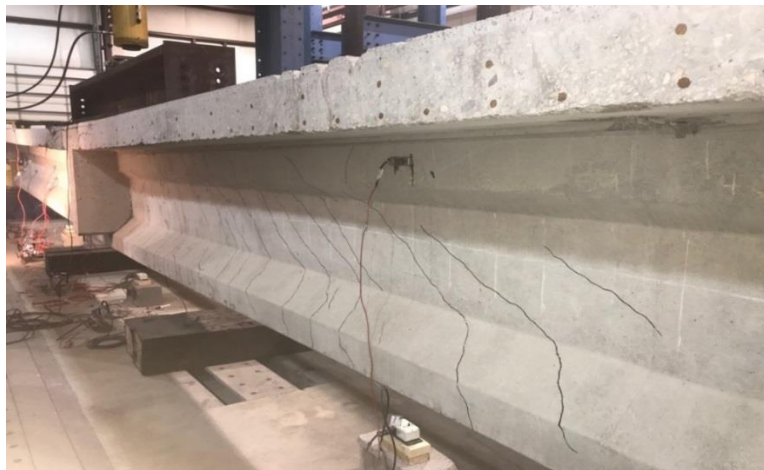
**Figure 44. Residual Deflection after Testing I-Beam 7**

One week later, the beam was re-tested. The load was applied in increments of 20 kips until reaching 140 kips, at which point 10-kip increments were applied until the failure load of 190 kips with a deflection of 8.93 in. The failure was caused by crushing of the top slab as shown in Figure 43. The beam after testing is shown in Figure 44.

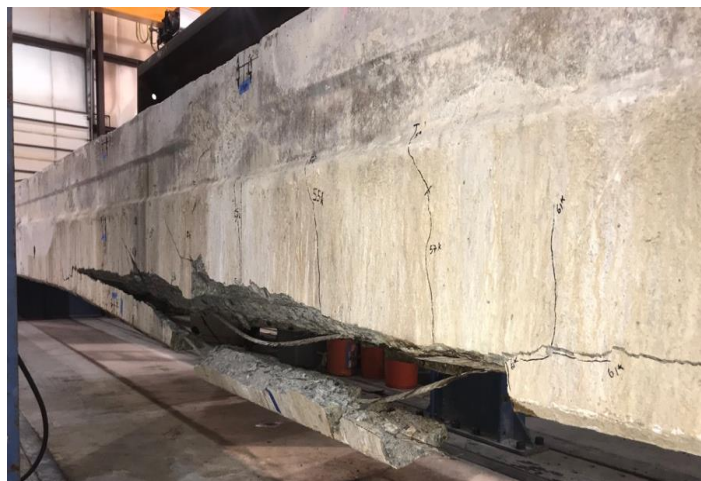
**Figure 67. Box Beam 4 East Side after Testing**

Figure 66 shows a horizontal crack along the east side of the beam prior to testing. Upon examination after the test, strands along that side did not show significant corrosion, but the strands had yielded (see Figure 67). Figure 68 shows the condition of the west side before testing. It can be seen that the edge strands in the lowest level had severe corrosion, possibly exacerbated by the water that had been trapped in the beam. Figure 69 and Figure 70 show the condition of the west side of the box beam after testing. After the bottom concrete cover had spalled off, it was apparent that the three outermost bottom layer strands were severely corroded.

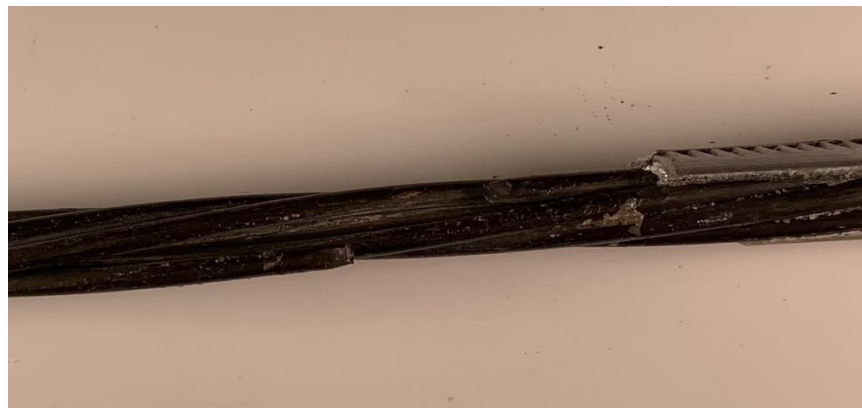
**Figure 83. Strand Taken from I-Beam 7 after Testing**

Table 10 shows the yield and ultimate tensile strengths of the prestressing strands that were extracted from the end of each beam. As specified in the plans, 7/16-in, stress-relieved grade 270 strands were used in all of the beams. Figures 82 through 93 show the stress-strain relationships and photographs of the prestressing strands. In the plots of stress-strain behavior, the tensile tests results are compared to the stress-strain model which was used in the calculation of the capacity of the beams. The condition of the strands varied from beam to beam. Some of them were heavily damaged, such as the strand from I-beam 6 and all box beams, while strands from I-beam 3 were in a good condition. I-Beam 7 strand had light damage.

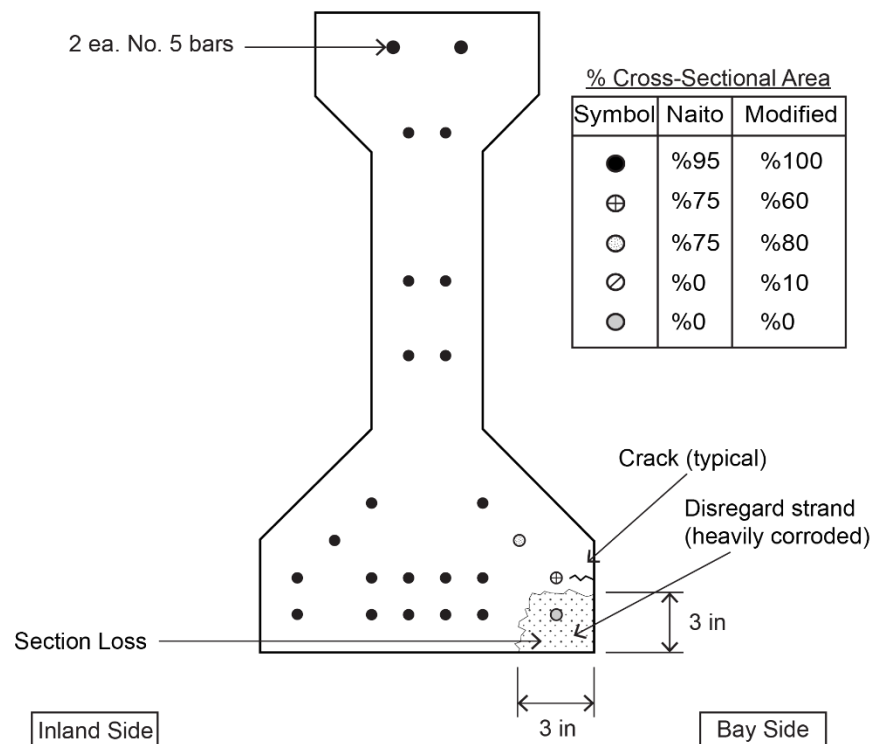
**Figure 98. Damage Estimated from Visual Inspection for I-Beam 3**

Naito et al. (2010) and the modified method were used to account for the damage in I-Beam 3 (see Figure 98). Prior to testing, there was one exposed strand in the first lower level. The deck concrete strength was 3500 psi and the beam concrete strength was 5600 psi. The haunch at mid-span was 1.5 in. The tested strength of this beam was 1873 k-ft. The effective

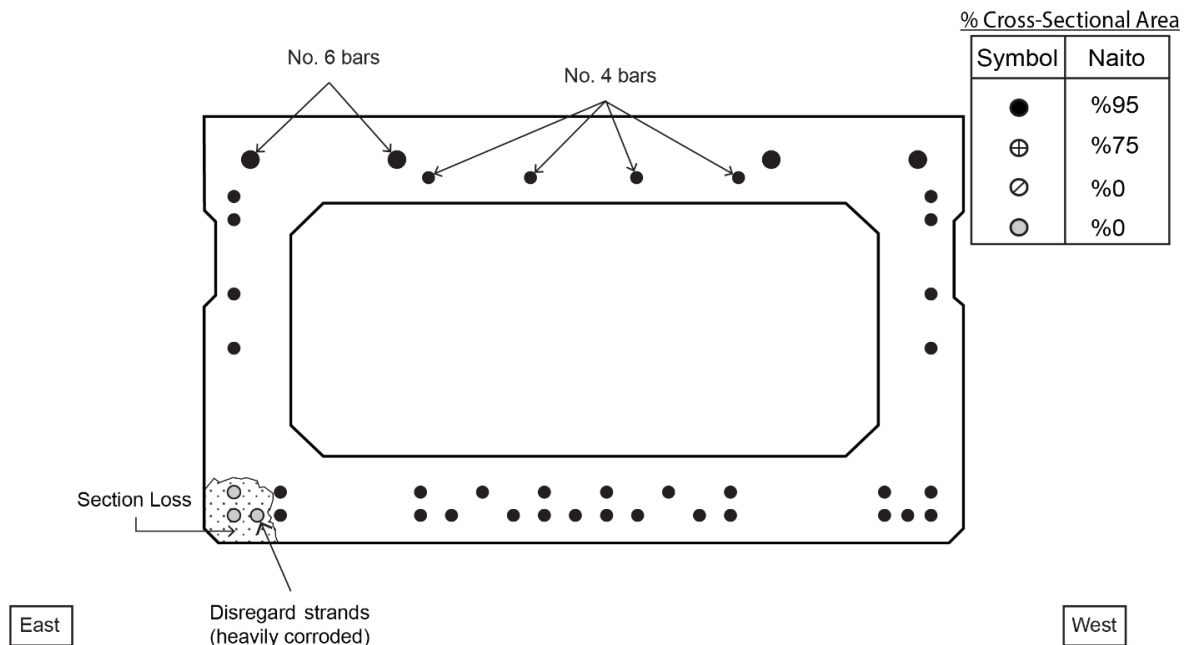
**Figure 101. Damage Estimated from Visual Inspection for Box Beam 2**

The residual capacity for Box Beam 2 was calculated using the recommendations of Naito et al. (2010) to estimate the remaining cross-sectional area of the strands. Three exposed strands were disregarded in the calculation of the flexural strength (see Figure 101). The concrete

strength used in the calculation was 7100 psi which was obtained from compression tests of extracted cores. The tested strength of this beam was 1284k-ft. Following the strain compatibility method, the flexural strength was calculated to be 1292 k-ft. Using the AASHTO method resulted in a moment equal to 1289 k-ft. Based on the actual cracking load (49 kips), the effective prestress calculated was 146 ksi. On the other hand, the effective prestress calculated from the AASHTO method was 156 ksi.
