INSTALLATION REPORT  
THE USE OF FABRIC REINFORCED OVERLAYS  
TO CONTROL REFLECTION CRACKING OF  
COMPOSITE PAVEMENTS

K. H. McGhee  
Highway Research Engineer  
and  
C. S. Hughes  
Senior Highway Research Scientist

Virginia Highway Research Council  
(A Cooperative Organization Sponsored Jointly by the Virginia  
Department of Highways and the University of Virginia)

February 1973  
VHRC 72-R27

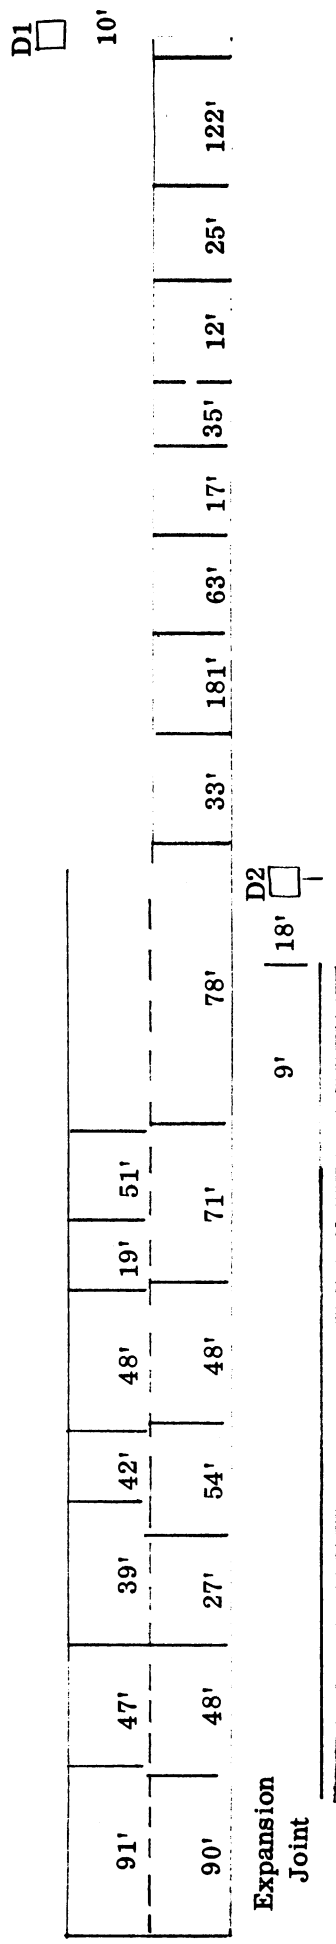
North of Bridge 619.  
Sta. 23 + 48

∞ 22 Petromat

M indicates crack covered with Monsanto. Total = 25

P indicates crack covered with Petromat. Total = 25.

Dashed line indicates uncovered crack. Total = 8.
