A FIELD EVALUATION OF TRANSFLEX  
BRIDGE JOINT PERFORMANCE

Marvin H. Hilton  
Highway Research Engineer

Virginia Highway Research Council  
(A Cooperative Organization Sponsored Jointly by the Virginia  
Department of Highways and the University of Virginia)

November 1972  
VHRC 72-R16

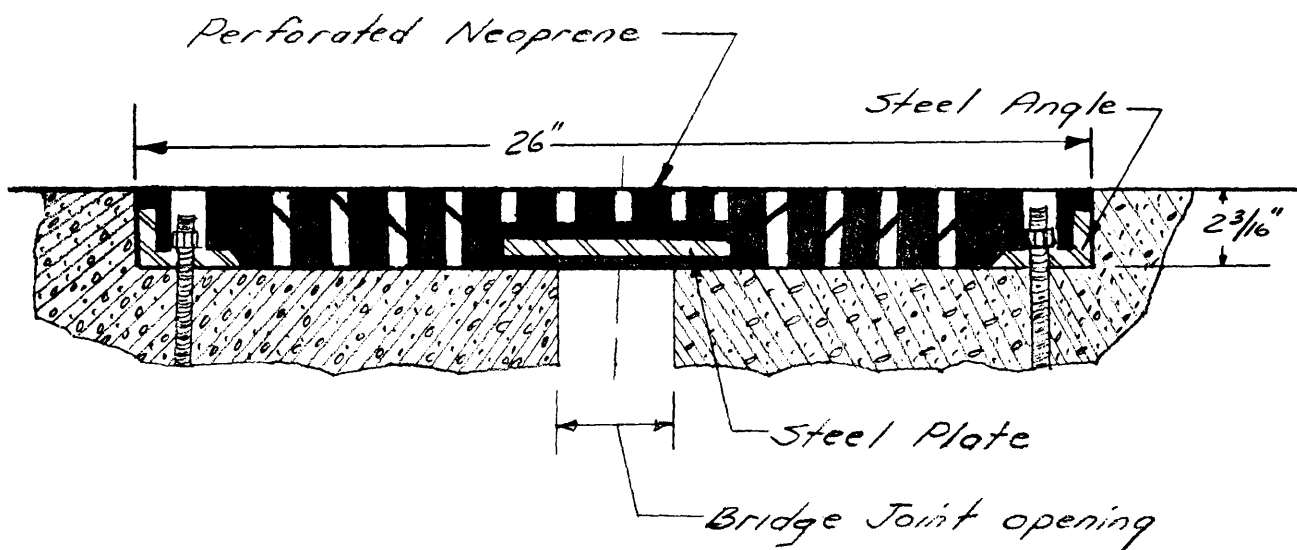
Figure 1. View of an old model Transflex 400 joint with the "honeycomb" type surface texture. (Rte. 154 over Jackson River.)

The model 400 joint (shown earlier in Figures 1 and 2) is in service on three bridges. One, the Route 154 bridge over the Jackson River at Covington, has a steel joint installed at one abutment and a Transflex joint at the other. Inspection of the bridge revealed a number of stained streaks down the face of the abutment backwalls, which suggests that leakage of both joints has occurred. Assuming that joint leakage caused the streaks, it was apparent from a comparison of the two backwalls that the Transflex joint was allowing much less water to pass through.

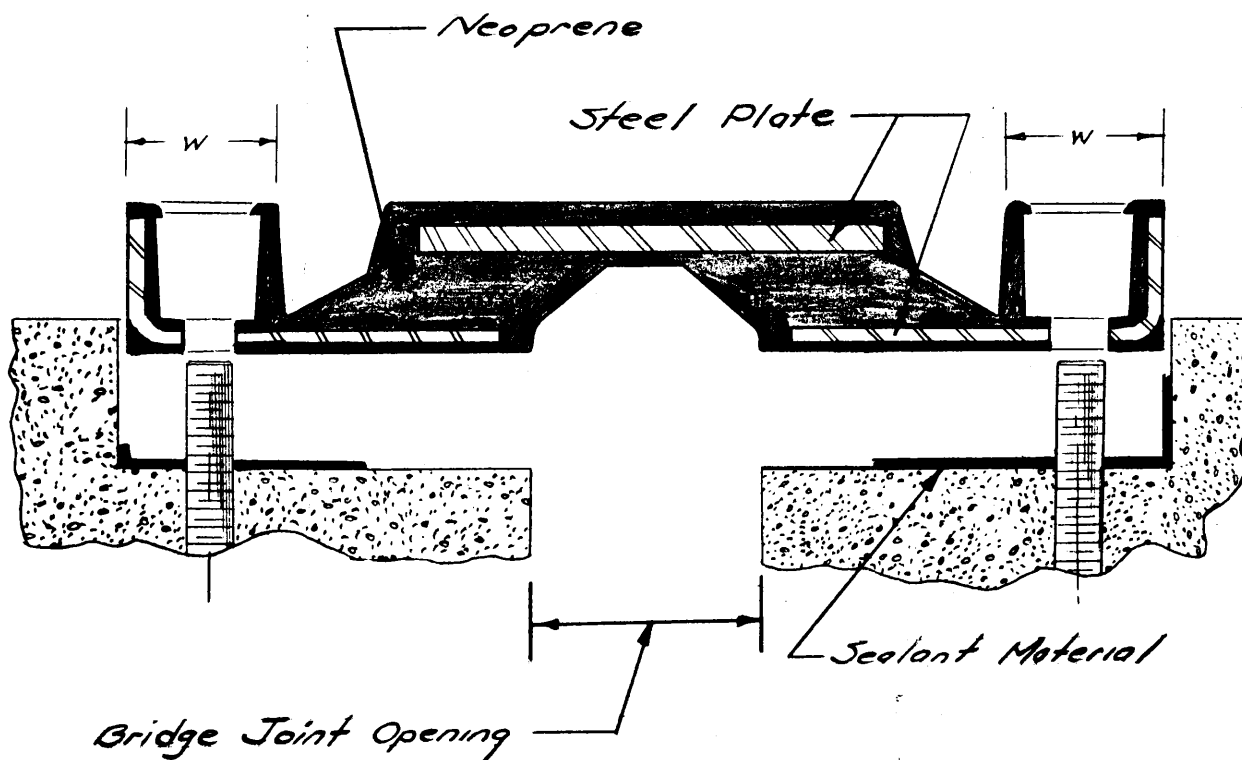
One of the earlier models, which is in service on three Virginia bridges, has been entirely redesigned by the manufacturer. This particular joint, the old model 400, shown in Figure 1, has a perforated or honeycombed surface that was designed to accommodate horizontal movement. As shown in Figure 2, the neoprene portion of the joint is reinforced with a steel plate which falls directly over the bridge deck opening. In addition, two steel angles are located on each side of the joint in the anchorage area. This 26 inch wide joint was supplied in 4 foot lengths and had five mounting slots on each side for the anchoring studs. After the joint has been placed and anchored, the cavity slots are plugged with neoprene caps to aid in sealing out moisture and preventing corrosion. In order to seal the interface between the neoprene joint and the concrete deck, a sealant material must be used on all Transflex joint models.

Figure 2. Transverse section of an older model Transflex 400 joint.
