MEASURES FOR PREVENTING WRONG-WAY ENTRIES ON HIGHWAYS

N. K. Vaswani  
Highway Research Engineer

Virginia Highway Research Council

June 1973  
VHRC 72-R41

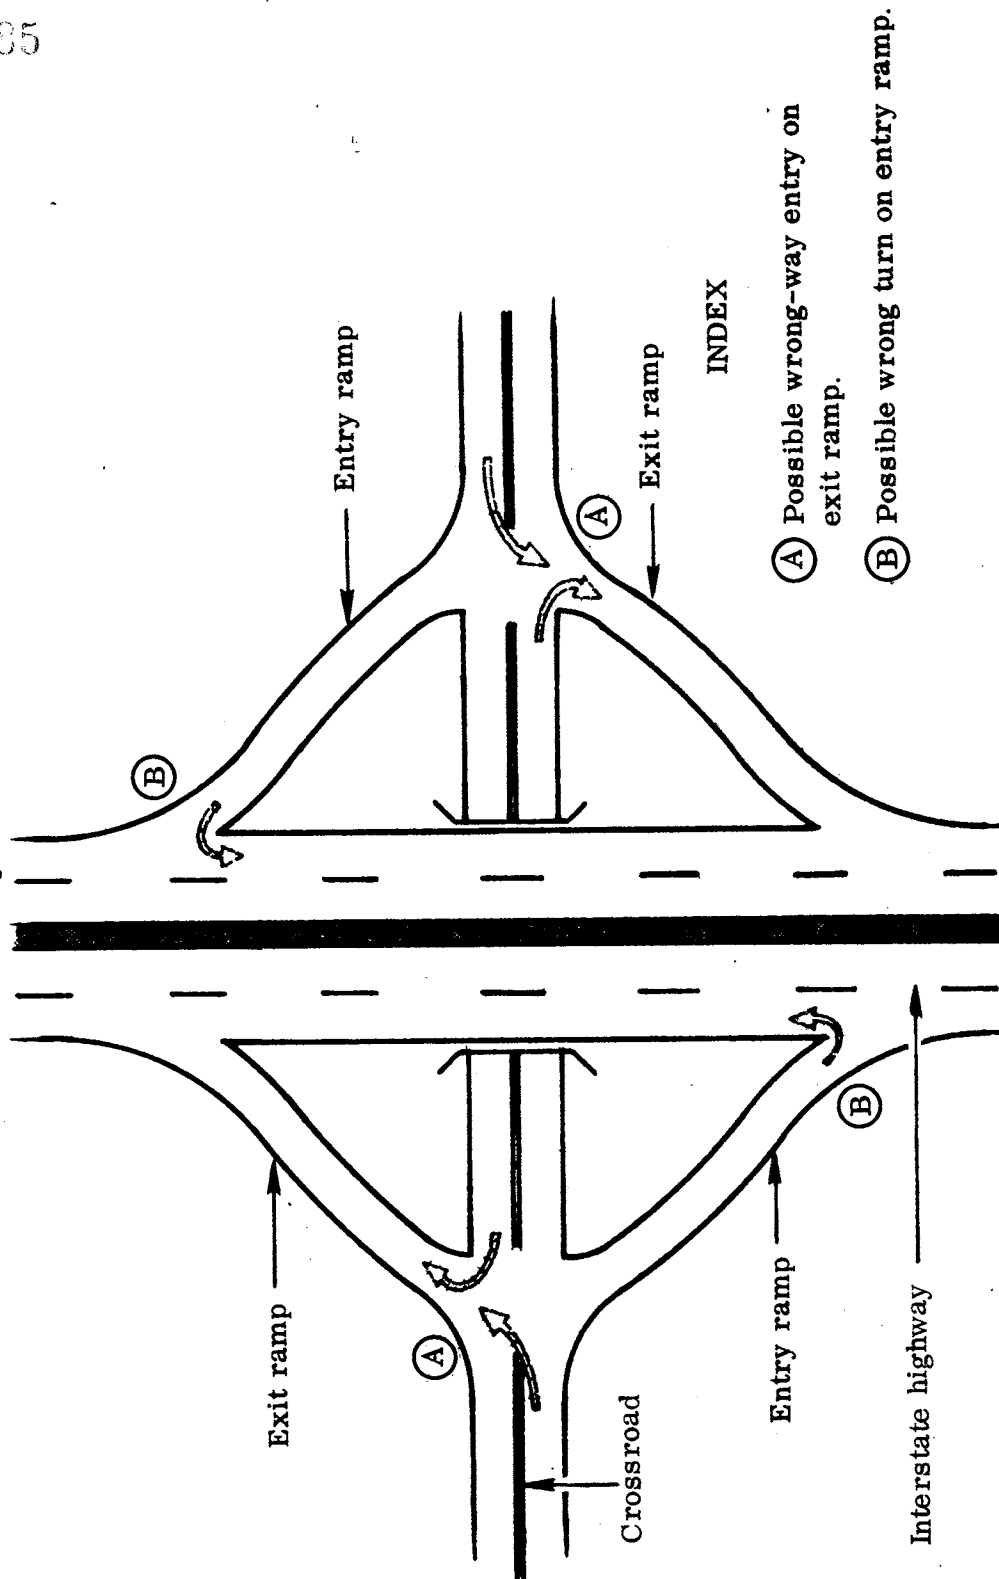
- (a) From an undivided crossroad into the exit ramp by left and right turns as shown by the arrows in Figure 2.

Figure 2. Location and direction of wrong-way entries on interstate highway.

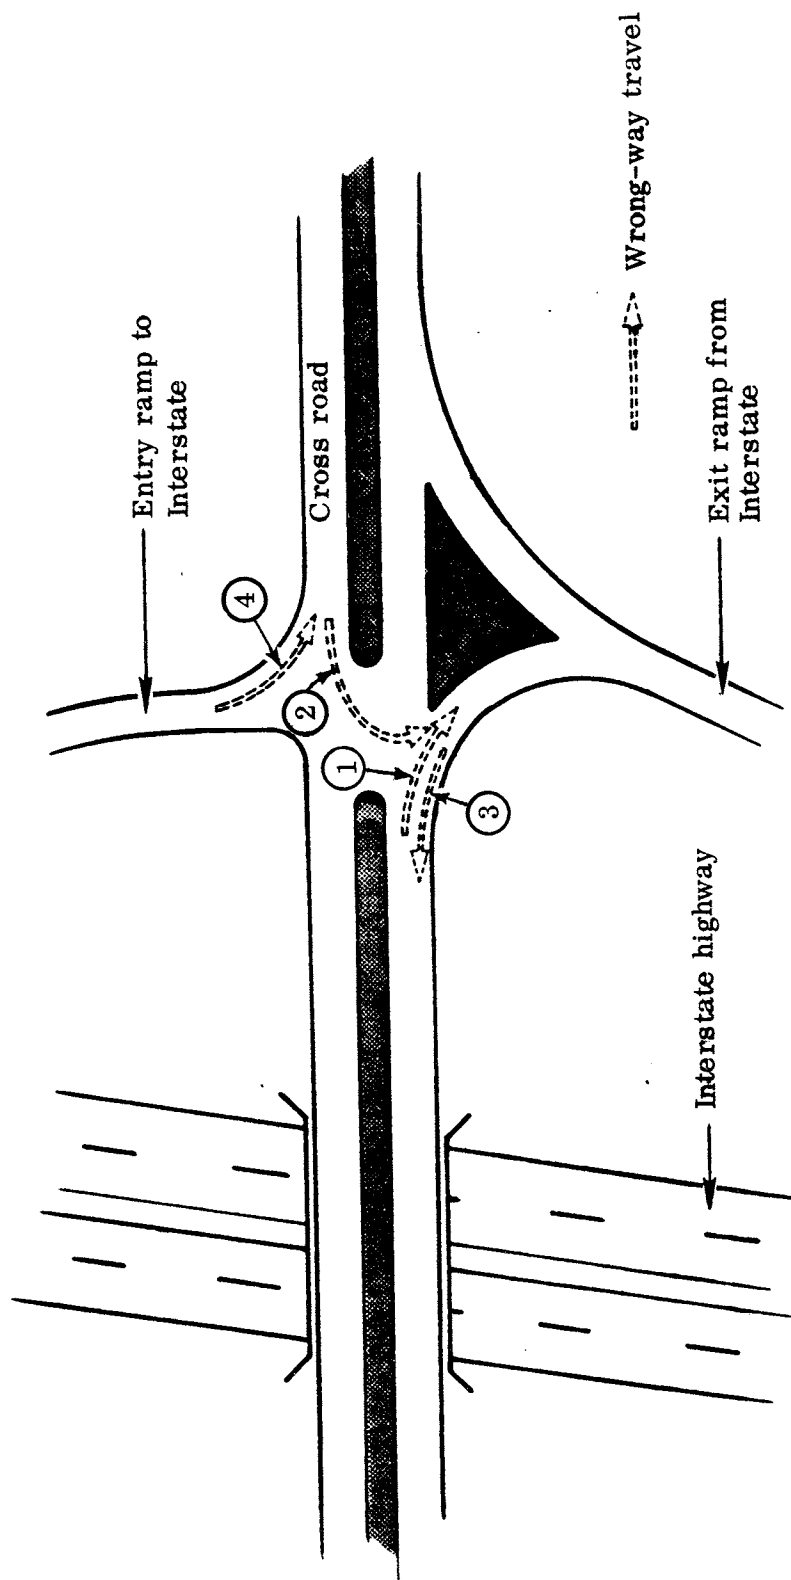
- (b) From a divided crossroad into the left lane of the exit ramp as shown by arrows 1 and 2 in Figure 3.
- (c) From the Exit ramp (or its left lane if divided) into the wrong lane of a four-lane divided crossroad as shown by arrow 3 in Figure 3.
- (d) From the entry ramp of the interstate highway instead of the exit ramp into the wrong lane of a divided crossroad, as shown by arrow 4 in Figure 3.

Figure 3. Wrong-way entry and egress on left lane of exit ramps.

Arrow 3 in Figure 3 shows the type of wrong-way entry onto a crossroad a driver turning left from the exit ramp is likely to make. The same problem exists on intersections where four-lane divided roads intersect other roads. This type of maneuver accounts for about 32% of the wrong-way entries in Virginia.

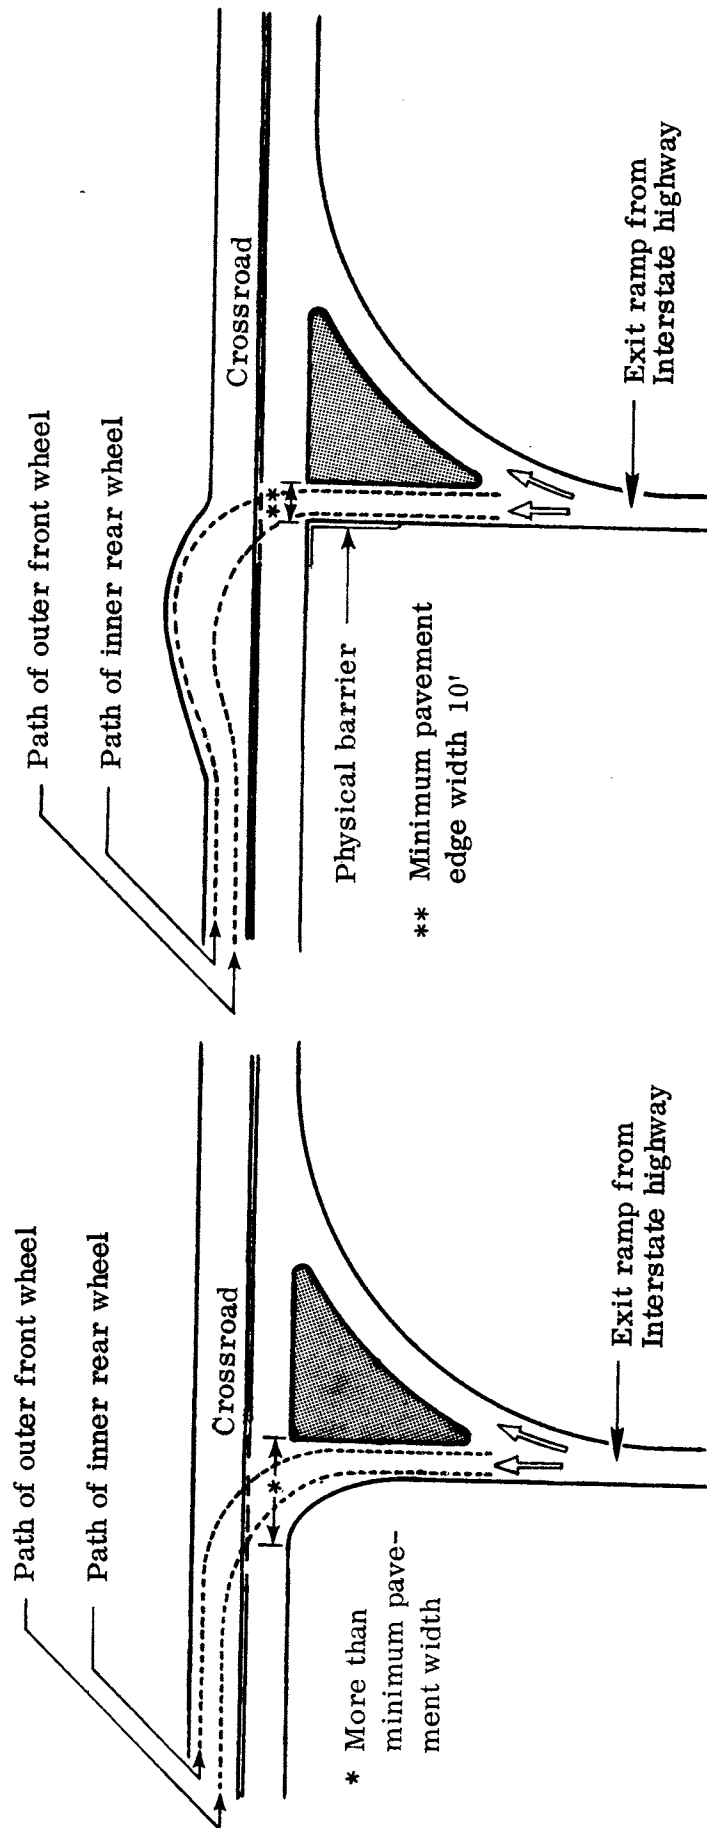
Figure 9. Two-lane crossroad. Suggested improvement to prevent flare at the junction of exit ramp and crossroad.

- (2) Alter the present design to eliminate the flares. A new design based on a partial S curve (convex-concave type) or any other type could be adopted. Figure 9 (A) shows a concave curve which needs a flare, but with the introduction of a partial S curve as shown in Figure 9 (B) the flare could be removed.

A right-angled junction of the left lane of the exit ramp with the crossroad, without a flare, would reduce wrong-way entries and exits. This design would provide a minimum width of the left lane of the exit ramp and make it difficult for a driver from the right lane of the crossroad to maneuver onto the left lane. Most of the left lanes are at right angles with the crossroads; hence after the flare is removed, the minimum width would automatically be obtained. An example is shown in Figure 9 (B).

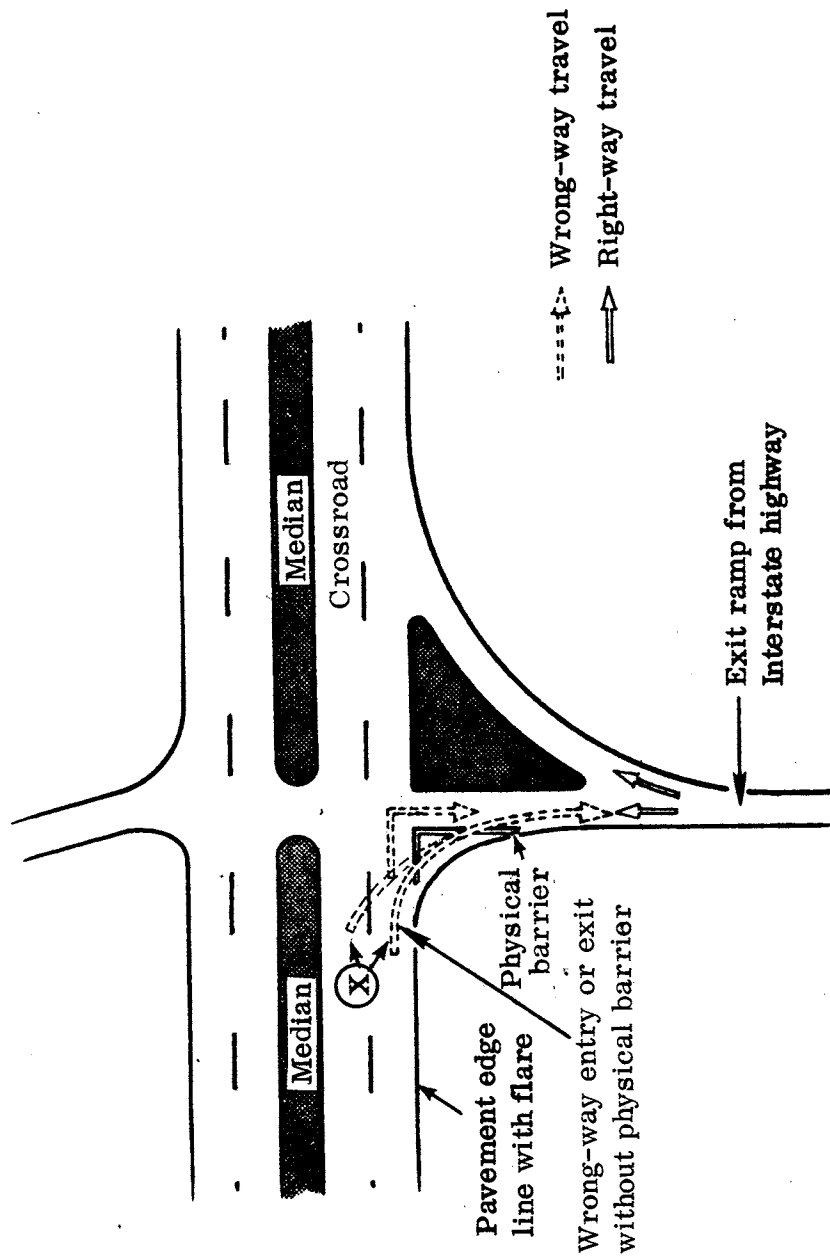
Figure 11. Location of physical barrier to prevent wrong-way entry into the exit lane.

If a narrow left lane without a flare is provided, the junction could be made further foolproof by providing a physical barrier as shown in Figure 11. If such a barrier was provided, to make a wrong-way maneuver a driver could not make an easy right turn into the exit ramp, but would have to negotiate a very sharp turn over a right angle. In order to do the latter, he would have to come to an almost complete stop before maneuvering his vehicle into the exit lane. Such a barrier would greatly discourage a driver from turning in the wrong lane or using the shoulder for an easy wrong-way entry into the exit ramp, or turning from the exit ramp into the crossroad.

- (a) A barrier could be installed at the corner of the edge of the left lane of the exit ramp and the right edge of the crossroad, as shown in Figure 11, to prevent the use of the shoulder or flare by the wrong-way driver to enter the exit ramp. This barrier would make it very difficult for the driver to make a right turn from the crossroad into the exit lane, as has been discussed previously in this report under physical barriers for channelization.
- (b) A physical barrier (e.g. a small-width raised median) could be used in place of the double solid yellow lines proposed earlier to eliminate wrong-way entries by a left turn.

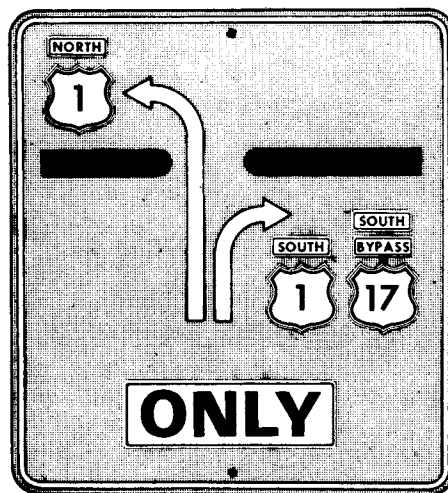
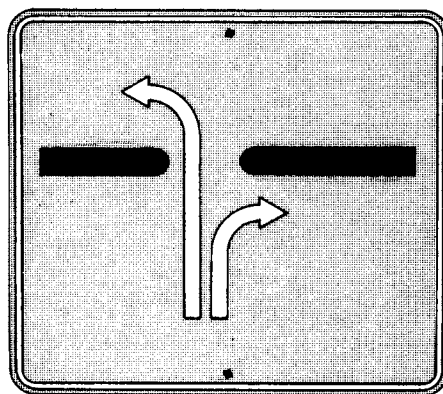
Figure 13. 'Geometry' signs for installation on exit ramps.

The Information Decision Action (IDA) sequence developed by Taylor and McGhee<sup>10</sup> shows that for a left turn nine actions are needed. In order to execute these actions the driver needs the following information: (1) destination/direction, (2) advance warning of intersection, and (3) intersection geometry. Preferably, this information should be given to the driver during his first action, i. e. in the "approach vicinity of the intersection". In the present system of signing, the driver is unaware of the intersection geometry, and while taking the third action, "entering the appropriate lane", some drivers make a faulty maneuver and enter the wrong lane. It is therefore necessary that the driver be supplied information on the intersection geometry before he takes the third action. Two signs that supply this information are shown in Figure 13.

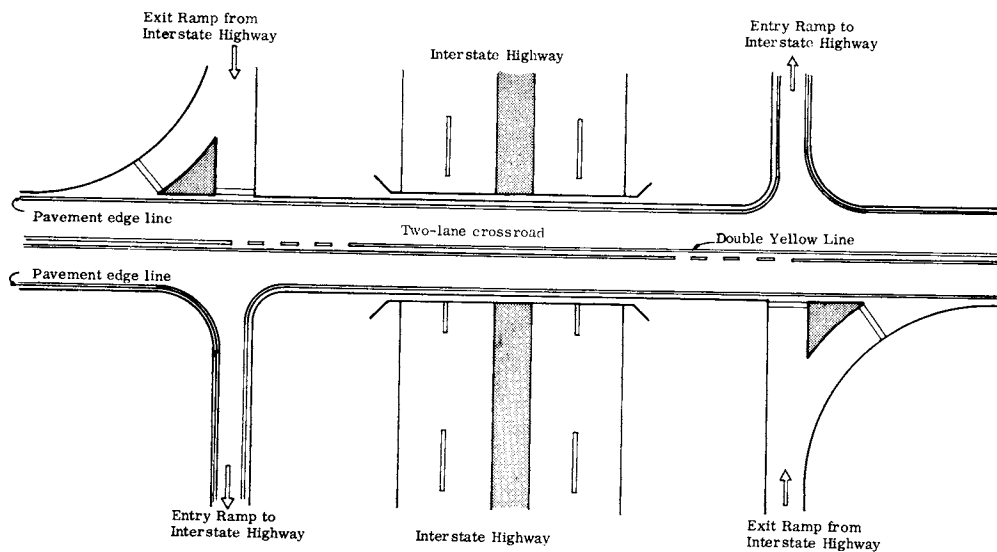
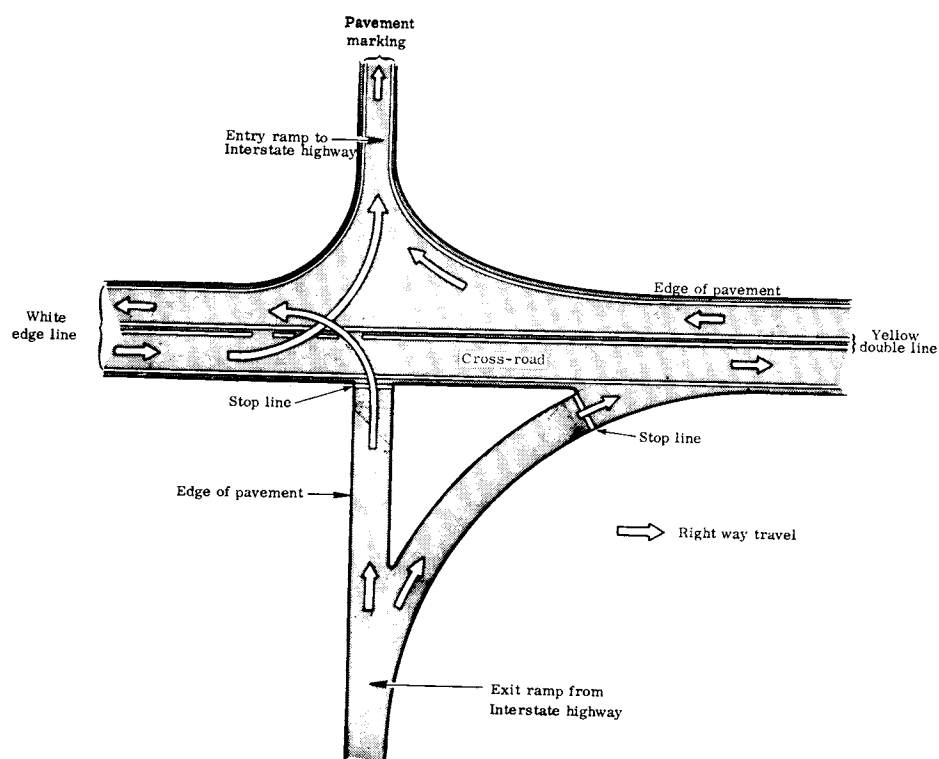
Figure 15. Recommended edge and center line marking on undivided crossroad.

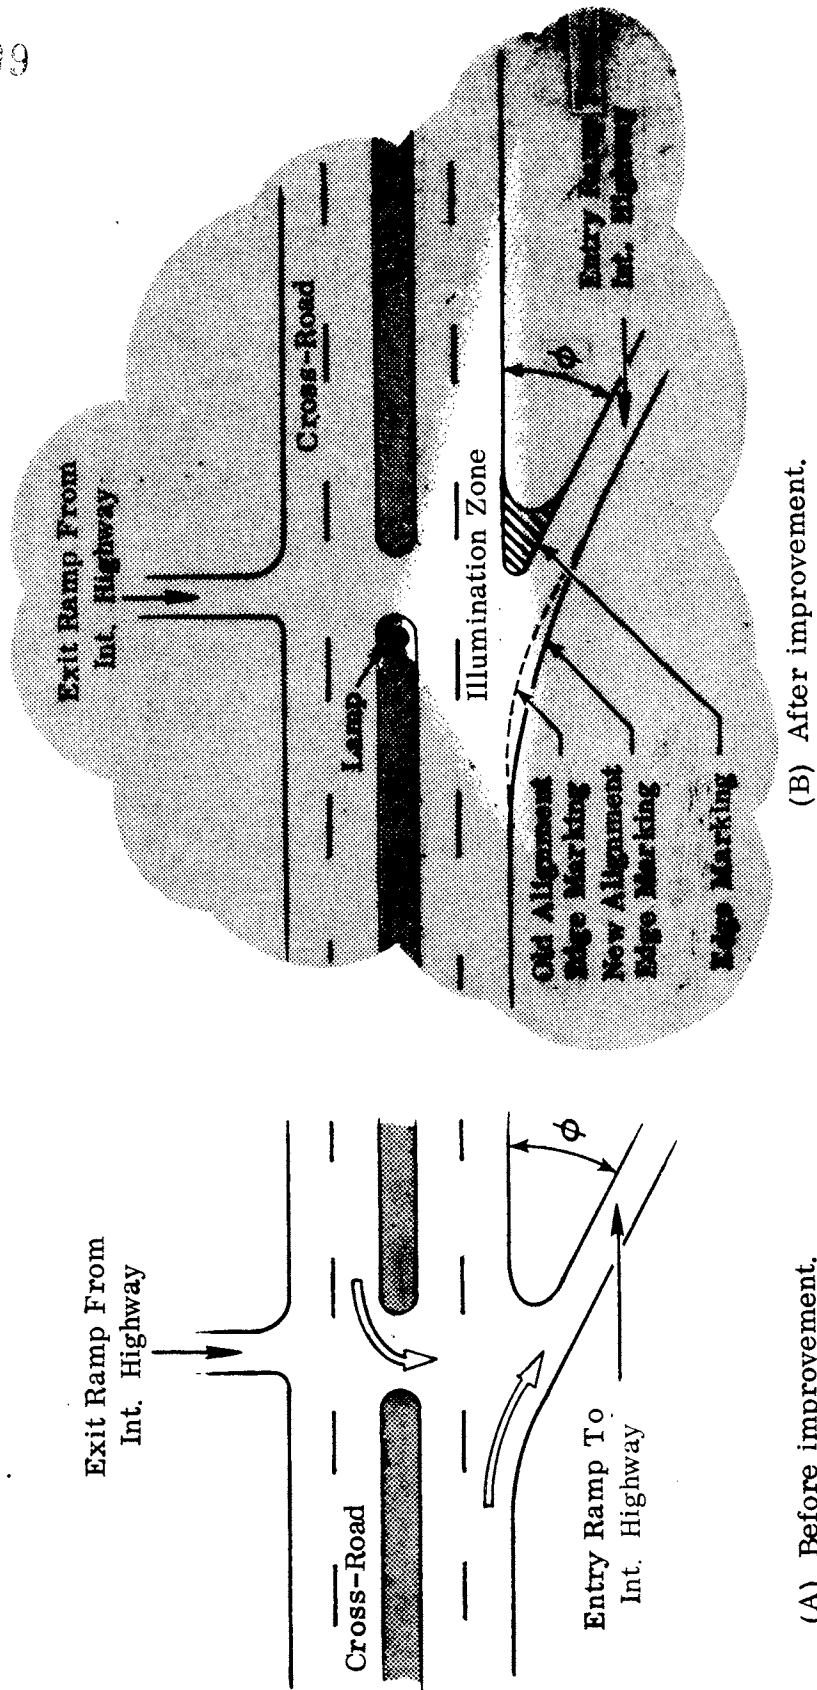
Figure 17. Improvement on entry ramp.

Entry ramps could be made more conspicuous to a driver on the crossroad by (1) providing flatter angles of entry for the right-hand turn, (2) applying pavement markings, and (3) spotlighting the ramp as shown in Figure 17. Spotlighting of the entry ramp junction could also help in illuminating the lane for the driver turning left from the exit ramp into the crossroad.
