A CASE STUDY

EARLY CRACKING OF UNREINFORCED CONCRETE PAVEMENT

K. H. McGhee
Highway Research Engineer

October 1973
VHRC 73-R20

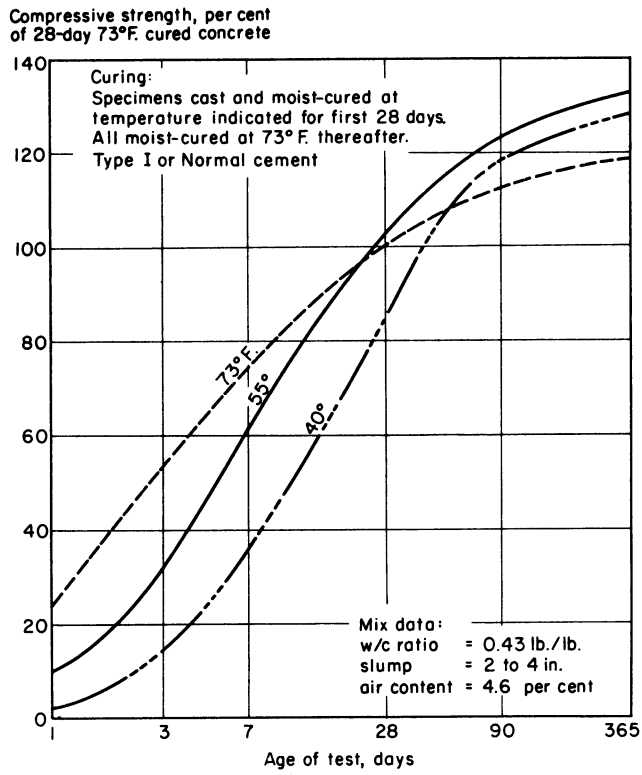
The nature of the cracking as observed from cores discussed earlier suggests that warping stresses, which are usually too low to cause a problem, may have been significant in the present case. This is particularly true in the case of Ramp B, which cured for the first 24 hrs. at an average ambient temperature of 36°F and consequently could have gained but little strength during this period. Note in Figure 2 in the first few days concrete cured at 40°F gains only a fraction of the strength gained by concrete cured at 73°F or even 55°F.

Figure 2. Effect of low temperatures on concrete compressive strength at various ages.

Note in Table II that the warping stresses for the cracked portion of Ramp B are nearly twice those for the uncracked sections of pavement. While the computed tensile stresses of from 50 to 98 psi would cause no problem with mature concrete, it is entirely possible that they would exceed the tensile strengths of the present concrete, which obviously gained strength very slowly due to the low curing temperatures.

1. Avoid paving on days when atmospheric conditions indicate a combination of low relative humidity and high wind velocity.
2. Paving should be avoided on cold days when it is likely that a substantial overnight drop in air temperatures will occur.
3. If the above conditions develop during the paving operation, extra precautions in terms of early application of curing compounds and possibly insulation of the pavement may be necessary.
