DETERIORATION OF JOINTED
PORTLAND CEMENT CONCRETE PAVEMENTS

Samuel S. Tyson
and
Kenneth H. McGhee
Research Engineers

Virginia Highway & Transportation Research Council
(A Cooperative Organization Sponsored Jointly by the Virginia
Department of Highways & Transportation and
the University of Virginia)

November 1975
VHTRC 76-R19

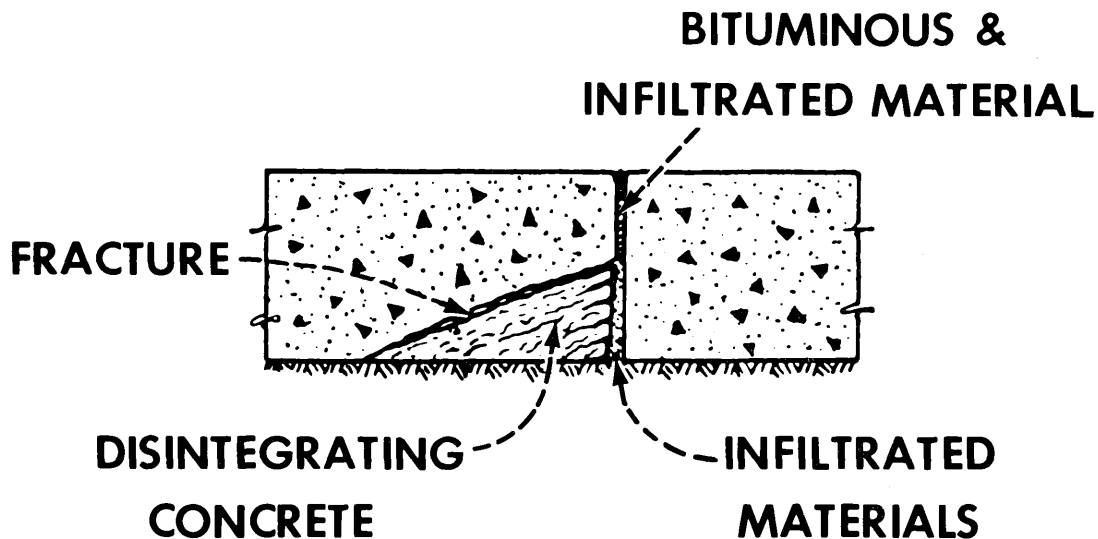
Figure 6. Conditions prior to blowup.
(After Griffin(11)).

A widely accepted theory of blowup development consistent with the above measurements and observations was given by Griffin in 1943.(11) The first stage of failure occurs sometime prior to the actual blowup when compressive stresses become high enough to fracture the concrete below the surface, but no distress is evident on the pavement surface. This condition is shown schematically in Figure 6 where it may be seen that disintegrating concrete at the lower joint corner forms an inclined plane with the undamaged concrete above. As the compressive stresses increase, the situation changes to that indicated in Figure 7 where one slab has moved up the inclined plane with sufficient force to shear the corner of the adjacent slab. In this manner, the observed blowup characteristics of one slab overriding the other is generally explained.

Extensive deterioration from a blowup type of failure may not be readily apparent at the pavement surface. In Figure 13 it can be observed that the joint closing has resulted in spalling of the underside of the joint area while the pavement surface is apparently intact. This actual case is very similar to the case depicted earlier in Figure 6.

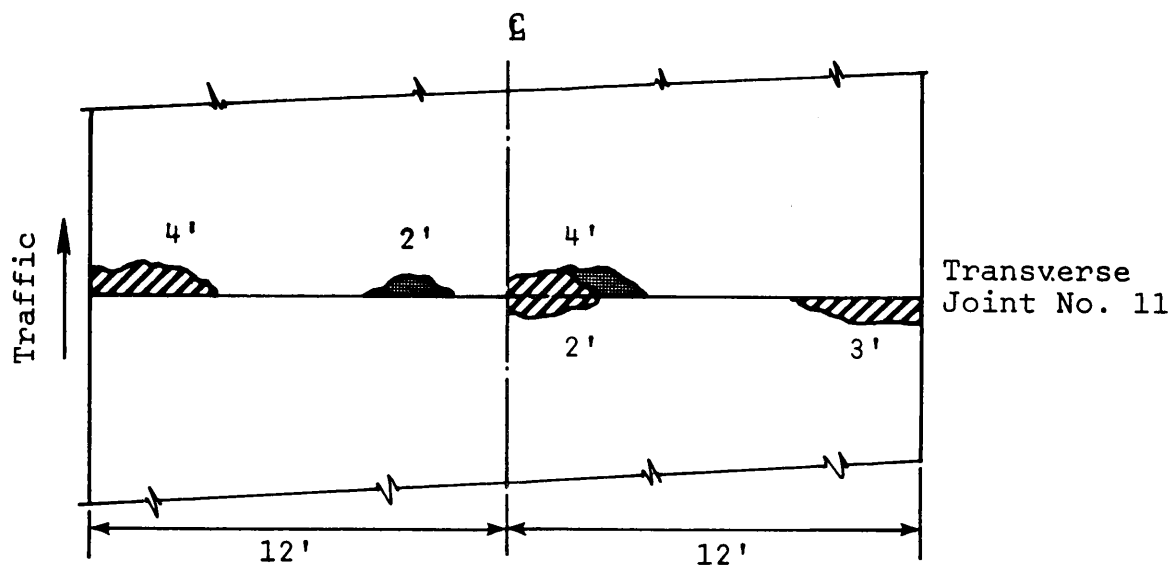
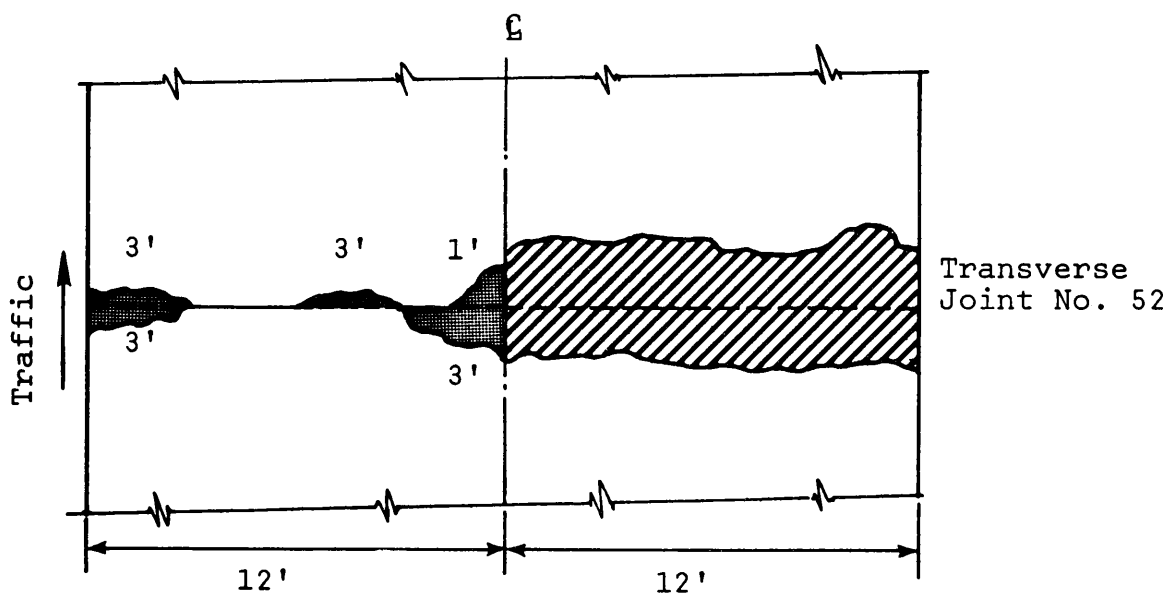
Figure 14. Typical plan of distress at transverse joints in PCC pavements.

Visual surveys have been made of jointed PCC pavements in which deterioration has occurred. Distress at the transverse joints has been recorded as in Figure 14. The total amount of unsound concrete at the joints as in Figure 14 could be determined by sounding with a ball peen hammer as described earlier in this report; however traffic control is not required for the visual survey and this information, along with knowledge of the factors causing distress, provides a rational basis for assessing the probable situation at each joint.
