POTENTIAL PROBLEMS ON I-77 CONCRETE CULVERT

Virginia Highway & Transportation Research Council
(A Cooperative Organization Sponsored Jointly by the Virginia
Department of Highways & Transportation and the University of Virginia)

May 1976

VHTRC 76-R55

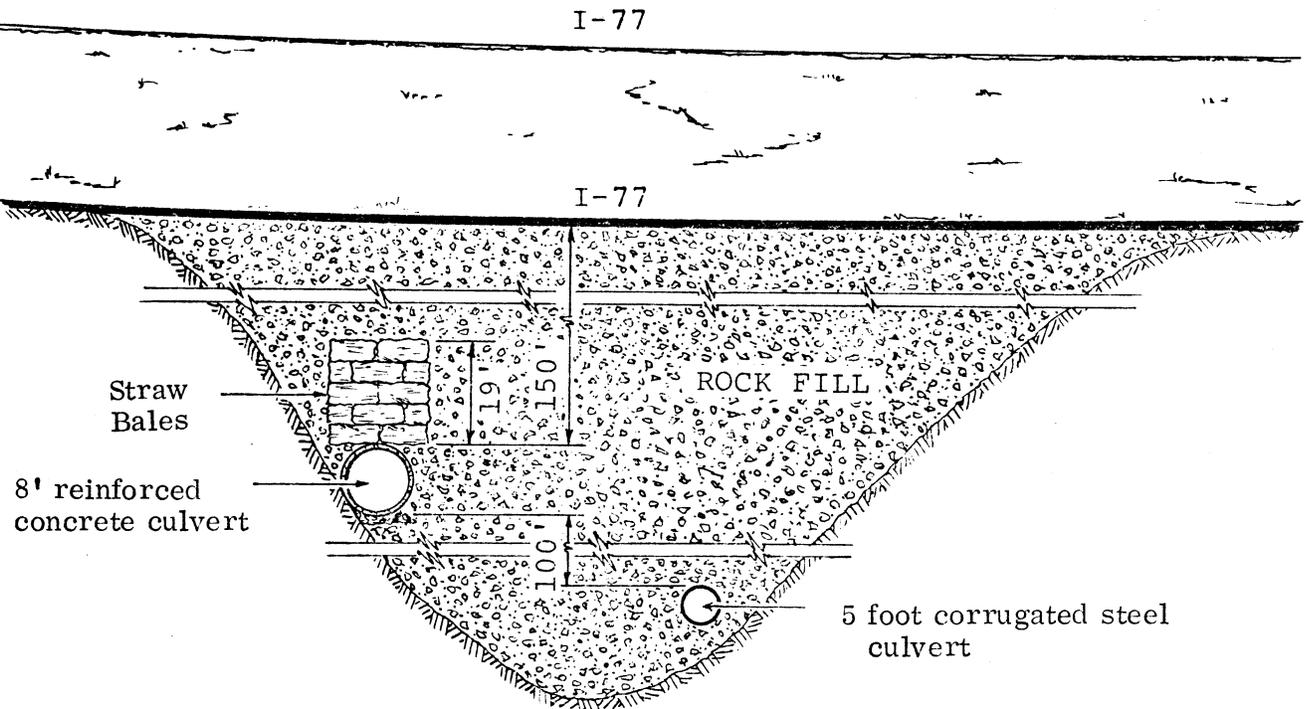
The temporary culvert was designed to provide drainage until the permanent culvert was installed. The latter pipe was constructed of C-5 reinforced concrete meeting the requirements of Class A5 concrete (VDHT Specs), and has an inside diameter of 8 feet (2.44 meters) and a wall thickness of 9 inches (0.2 meters). It was installed in a trench excavated after the fill was approximately 10 feet (3.05 meters) above the elevation of the culvert, and rests on a crushed stone bedding placed in the bottom of the trench at the grade of the culvert. After the sections of the culvert were put in position, layers of backfill were placed and compacted around them. Bales of straw were then stacked over the entire length of the backfill and the culvert (approximately 800 feet (244 meters)). The straw was placed the width of the pipe (9.5 feet (2.9 meters)) and to a height of 19 feet (5.8 meters) as shown in Figure 1. After placement of the straw the fill was built up to the plan elevation. The concrete pipe is 100 feet (30.5 meters) higher than the temporary steel drain and is overlain by 150 feet (46 meters) of fill.

Figure 1. Sketch of culvert installation.
