MINIMIZATION OF REFLECTION CRACKS  
ROUTE 17 GLOUCESTER COUNTY INSTALLATION REPORT 1976

C. S. Hughes  
Senior Research Scientist

December 1976  
VHTRC 77-R30

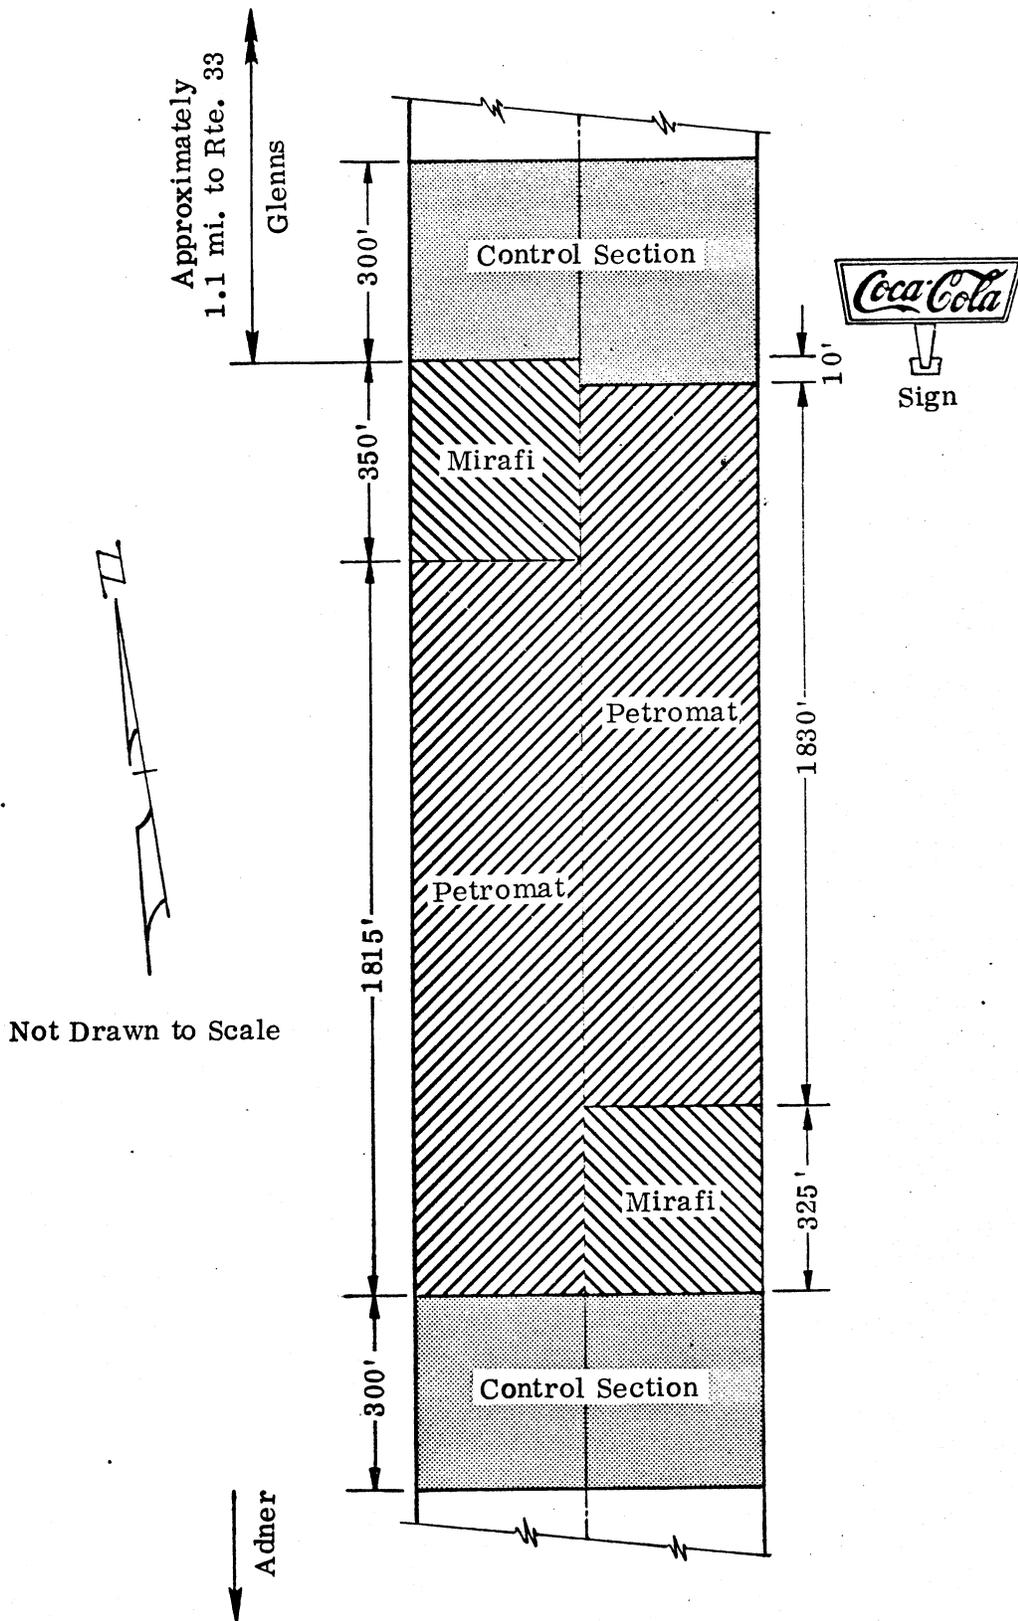
Figure 1. Location of test sections.

In August of 1976 two materials were installed on a two-lane section of Route 17 in Gloucester County. Figure 1\* shows the layout of the test and control sections.

To remove any bias that might result from the locations of the two materials, they were staggered end for end as Figure 1 indicates. In a comparative performance evaluation, control sections of approximately 300 ft. on both ends of the test sections will be observed.
