ROADWAY LIGHTING: ILLUMINATION STUDY
OF RTE. I-95, SHIRLEY HIGHWAY

Marvin H. Hilton
Research Engineer

Virginia Highway & Transportation Research Council
(A Cooperative Organization Sponsored Jointly by the Virginia
Department of Highways & Transportation and the University of Virginia)

VHTRC 77-R4

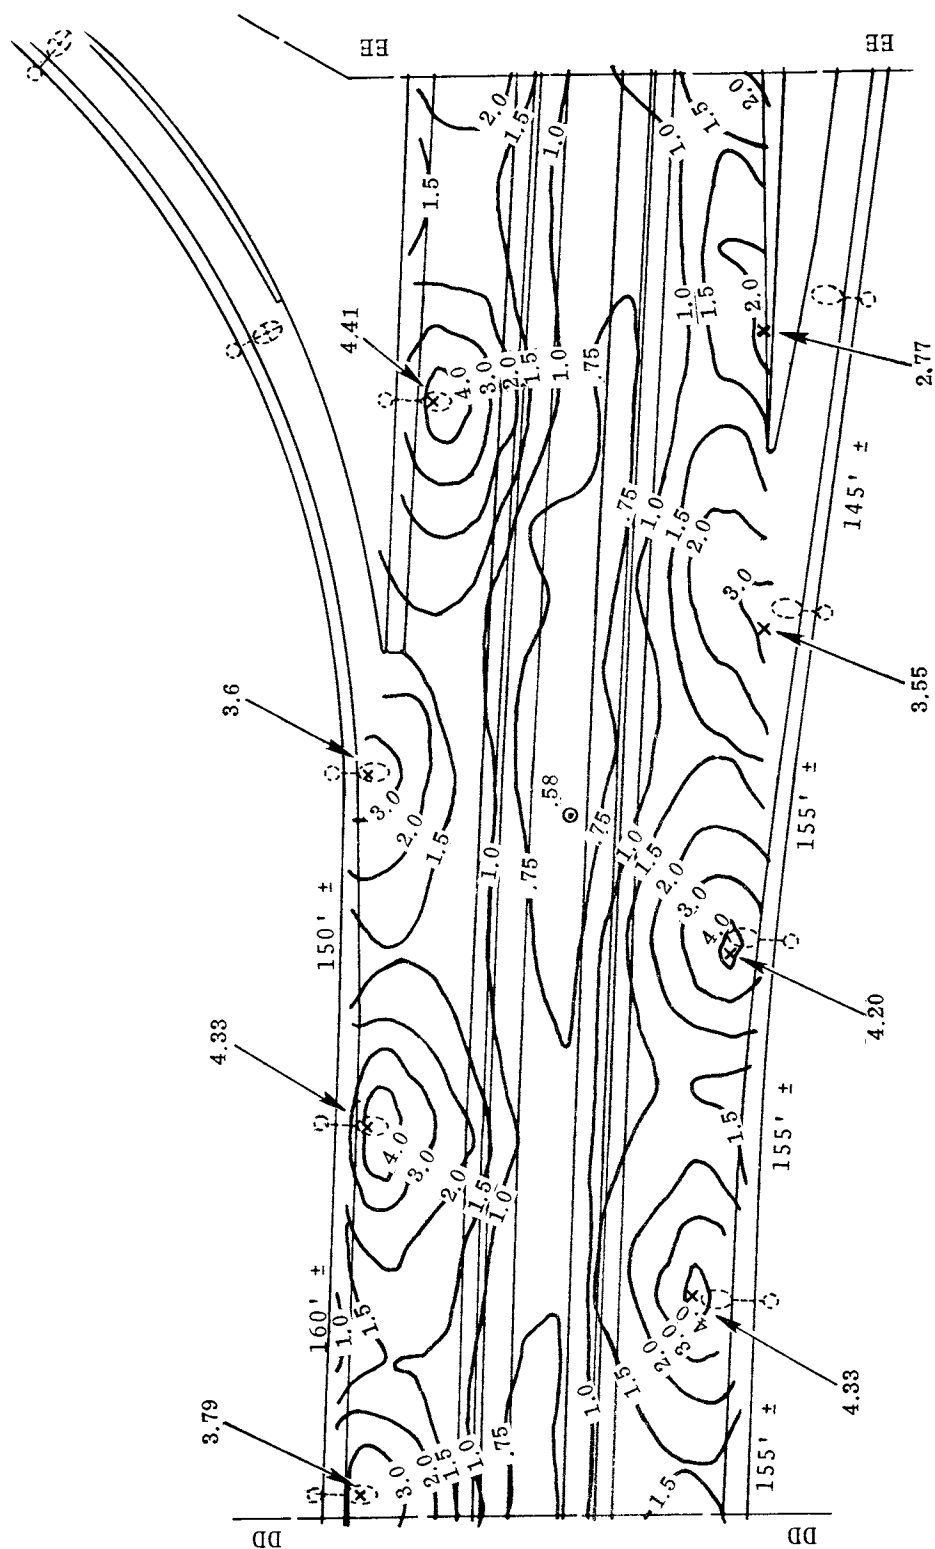
Figure 10. Continued isofootcandle diagram showing the distribution of illumination on a section of Rte. 95 just south of the Edsall Road interchange. (1 fc = 10.76 lx)

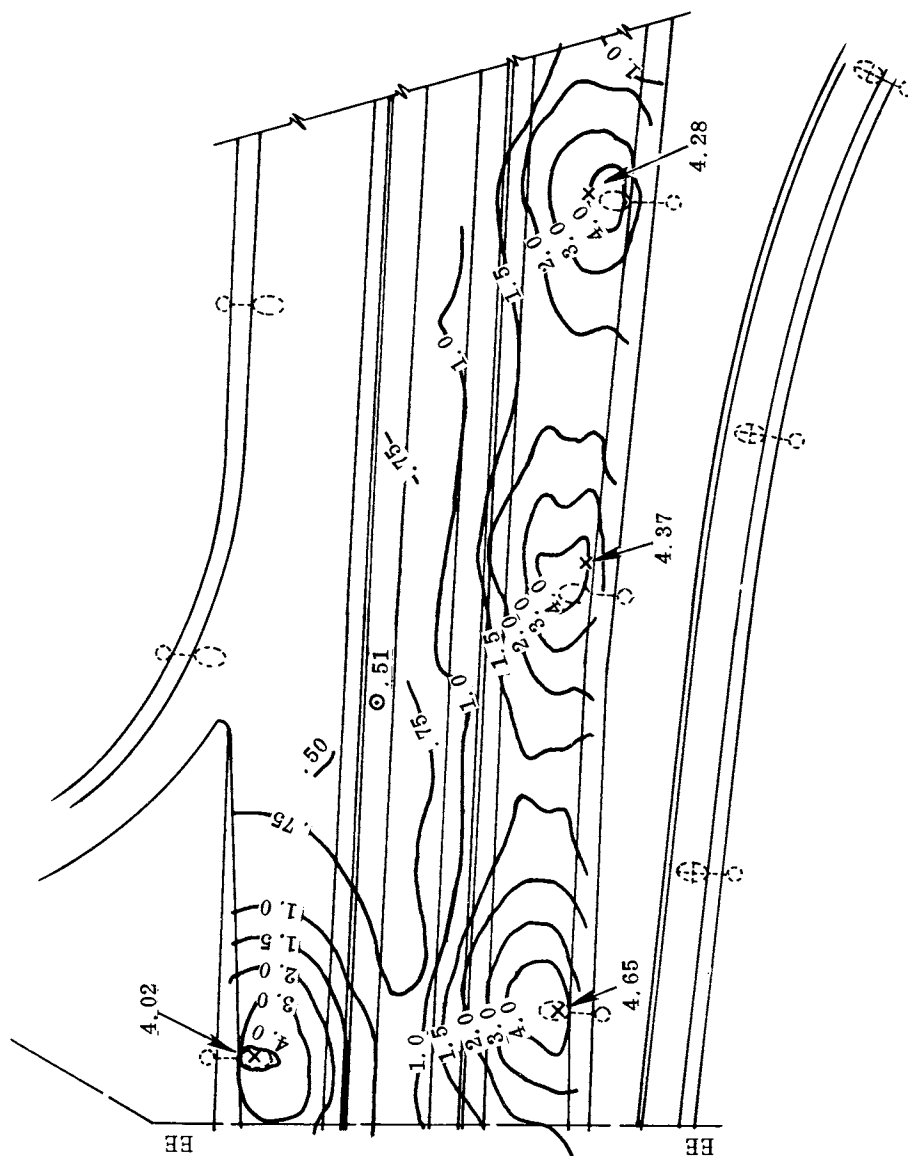
Figure 11. Continued isofootcandle diagram showing the distribution of illumination on Rte. 95 at the Edsall Road interchange.
(1 fc = 10.76 lx)

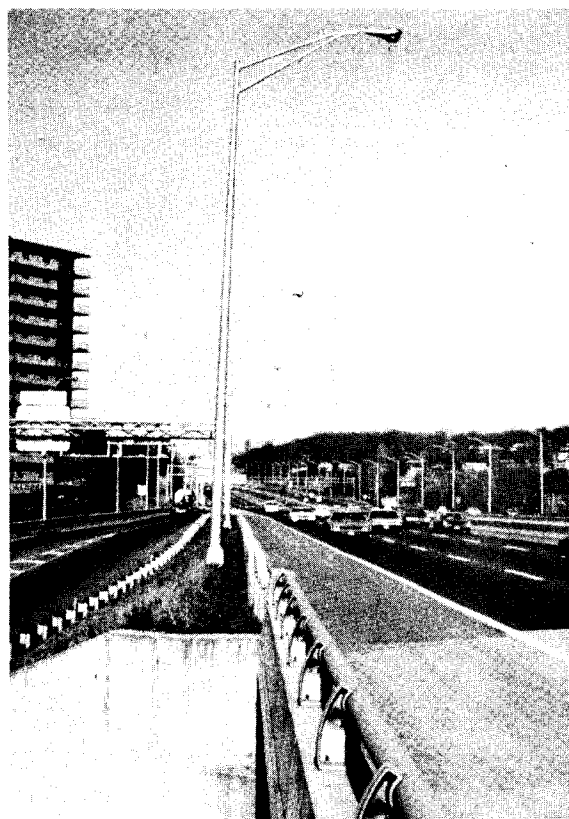
Measurements were taken on a portion of the main line of Glebe Road since this section of lighting, as well as that of the Glebe Road interchange itself, was initially turned on when the field study began. A view of this section of roadway looking north toward Washington, D. C. from the bridge over Glebe Road is shown in Figure 12. Luminaires typical of all those used on the main line can be observed in Figure 12, which shows a good view of the 50-ft. (15.24 m) mounting height and 12-ft. (3.66 m) mast arm used with the 1,000-watt mercury luminaires. The sector for which data will be discussed begins beyond the end of the ramp shown to the left in Figure 12 and extends northward. This sector runs from station 849 to station 865— a distance of approximately 1,600 ft. (488 m).

Figure 12. Lighted roadway section of Rte. I-95 north of Glebe Road.

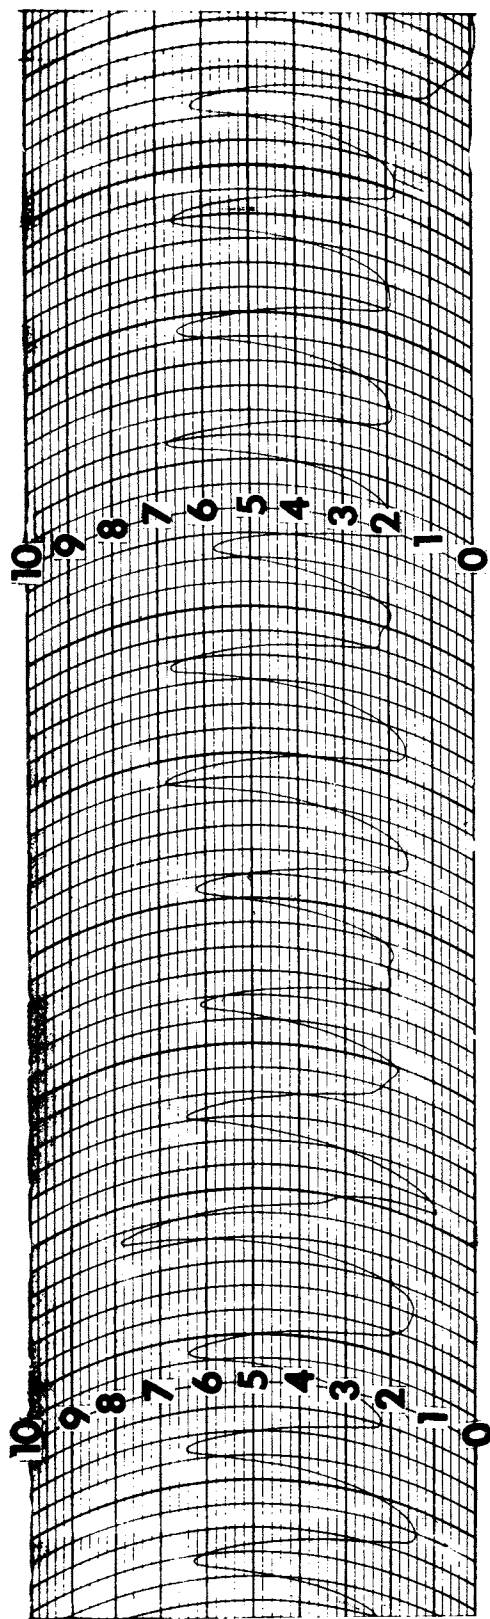
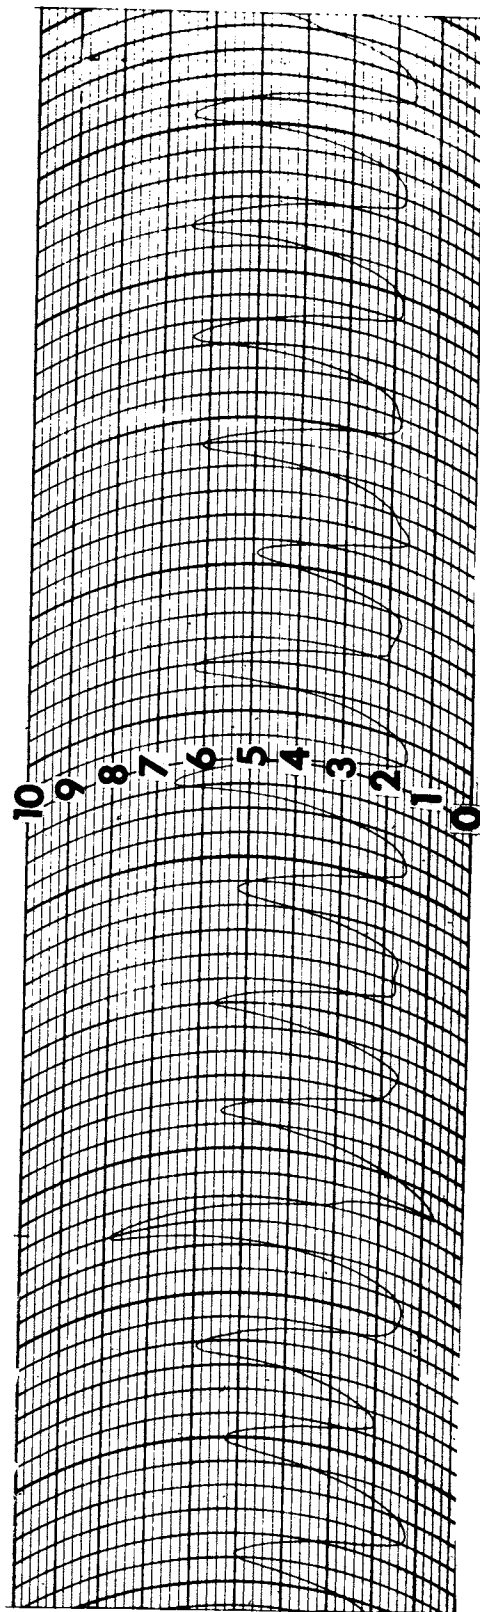
The initial maximum illumination levels on the sector averaged between 6 and 7 fc. (64.56 and 75.32 lx). After approximately 7 months of operation, considerable lamp lumen depreciation had occurred and the maximum levels had dropped to the 5 to 6 fc. (53.80-64.56 lx) range, although some were slightly higher. Some of the typical strip chart data for the second driving lane (with respect to the right-hand side of the road) of the SBL are shown in Figure 13. The longitudinal distance on the data chart is shown horizontally, with each division representing 35.2 ft. (10.73 m). The level of illumination in footcandles is shown vertically with each major division, in this case, being 1 fc. (10.76 lx). These data are representative of those for the lane shown and for the levels of illumination when the lights were initially turned on and later after approximately 7 month's service. Figure 14 shows the same kind of data for one of the reversible driving lanes. It can be noted from each of these figures that the general configuration of the footcandle trace is virtually identical for each test period. Only the magnitude of the illumination levels has dropped due to lamp and dirt depreciation (soiling of the luminaires). For the particular data shown, for example, the average depreciation in the second SBL was 10% while that on the reversible lane was 17% during the period indicated. This amount of initial depreciation is not unexpected during the early service life of the lamps.

Figure 13. Typical illumination data charts for a main line lane of Rte. 95 north of Glebe Road. (1 fc = 10.76 lx)

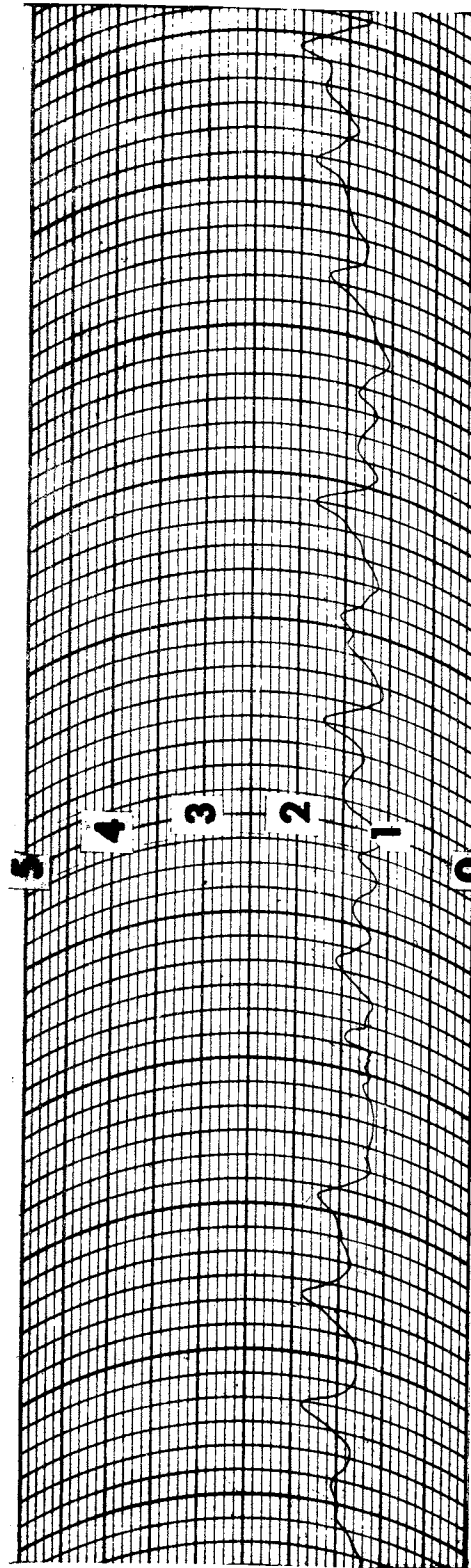
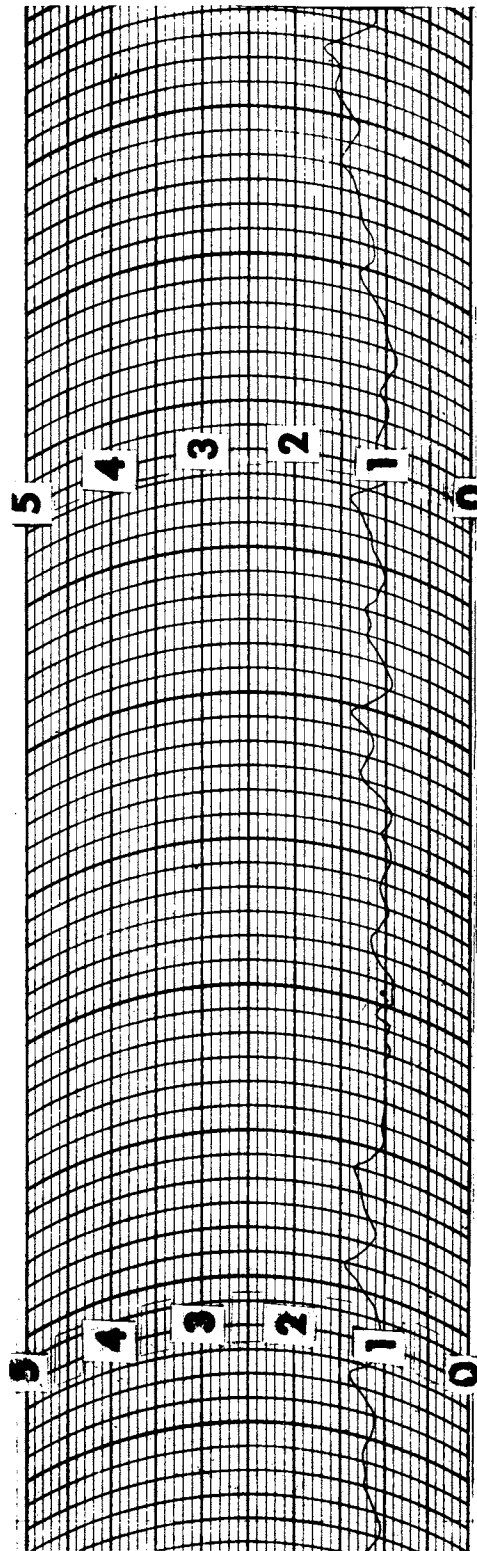
Figure 14. Typical illumination data charts for a driving lane of the reversible lanes of Rte. 95 north of Glebe Road. (1 fc = 10.76 lx)

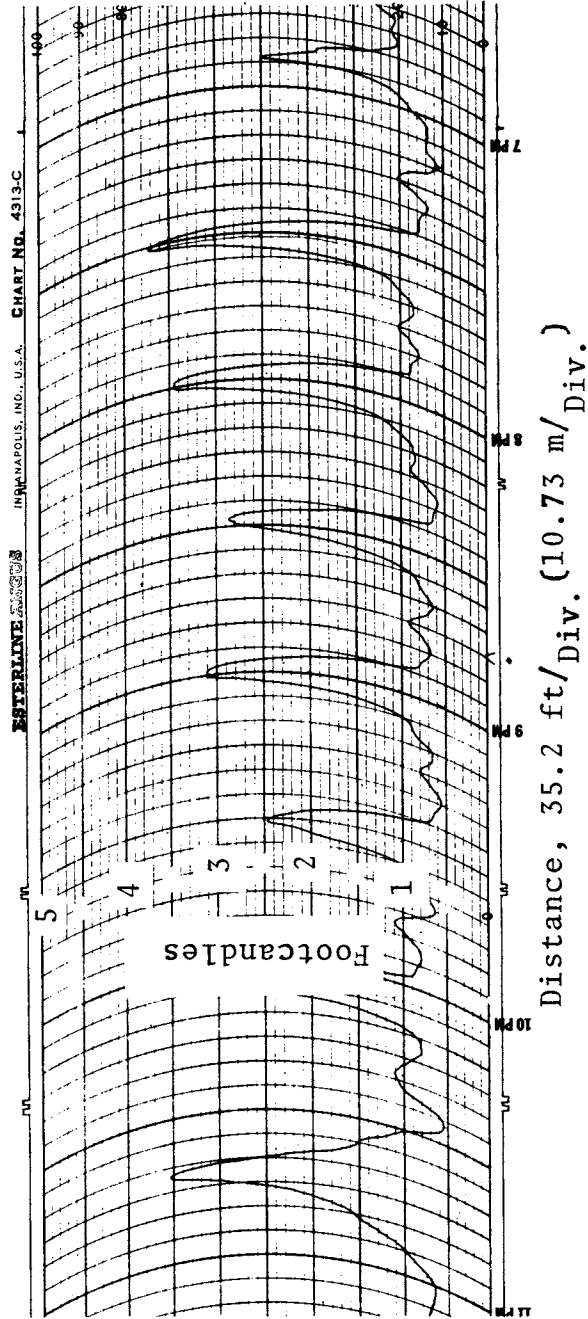
Seminary Road passes over both the main line of Rte. I-95 and the interchange ramps that serve the area. A plan view of the interchange is shown in Figure 27. Seminary Road is one of the few areas on the lighting project that is lit with 400-watt mercury luminaires mounted at a height of 30 ft. (9.14 m) on a 6-ft. (1.83 m) mast arm. A typical distance vs. footcandle data chart for the left-hand EBL is shown in Figure 28. These data were taken after the lighting had been in service for approximately one year. The data traces for the other lanes and shoulder of the roadway have a configuration similar to that shown in Figure 28; only the order of magnitude of the footcandle values differ between the lanes, as would be expected. The lamp posts are located on opposite sides of the roadway in an alternating fashion as can be detected by the alternating high and low peaks on the data trace shown.

Data charts like that shown in Figure 28 can be used for each driving lane and shoulder area to develop isofootcandle diagrams, or they can be used individually to calculate the average footcandle value for each lane. An overall average footcandle level can be obtained for the total area surveyed by averaging the individual lanes. The individual lane averages and overall average for a 1,100 ft. (335 m) section of Seminary Road are shown in Table 2 for two test periods taken at 6-month intervals. On an average, the illumination levels depreciated slightly during this time period and the uniformity ratios remained approximately the same at 3.80:1 and 3.73:1, respectively, for the initial and 6-month test periods. While some of the latter data averages appear to be slightly higher than the initial data shown in Table 2, experimental error associated with the positioning of the vehicle between test periods is probably the reason for the unexpected difference. Therefore, from a statistical viewpoint the overall averages would be more representative of the depreciation in the lighting than would be the individual lane averages. In general, however, the lighting was relatively good but the uniformity was slightly above the recommended standards.

Figure 28. Footcandle-distance data trace for the left-hand driving lane of the EBL of Seminary Road.
(1 fc = 10.76 lx)
