INSTALLATION REPORT
USE OF FABRIC IN FLEXIBLE PAVEMENTS— 1980

C. S. Hughes
Senior Research Scientist

Virginia Highway and Transportation Research Council
(A Cooperative Organization Sponsored Jointly by the Virginia
Department of Highways & Transportation and
the University of Virginia)

VHTRC 81-R43

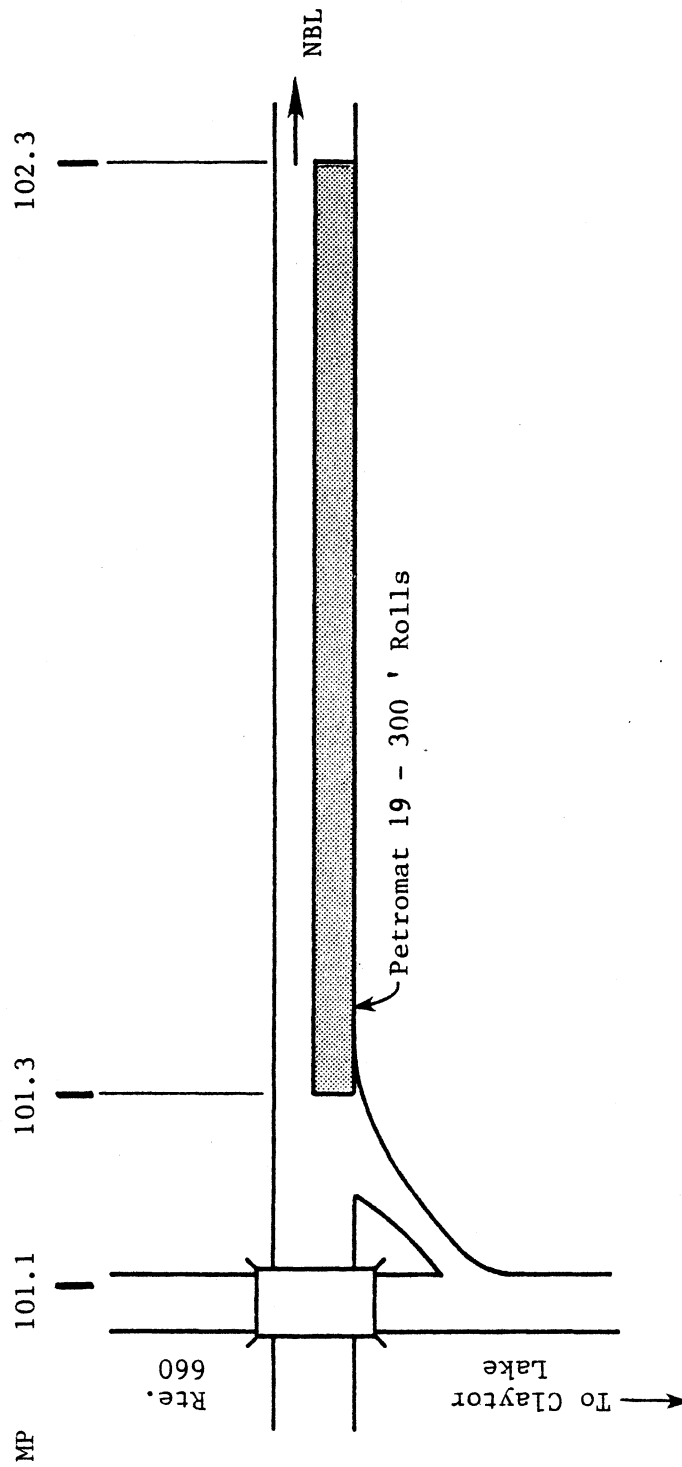
Figure 3. Location of Petromat fabric Route 81, Pulaski County,

In an attempt to waterproof the 1976 overlay and give additional strength to the proposed overlay, a fabric was specified for a 1-mile section of the northbound traffic lane (Figure 3).

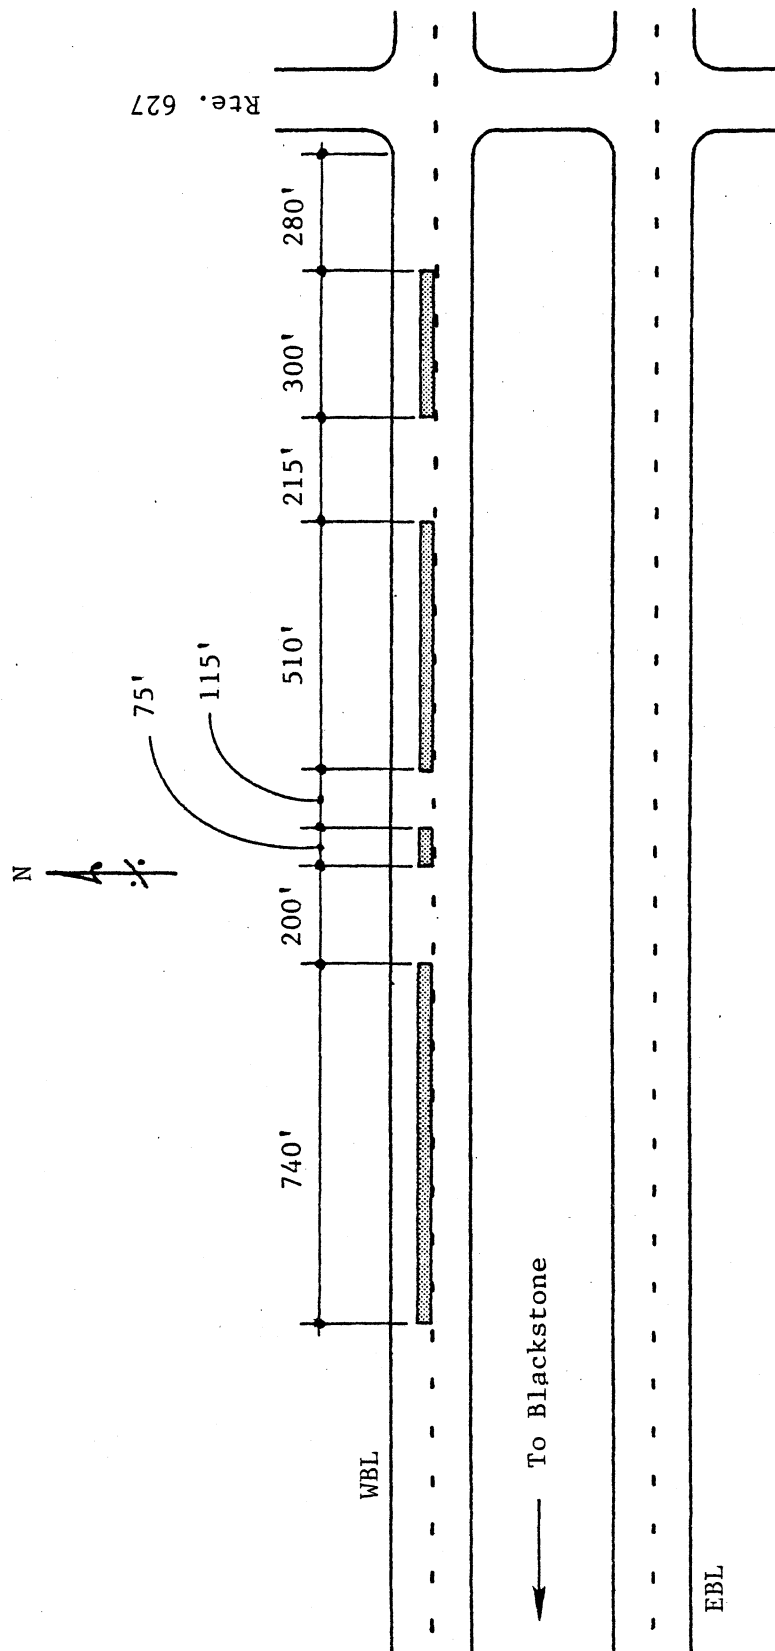
Figure 8. Prepave section Route 460, Dinwiddie County,

A heavy (0.8 psf) fabric-rubber membrane (Prepave) had been donated to the Department in 1979 for use over jointed concrete pavement on I-95, and almost 3,500 linear feet of this material had been left over. It was decided that this material might improve the performance of an overlay intended for Route 460, and it was used in the areas shown in Figure 8.

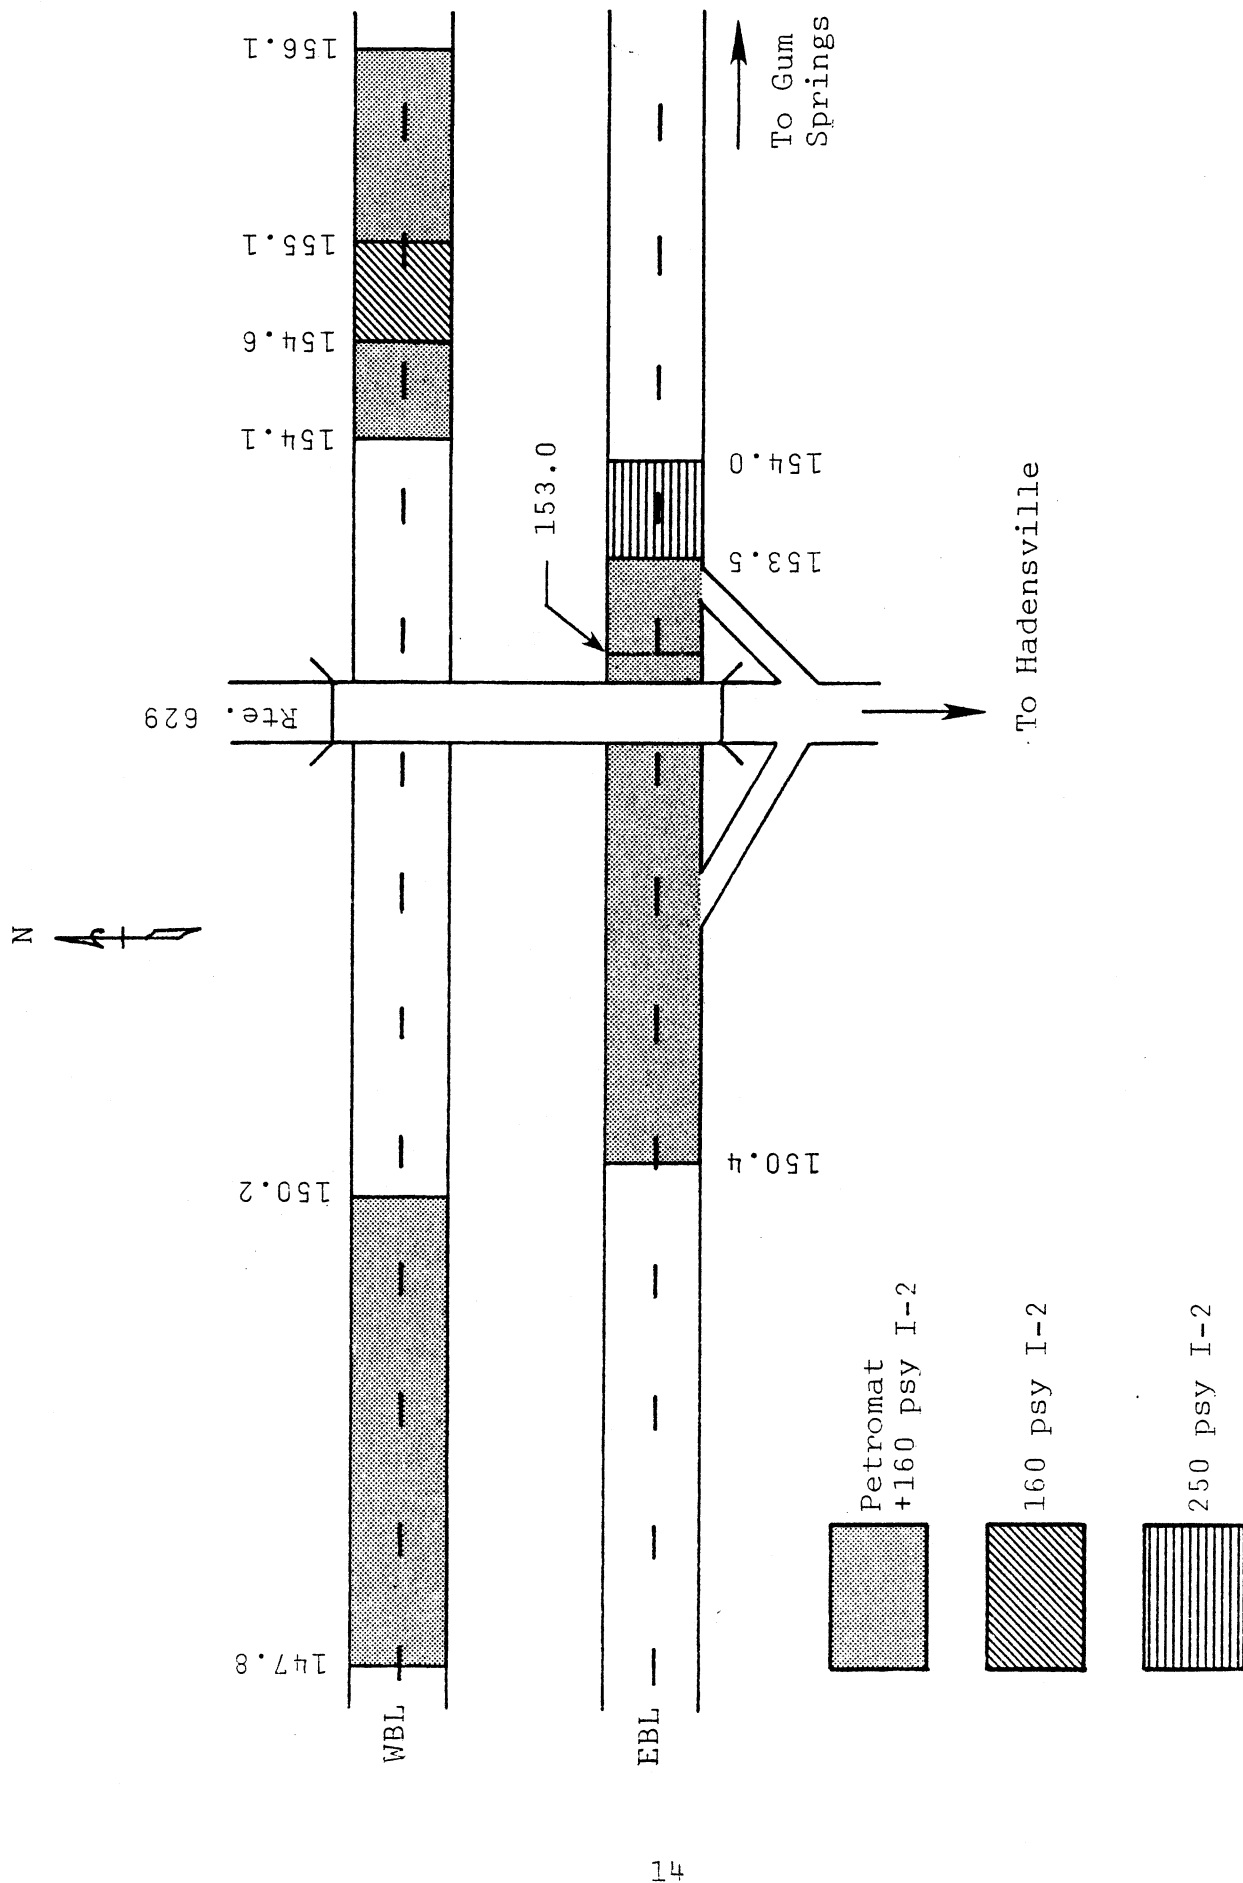
Figure 9. Fabric section Route 64, Goochland County.

Starting on September 23, 1980, fabric was used on several sections of I-64 near Hadensville as shown in Figure 9. The four 0.5-mile sections were used for comparisons of the performance of overlays of heavy and medium thicknesses and no fabric with that of two overlays of medium thickness and fabric. The longer sections shown in Figure 9 were constructed under a separate contract and are shown only to document their location.
