EVALUATION OF DECK DURABILITY ON CONTINUOUS BEAM HIGHWAY BRIDGES

Wallace T. McKeel, Jr.  
Research Scientist

Virginia Highway & Transportation Research Council  
(A Cooperative Organization Sponsored Jointly by the Virginia  
Department of Highways & Transportation and  
the University of Virginia)

April 1985  
VHTRC 85-R32

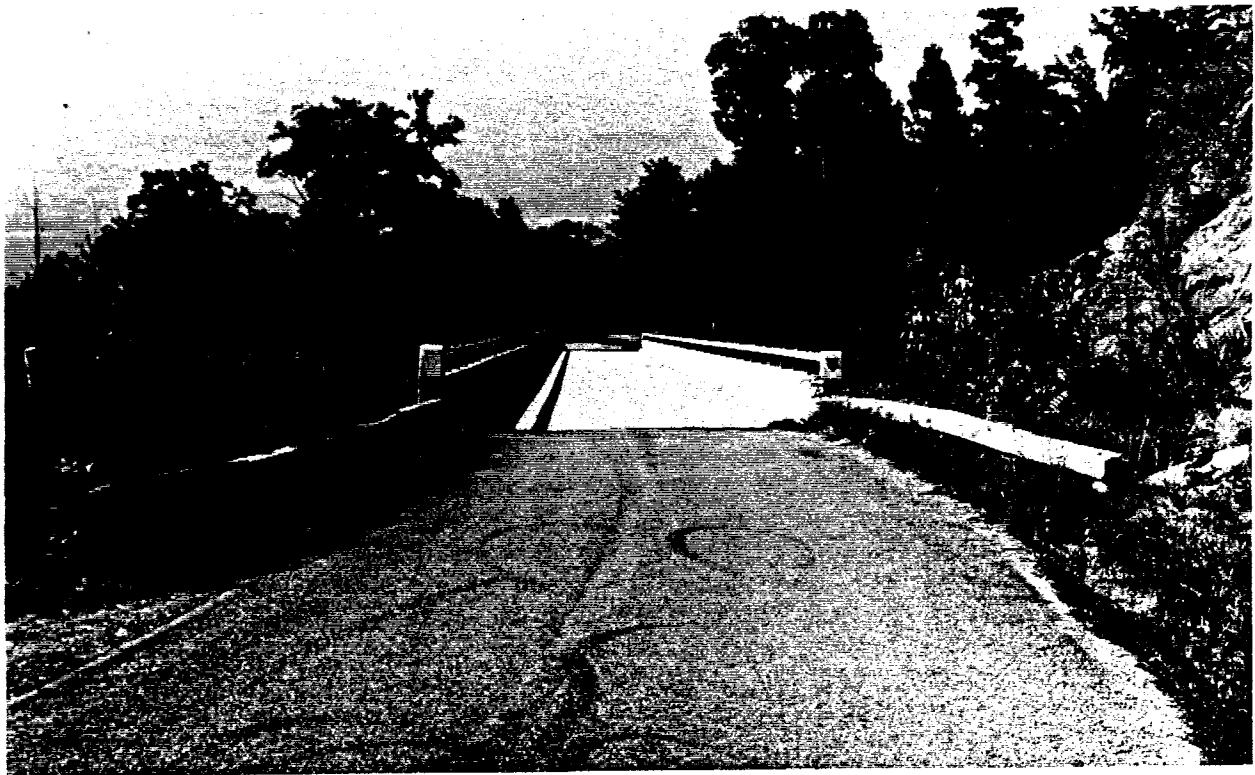
The contributions of vibration and other dynamic loading effects to the propagation of transverse cracking were indicated often by comparisons of bridges on the same limited access highway but exposed to different traffic conditions. Although the bridges were of essentially the same age, overpasses carrying fewer trucks and at lower speeds exhibited less cracking than bridges on the main highway. Despite the apparent correlation between the severity of cracking and the traffic volume, transverse cracking was noted to some extent on structures with very low traffic volumes. Figure 9 shows a transverse crack in the positive moment area of the single-lane service road bridge shown in Figure 10 that serves a single residence and small orchard.

Figure 9. Crack in positive moment area of single-lane service road bridge (Figure 10).

Figure 10. Low-volume service road bridge provides access to residence and orchard.
