**METHODS FOR INCREASING THE HARSHNESS
OF TEXTURE ON OLD CONCRETE PAVEMENTS**

—Mechanical Alteration with the Klarcrete Machine—

**Marion F. Creech
Highway Materials Research Analyst**

**Virginia Highway Research Council
(A Cooperative Organization Sponsored Jointly by the Virginia
Department of Highways and the University of Virginia)**

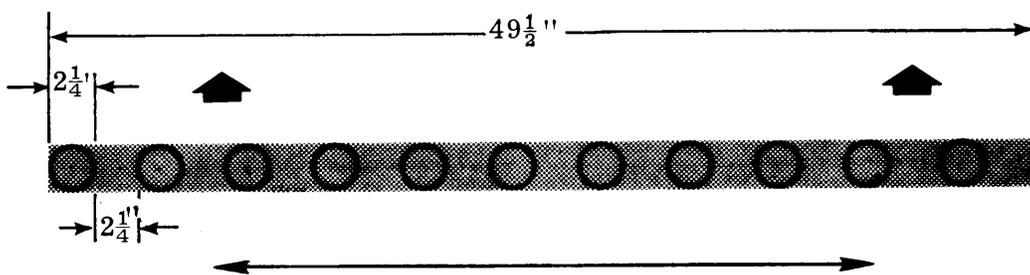
Figure 1. Configuration of cutting heads of the Klarcrete machine. Two-headed arrow indicates that the heads move to right and left on a transverse carriage to cut area in between.

The Klarcrete general purpose concrete repair machine removes the pavement surface by employing 11 percussive hammers that operate independently and each strike the pavement approximately 1,500 times per minute. The machine operates on

compressed air and requires at least a 600 cubic foot per minute compressor capable of producing 100 pounds of compressed air per square inch. The hammers are 2 1/4 inches in diameter and are 2 1/4 inches apart. They are mounted on a carriage that allows vertical movement and which in turn is attached to a transverse carriage that allows lateral movement. The lateral movement is necessary to get uniform removal of concrete over the width of operation. The width of cut is variable from 4 1/2 inches [2 1/4 inches (diameter of cutting head) + 2 1/4 inches (space between cutting heads) = 4 1/2 inches] to 49 1/2 inches in 4 1/2 inch increments by adding or deleting individual cutting heads. Figure 1 gives the configuration of the cutting heads. The cutting heads, which require no lubrication and are free to rotate, break the concrete into small particles of a gradation not much larger than dust and cause no damage to the surrounding concrete. When standing on the pavement beside the machine while it is in operation one can notice the vibrations but they are not great. The machine removes the surface by the number of impacts rather than the force of individual impacts. When the object is to remove the top surface of the concrete in a continuous sweep the machine travels slowly forward under its own power. The depth of removal of concrete is dependent upon the forward speed of the machine. A small pneumatic motor attached to the left rear wheel allows automatic operation and permits the towing of a compressor power source.

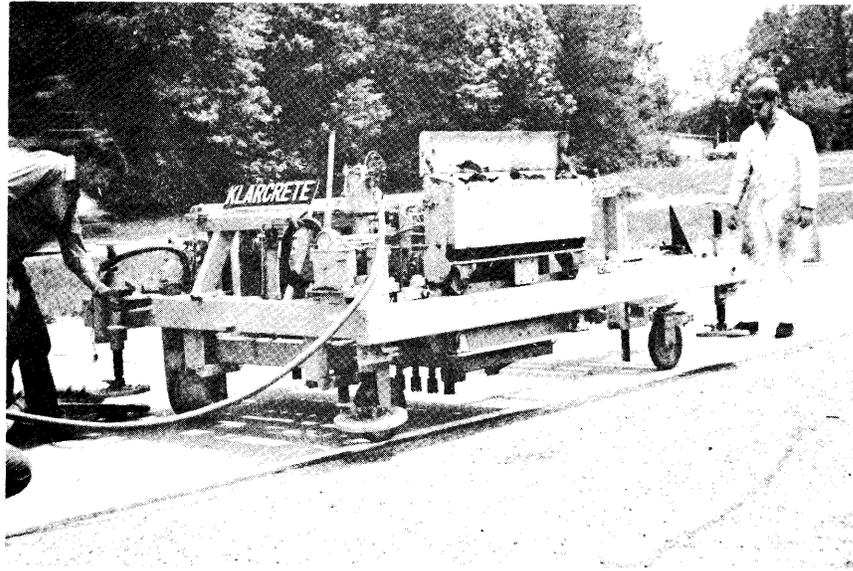
Figure 2. Klarcrete machine being positioned for operation.

Figure 2 is a view of the machine being positioned for operation. Note the cutting heads in the raised position. Figure 3 shows the machine with the 11 percussive hammers in operation, and Figure 4 shows the machine with the compressor attached.

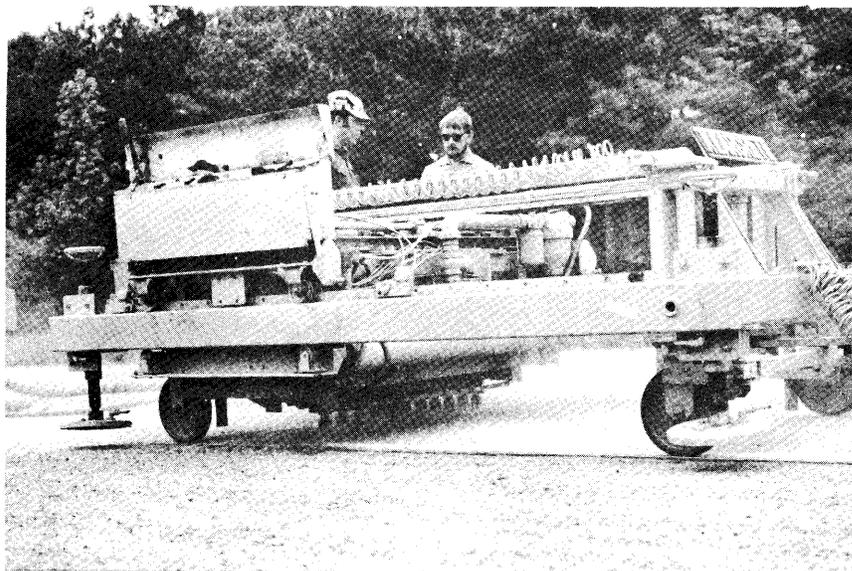
Figure 3. Klarcrete machine in operation.

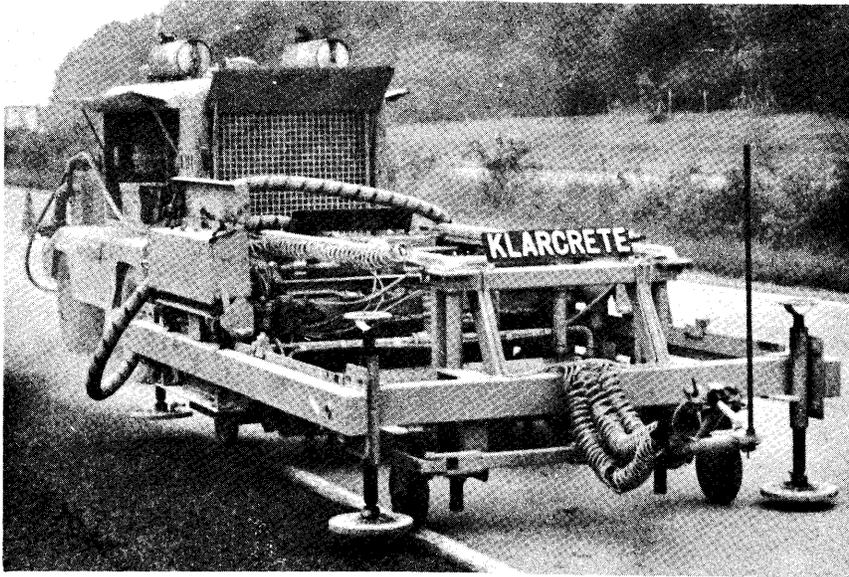
Figure 4. Full view of Klarcrete machine and compressor.

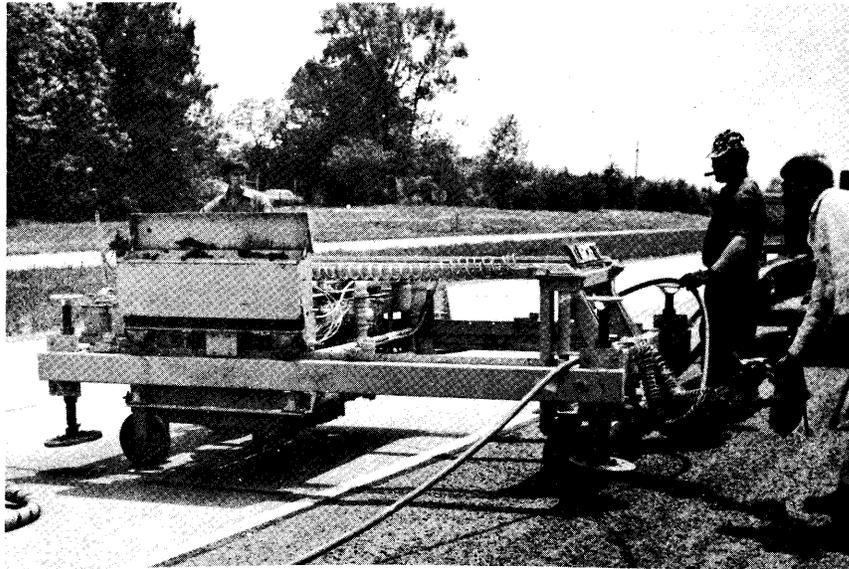
Figure 5. Klarcrete machine being turned and positioned.

The control mechanisms for adjusting the speed of the machine, reversing its direction, and steering it are located on the tiller, which is attached to the front of the machine. Figure 5 shows the technician backing the machine by the controls and steering mechanism on the tiller. A second set of controls located on the right side of the machine control the speed — both transverse and vertical — and the pressure to the cutting head. A side view of the control box may be observed in Figure 5.

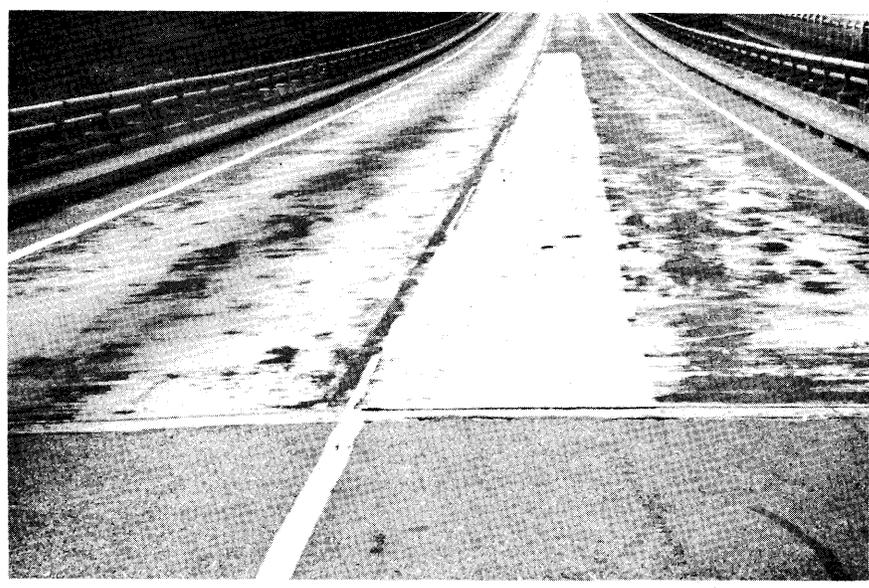
Figure 6. Cold tar epoxy on deck of northbound Meherrin River Bridge. Note single swath cleaned by Klarcrete machine.

As previously noted, two bridges were selected for testing to determine the capabilities of the machine for bridge deck cleaning. The bridges were covered with old, cracked, partially deteriorated coal tar epoxy requiring removal prior to resealing with new epoxy. Considerable time, effort, and funds were spent last winter sandblasting the bridges in an effort to remove the epoxy, but with little success. Figure 6 is a view of one of the bridges showing the coal tar epoxy after sandblasting. The right center cleared path was made by the Klarcrete machine.

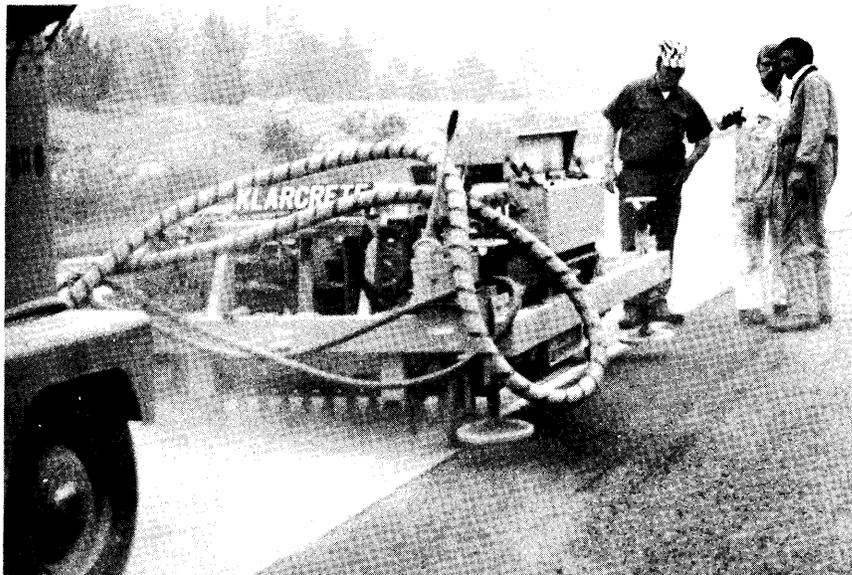
Figure 7. Dust produced by Klarcrete machine operating on dry pavement.

Air pollution by dust can be great as can be seen in Figure 7, where the machine is operating on dry pavement; however, on wet pavement, as shown in Figure 8, no air pollution occurs. Figure 8 shows the machine operating after a downpour but a water truck with a spray bar was employed at other times. In very hot weather water evaporation is fast and the pavement has to be wetted often. The machine operates as well on wet pavement as on dry. A companion problem was that particles left by the machine had to be swept from the road with a mechanical sweeper that produced a dust cloud. The particles, nearly 1/4 inch in depth, turned into a paste-like substance when sprinkled with water and could not be swept from the road. This problem was not solved at the test site and the particles were swept from the road while dry. A solution for this could be a vacuum type street sweeper such as those employed by some cities.

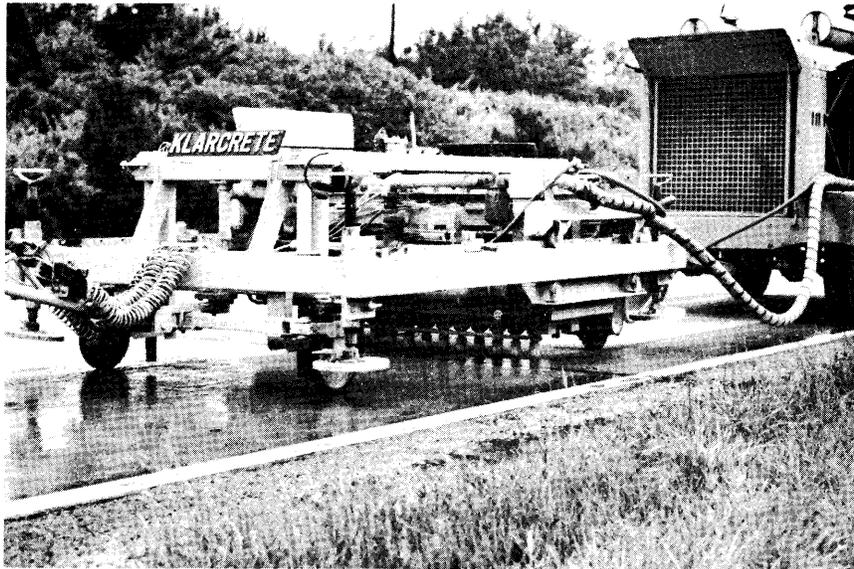
Figure 8. Klarcrete machine operating on wet pavement.

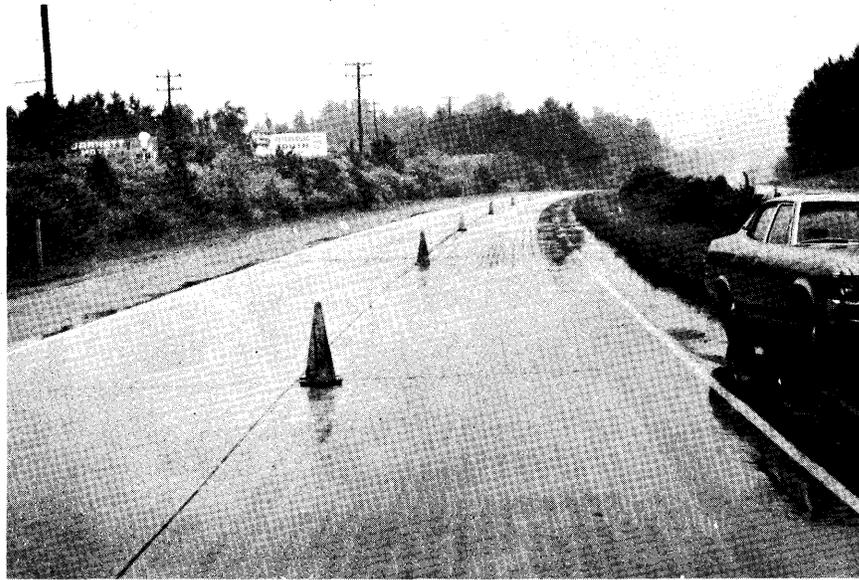
Figure 9. Wet pavement after treatment with Klarcrete machine. Note the ponding of water on the untreated portion.

The sharp surface of the granite aggregate protruded above the surrounding cement mortar to produce a texture that was coarse. The coarse texture allows considerable space for water to escape and also exposes a polish resistant aggregate for contact with the tires of vehicles. Figure 9 shows the pavement after a heavy rain. All of the pavement has been treated except the extreme right portion with the edge line marking.

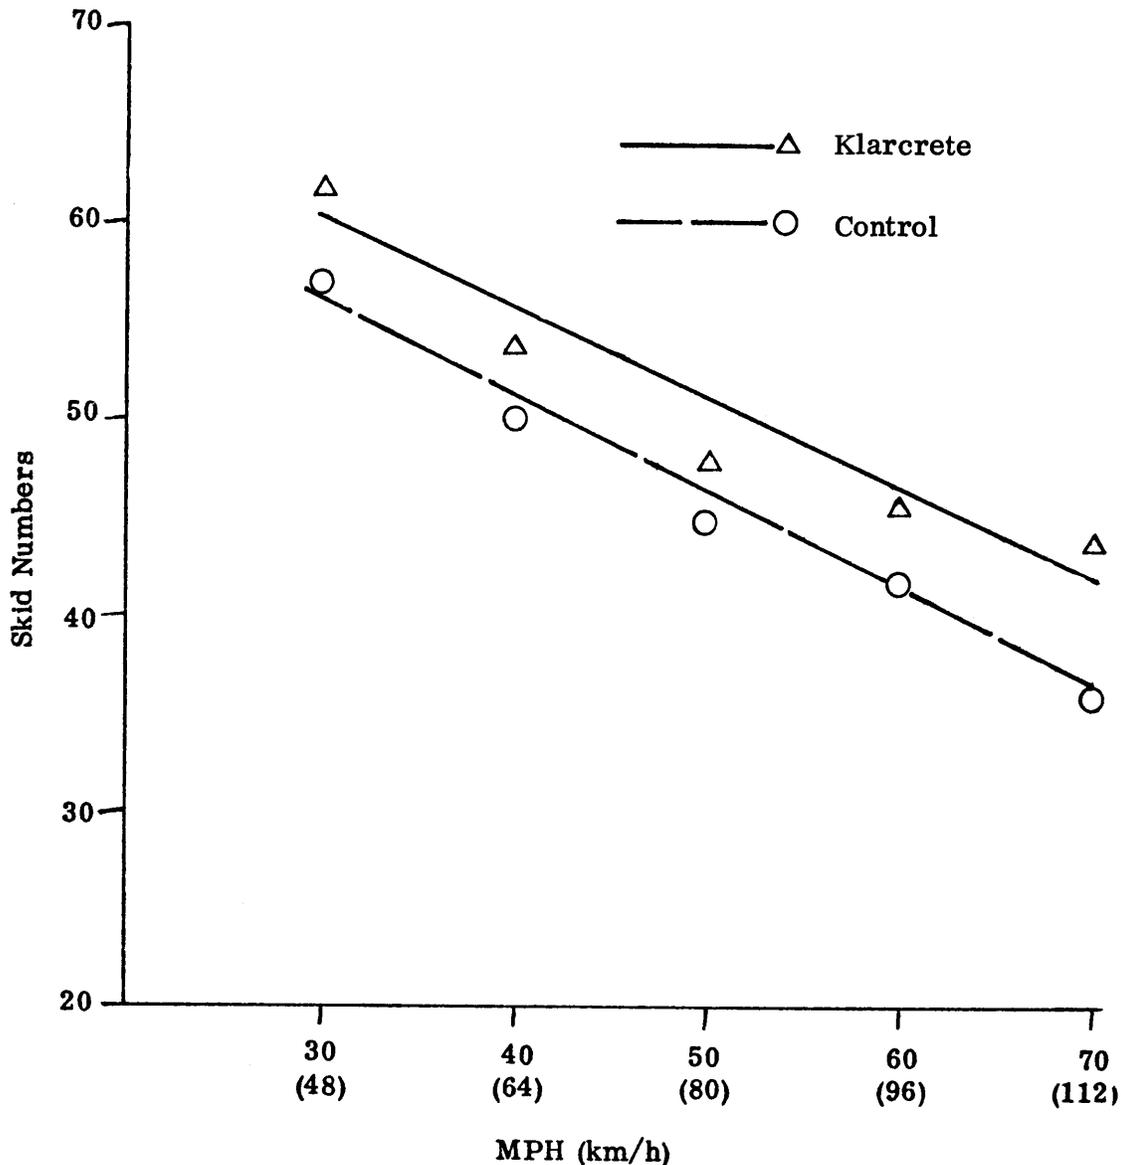
Figure 10. Skid test results for the traffic lane on the treated and untreated sections. ASTM Method 274, which employs a new tire and a .020" water film thickness.

Figure 10 shows that the pavement not only had very good skid resistance before treatment when tested by ASTM Method E 274, but also had an acceptable skid number at 70 mph. Even so the Klarcrete treatment improved the skid number by about four units up through 60 mph and by about eight skid numbers at 70 mph. If tests were performed at 40 mph only, it would be questionable if the increase in skid number from 50 to 54 would justify the expense of the treatment. However, the increase of eight skid numbers, from 36 to 44, at 70 mph would justify the treatment if the site had a high wet accident history. Both curves in Figure 10 depict only a moderate loss in skid resistance with increased speed, which indicated no tendency toward hydroplaning.

The values in Figure 14, obtained in the traffic lane with a new tire, are essentially the same as those shown in Figure 10, which were recorded in tests on half the water film thickness. This finding indicates two things: first, a film thickness of .040" is not enough water to overtax a new ASTM tire; and second, for realistic testing, the .020" film thickness prescribed by ASTM is sufficient.

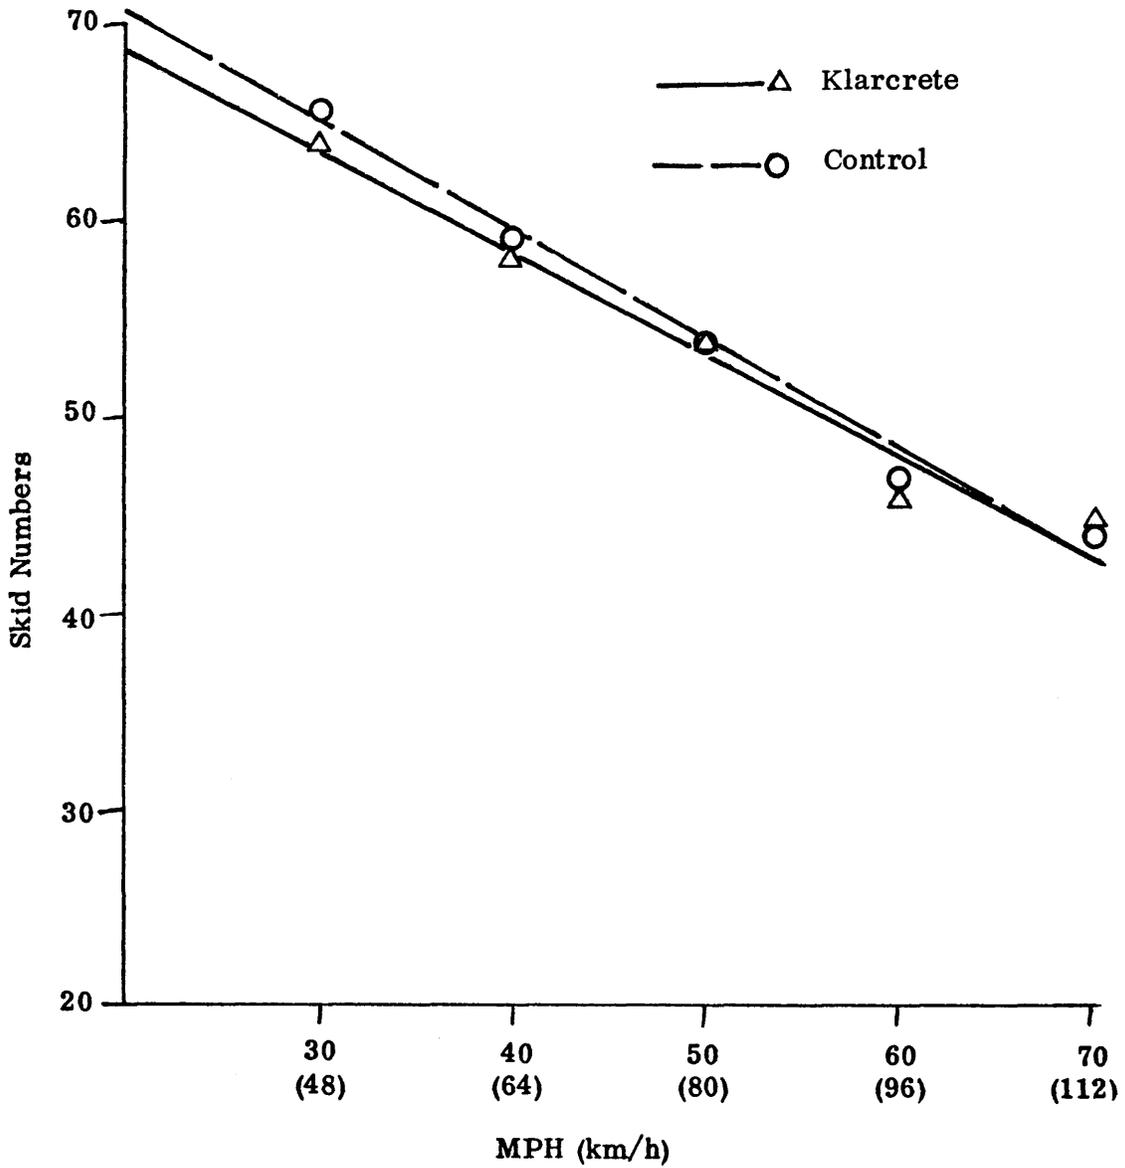
Figure 11. Skid test results for the passing lane on the treated and untreated sections. ASTM Method 274. .020" water film thickness.

Figure 11, like Figure 10, reflects data gathered by ASTM Method E 274, but for the passing lane as opposed to traffic lane. This lane had received less traffic, and it can be seen that no improvement was realized.

Figure 15 shows the skid values obtained on the passing lane with the new test tire and a film thickness of .040". Remember that in Figure 11, which showed tests with the same tire but half the amount of water, some values were higher for the untreated pavement than for the treated. Figure 15 reveals the same phenomenon, which is accepted as insignificant or as a testing error due to the small amount of data. However, it could well be that a reduction in surface area under some conditions could reduce skid numbers.

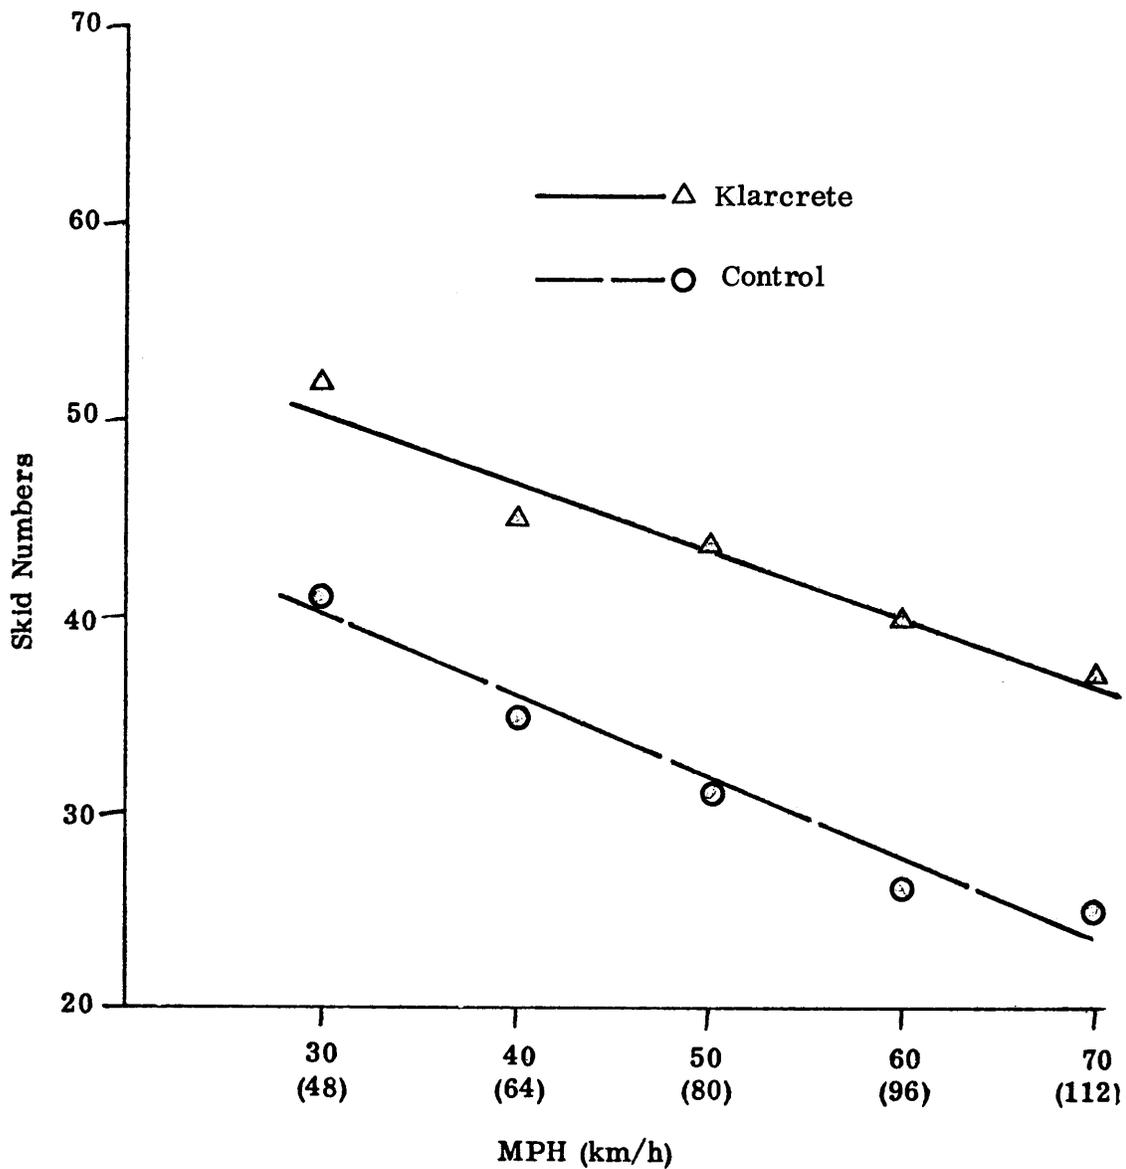
Figure 12. Skid test results for the traffic lane on the treated and untreated sections. Tests employed bald tire and a .020" water film thickness.

Figure 12, shows results on the traffic lane, with the bald E 249 tire. The improvement in skid resistance is significant, even at the low speed of 30 mph, where the treatment caused an increase of 11 skid numbers. Since the curves are parallel and neither approaches zero, there is still no indication of absolute hydroplaning, although it is obvious that the channels in the pavement surface effectively provide for the escape of water when a bald tire is in use.

Figure 16 differs from Figure 12 in that the tests were performed with a water film thickness of .040". The values for both the treated and untreated pavements with the increased water are lower by about 4 SN for the test speeds of 50, 60, and 70 mph. The decrease on the untreated surface was expected but that on the treated was not. This indicates the greater water output resulted in a thicker film of water even on the rough textured surface as a result of the greater water output and that this additional water decreased the skid resistance at the higher speeds. This observation should be accepted as a possibility and not as a positive conclusion.

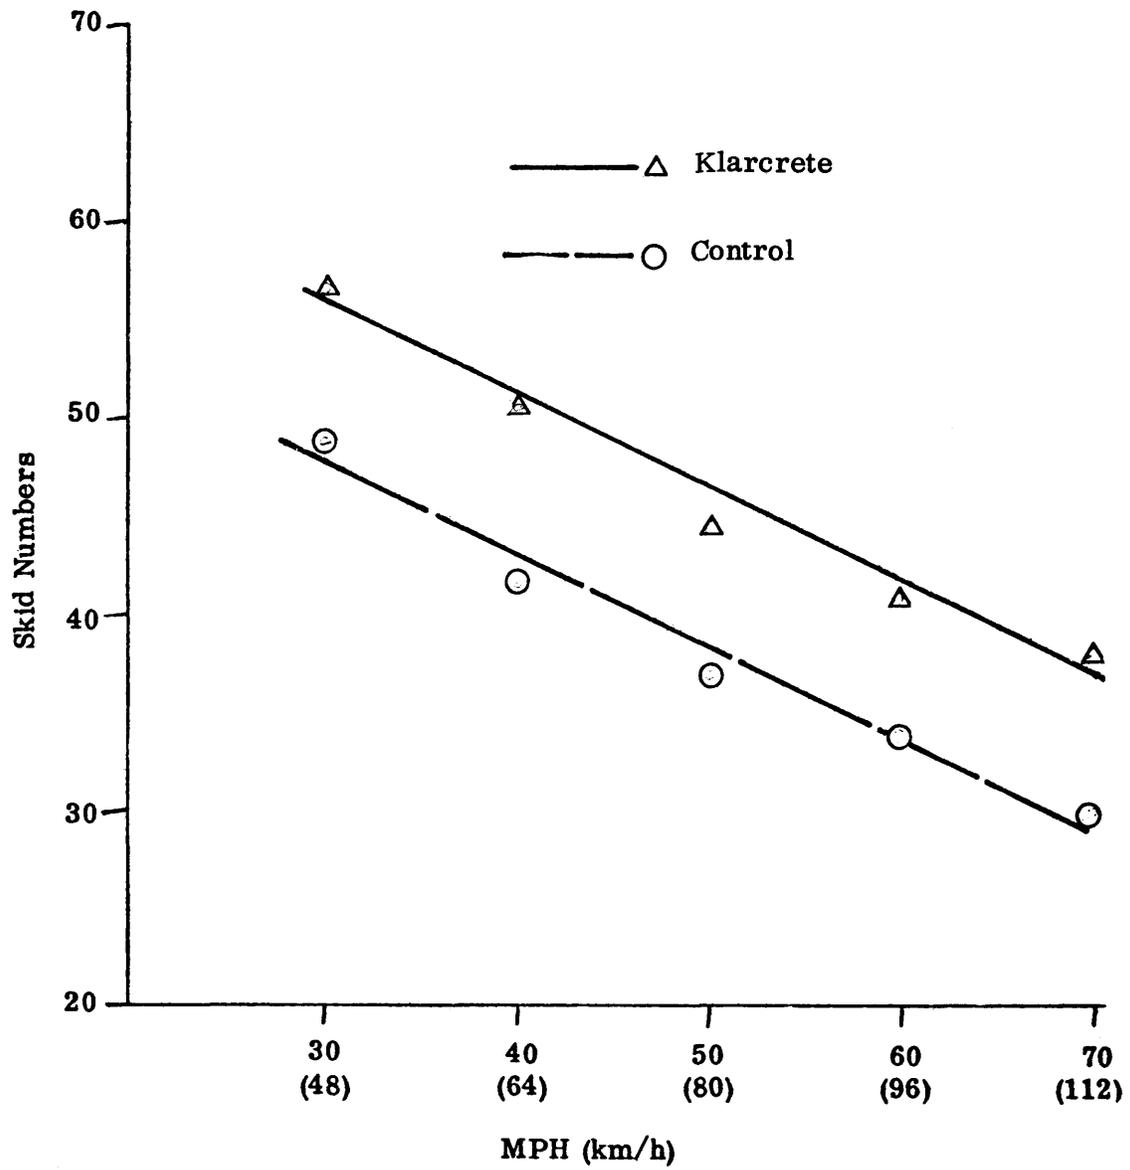
Figure 13. Skid test results for the passing lane on the treated and untreated sections. Tests employed bald tire and a .020" water film thickness.

In Figure 13, which shows results of the bald tire tests in the passing lane, two things should be noted. First, there is a smaller increase in the skid number as a result of treatment than there was in the traffic lane (8 SN as compared to 11 SN); and second, the skid number before treatment is about 6 SN higher than that in the traffic lane before treatment. The latter fact indicates that the texture in the passing lane prior to treatment, although it was very fine and would probably be classified as microtexture, did provide for enough contact with the bald tire to generate skid values which would satisfy any minimum requirements with which the author is familiar.

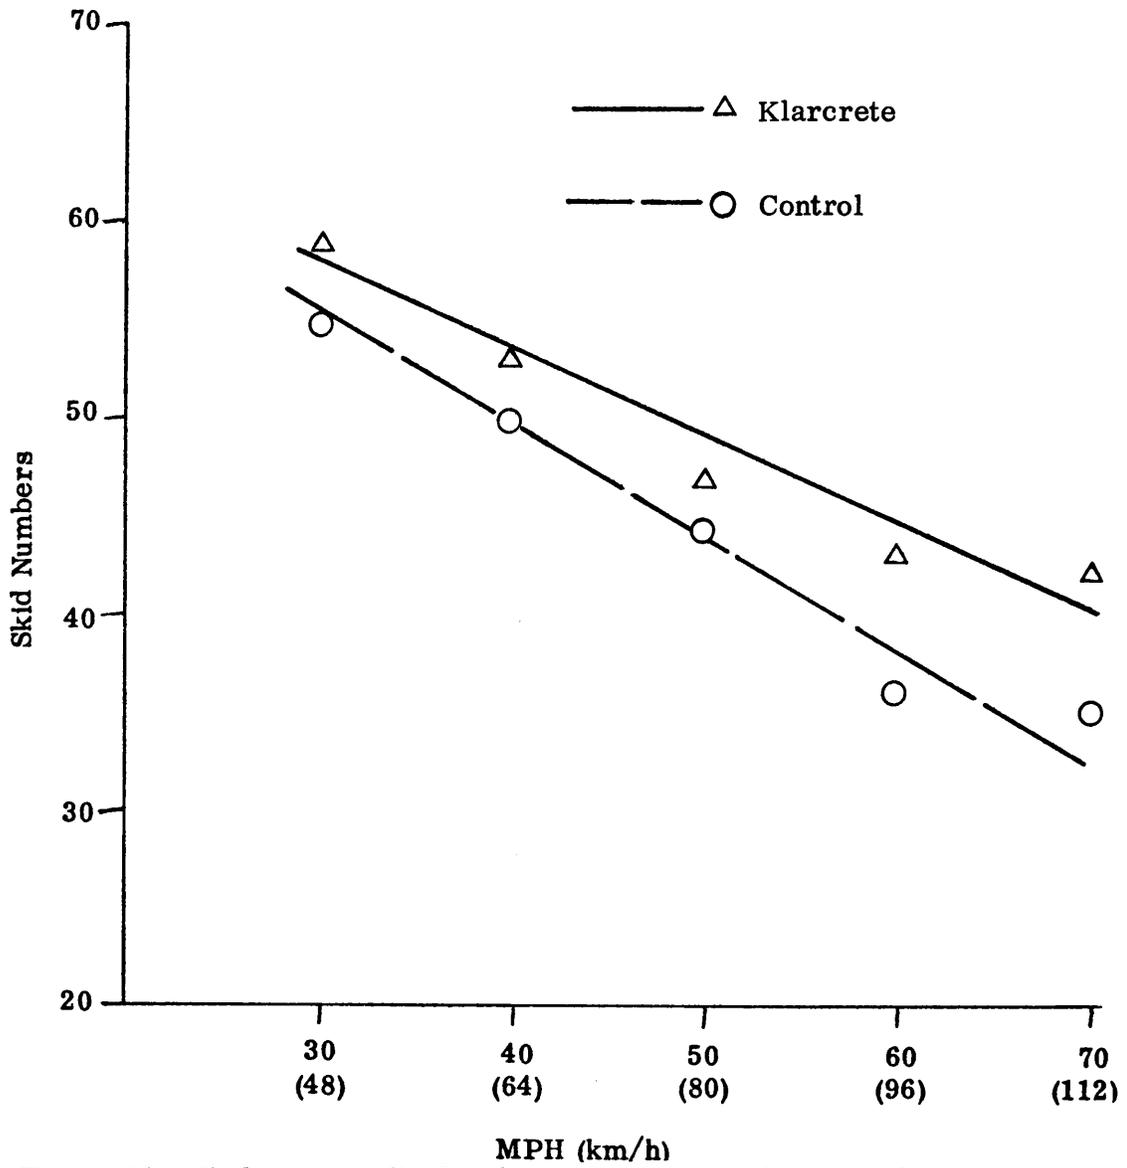
Figure 14. Skid test results for the traffic lane on the treated and untreated sections. New tire and a .040" water film thickness.

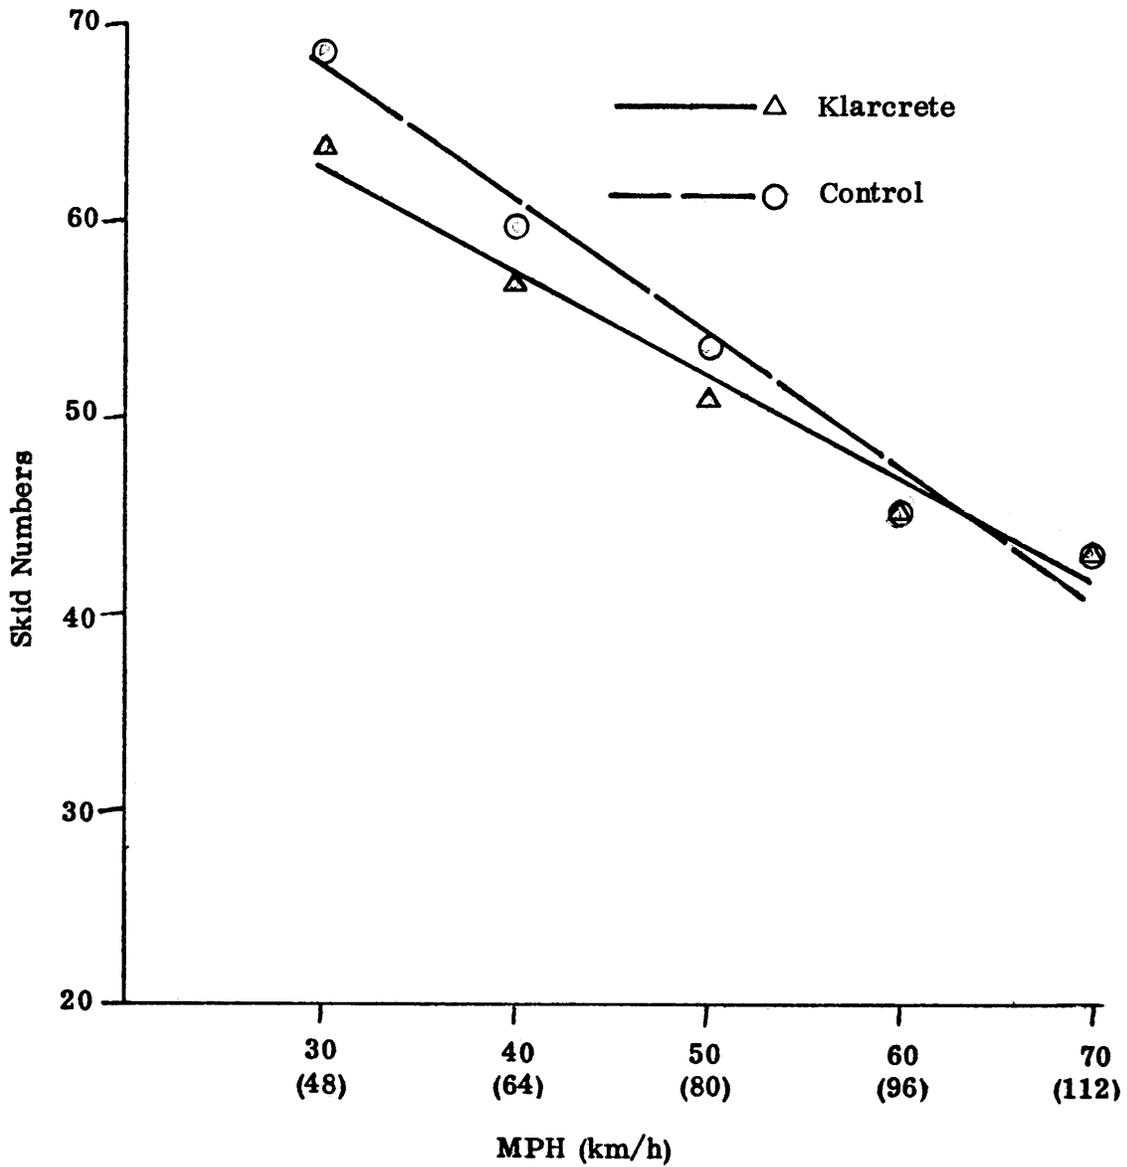
Figure 15. Skid test results for the passing lane on the treated and untreated sections. New tire and a .040" water film thickness.

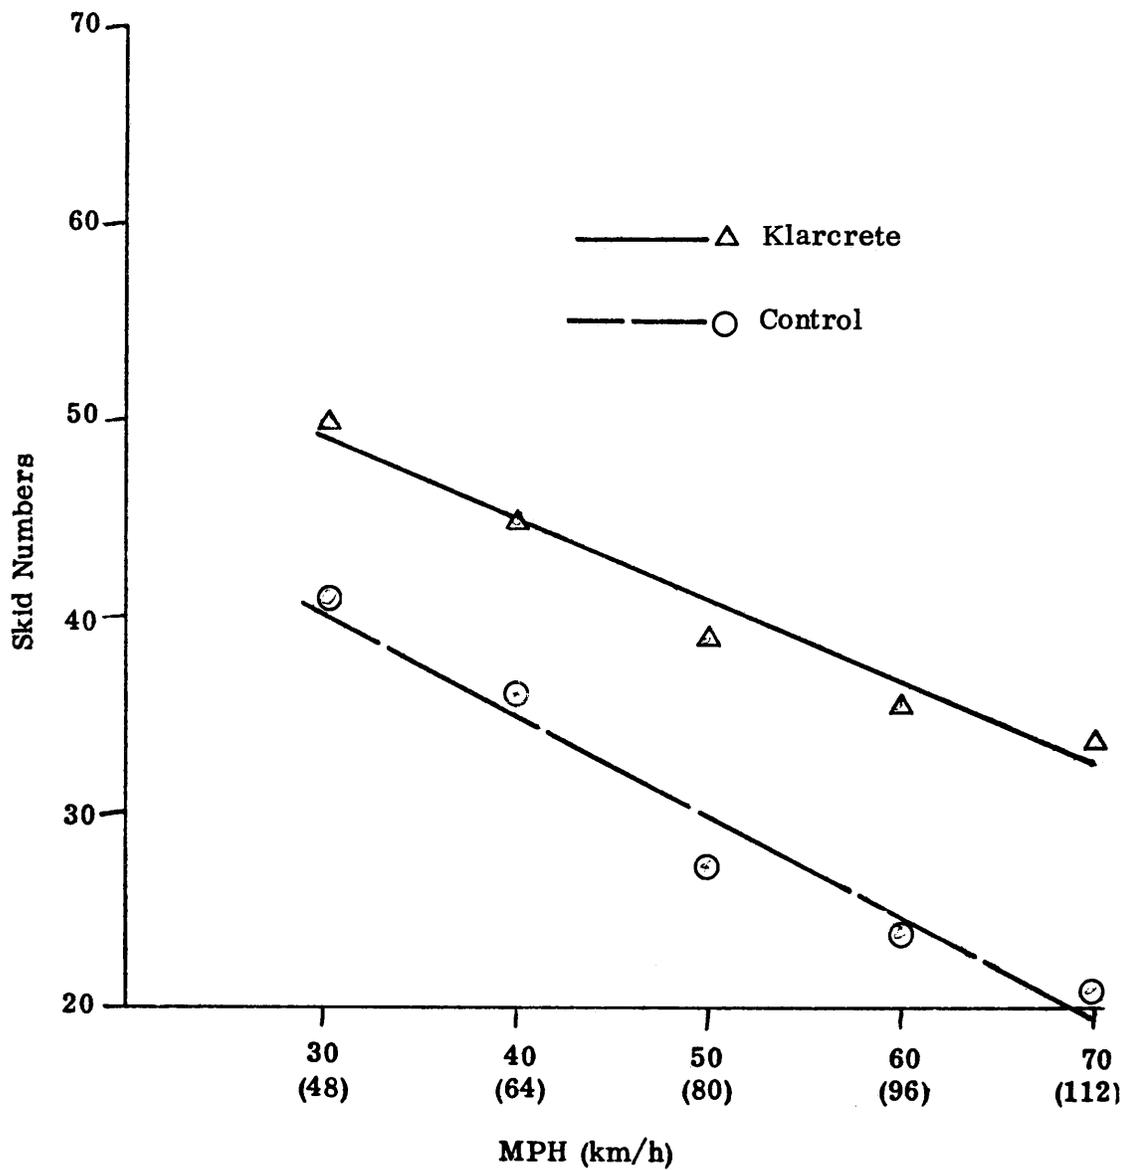
Figure 16. Skid test results for the traffic lane on the treated and untreated sections. Bald tire and a .040" water film thickness.

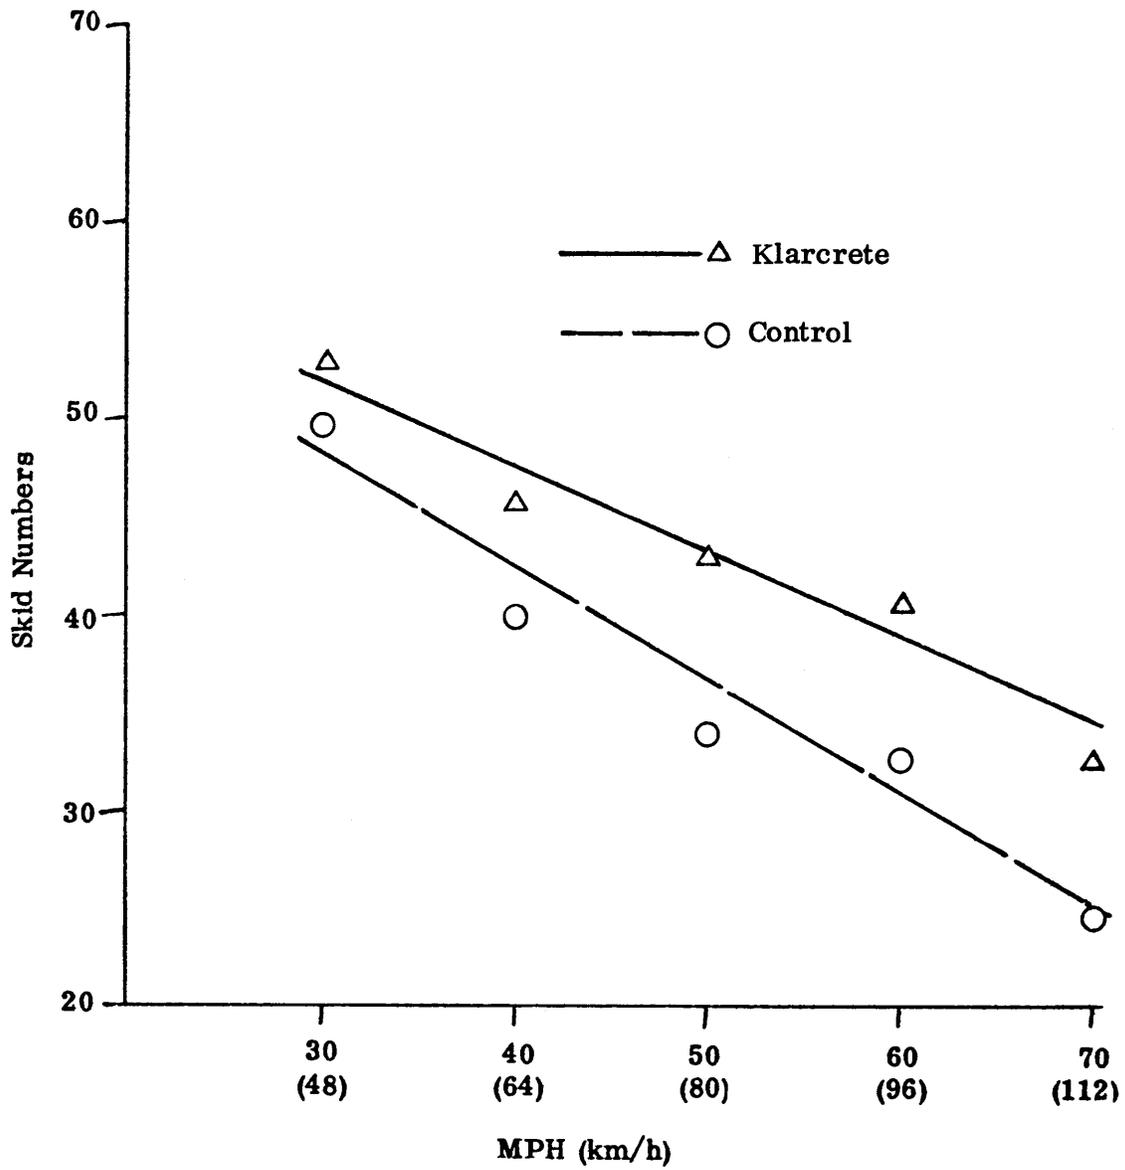
Figure 17. Skid test results for the passing lane on the treated and untreated sections. Bald tire and a .040" water film thickness.

Figure 17 gives the data for the passing lane tests with bald tires and a .040" water film thickness. Again there was a decrease in skid resistance on both the treated and untreated surfaces as compared to the results when .020" water was applied, but it did not occur until the test speed reached 70 mph.

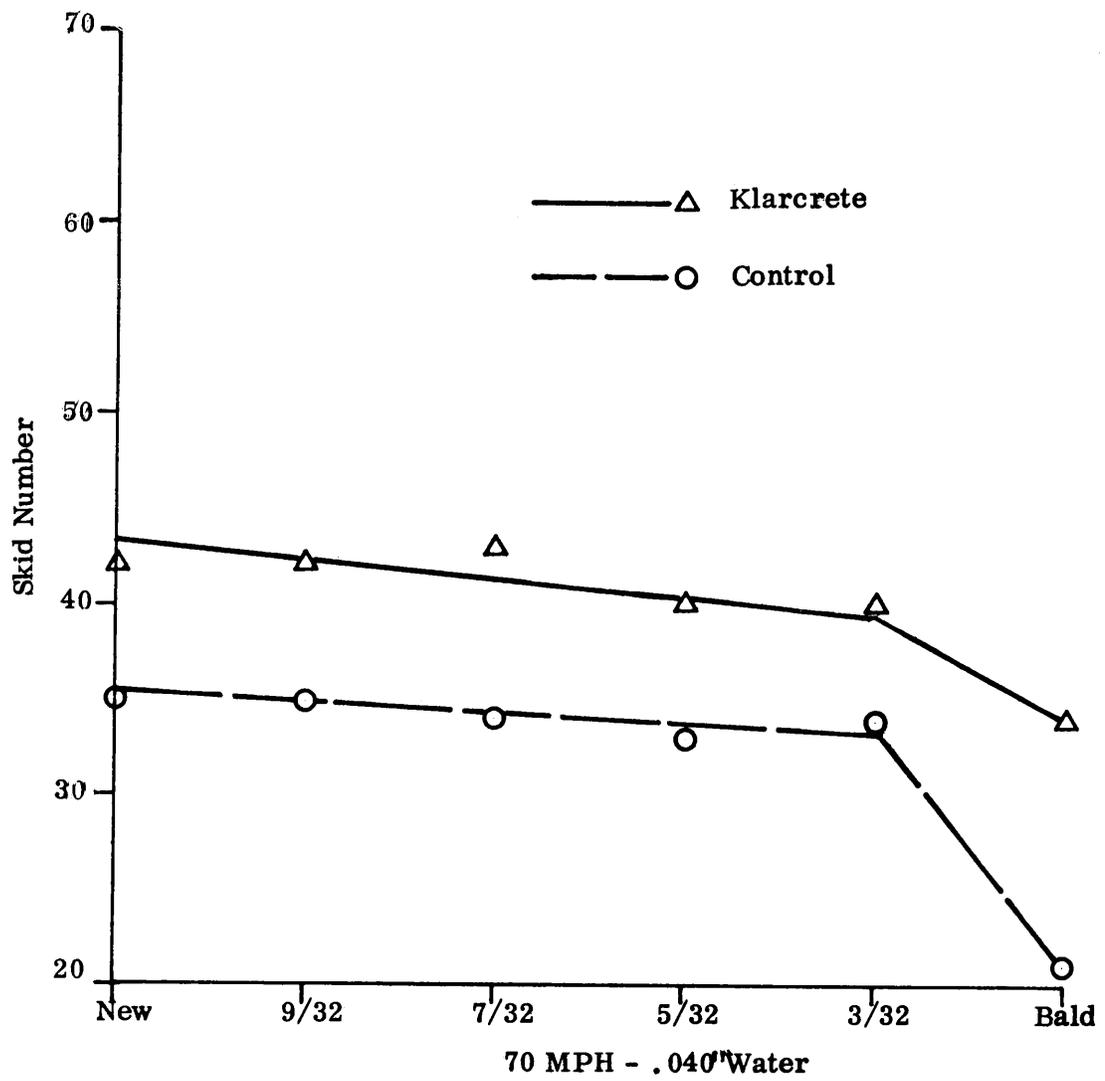
Figure 18. Skid results with respect to tire tread depth for 70 mph and .040" water film thickness for both control and Klarcrete traffic lane sections.

Figures 18 and 19 show a different type of data from those given in the figures presented thus far. Both show data for 70 mph tests with .040" of water and for six tire conditions ranging from new to bald. The values in Figure 18 are for the traffic lane and those in Figure 19 for the passing lane. These data clearly show that tread depth has no affect on the ASTM Standard E 249 tire until it reduces to less than 3/32" for water depths as great as .040". In addition, if the .040" water depth can be accepted as representative of the films produced by many of our rains, the data suggest that a 3/32" tread depth is sufficient for most wet weather driving conditions.

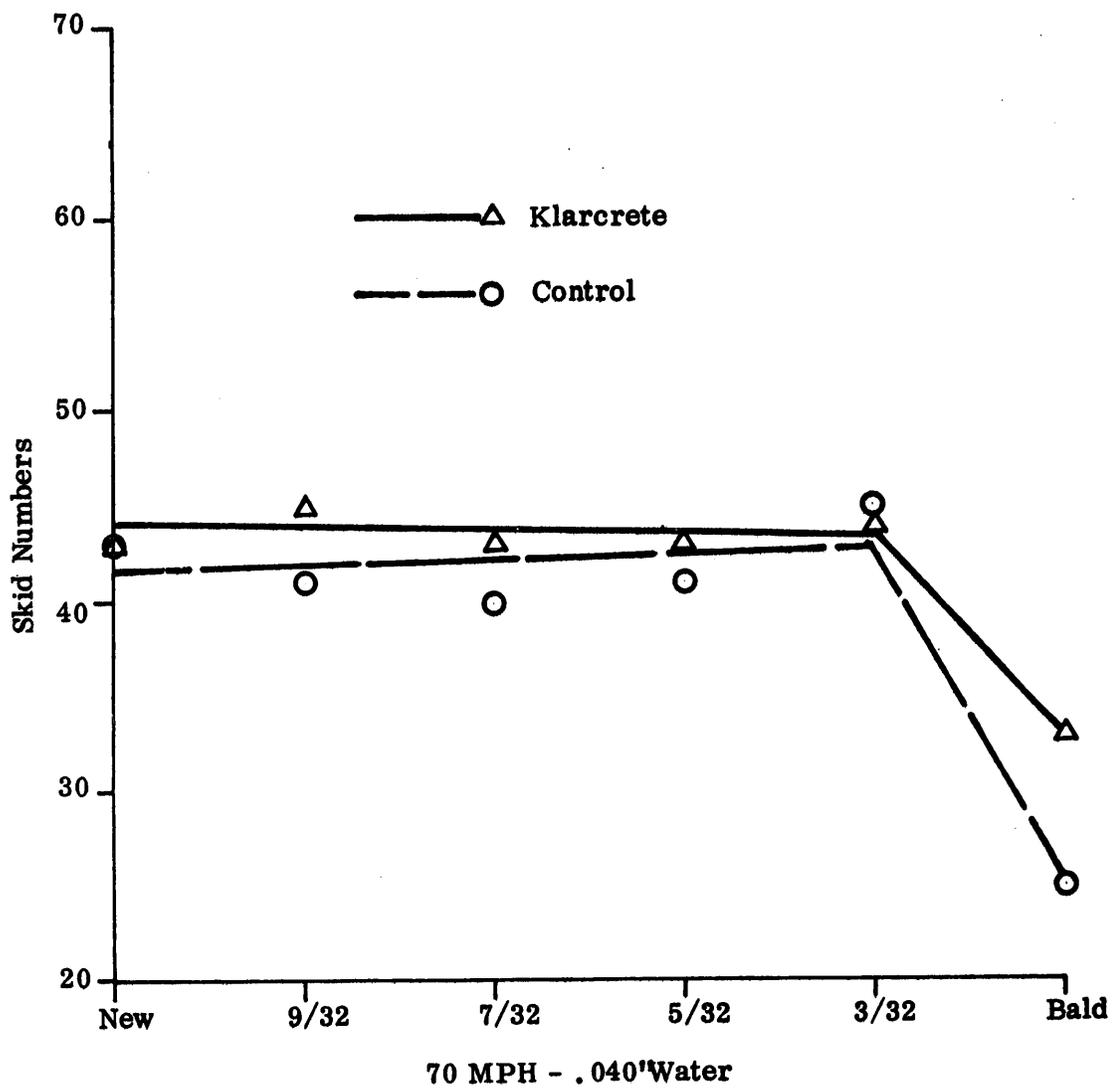
Figure 19. Skid results with respect to tire tread depth for 70 mph and .040" water film thickness for both control and Klarcrete passing lane sections.

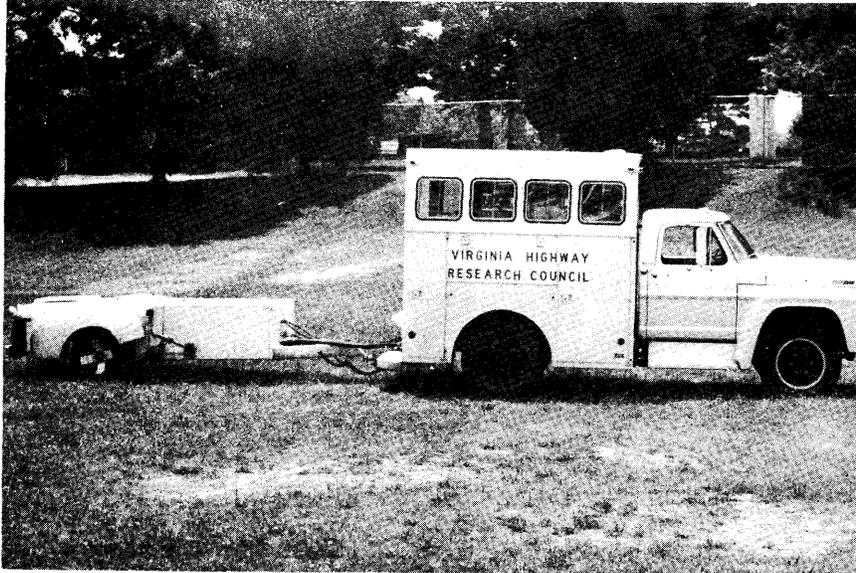
Figure 20. Research Council's skid-resistance measurement vehicle.

The skid data just presented was obtained using the Virginia Highway Research Council's skid trailer, which is shown in Figure 20.

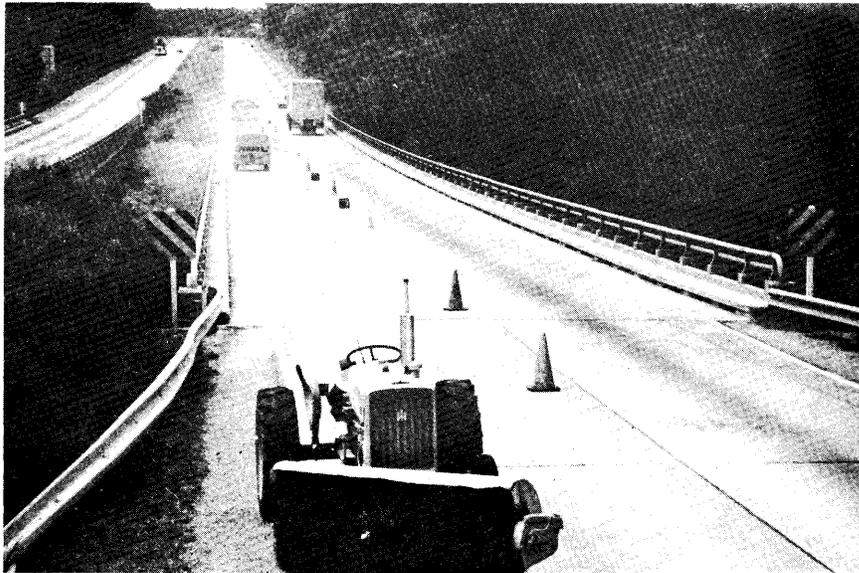
Figure 21. Long-range view of Klarcrete machine in operation on bridge deck.

The Klarcrete machine did an excellent job of cleaning the bridge to a depth that exposed the coarse aggregate as is shown by Figures 21 and 22. It is faster and less expensive than sandblasting. From the results of this experiment it appears that the machine holds real promise for cleaning bridges. Figure 21 is a view of the bridge cleaning operation, and the near white path directly behind the machine indicates the quality of work being performed by the machine. In some areas where the coal tar epoxy was especially thick two passes were made. Figure 22 shows a portion of the bridge after cleaning was completed.

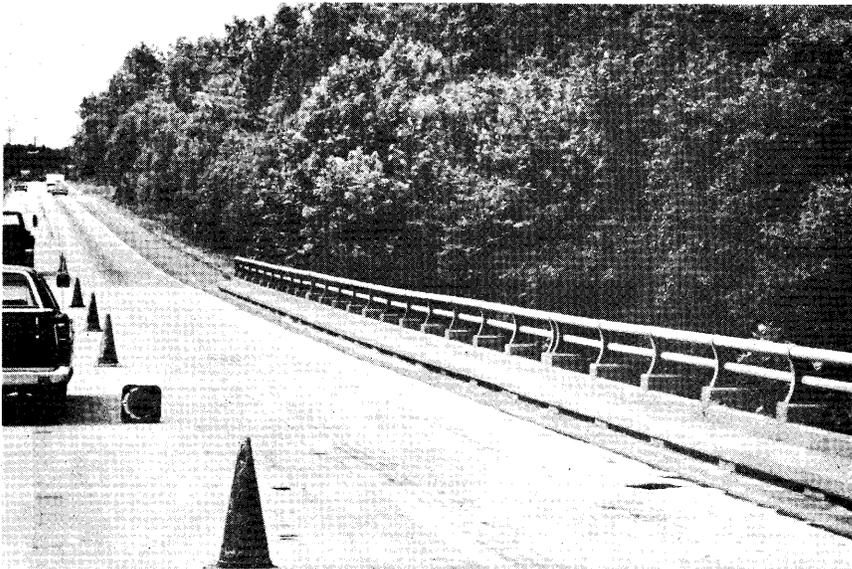
Figure 22. The southbound bridge after cleaning.

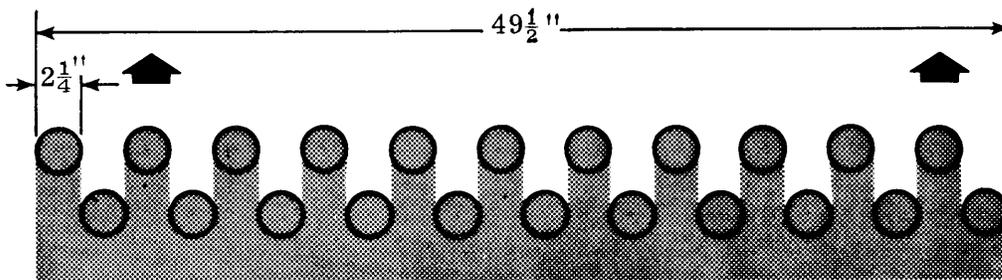
Figure 23. Configuration of 22 cutting heads of new Klarcrete machine. There will be no transverse motion of heads.

A newer model Klarcrete machine, scheduled to be delivered to this country in late fall or early winter of 1973, will double the rate of production and will, in fact, be considerably faster than grooving. The increase in production will be accomplished by having two rows of heads with the second row being offset 2 1/4 inches from the path of the first row. This will enable the machine to bush hammer the 4-foot swath without transverse movement of the heads and by removing this operation will not increase the compressed air requirements. Figure 23 shows the configuration of the heads of the new machine.
