1. Report No. FHWA/VA-89-23	2. Government Accession No.	3. Recipient's Catalog No.	
4. Title and Subtitle Major Factors Affecting the Performance of Bridges During Floods		5. Report Date May 1989

## MAJOR FACTORS AFFECTING THE PERFORMANCE OF BRIDGES DURING FLOODS

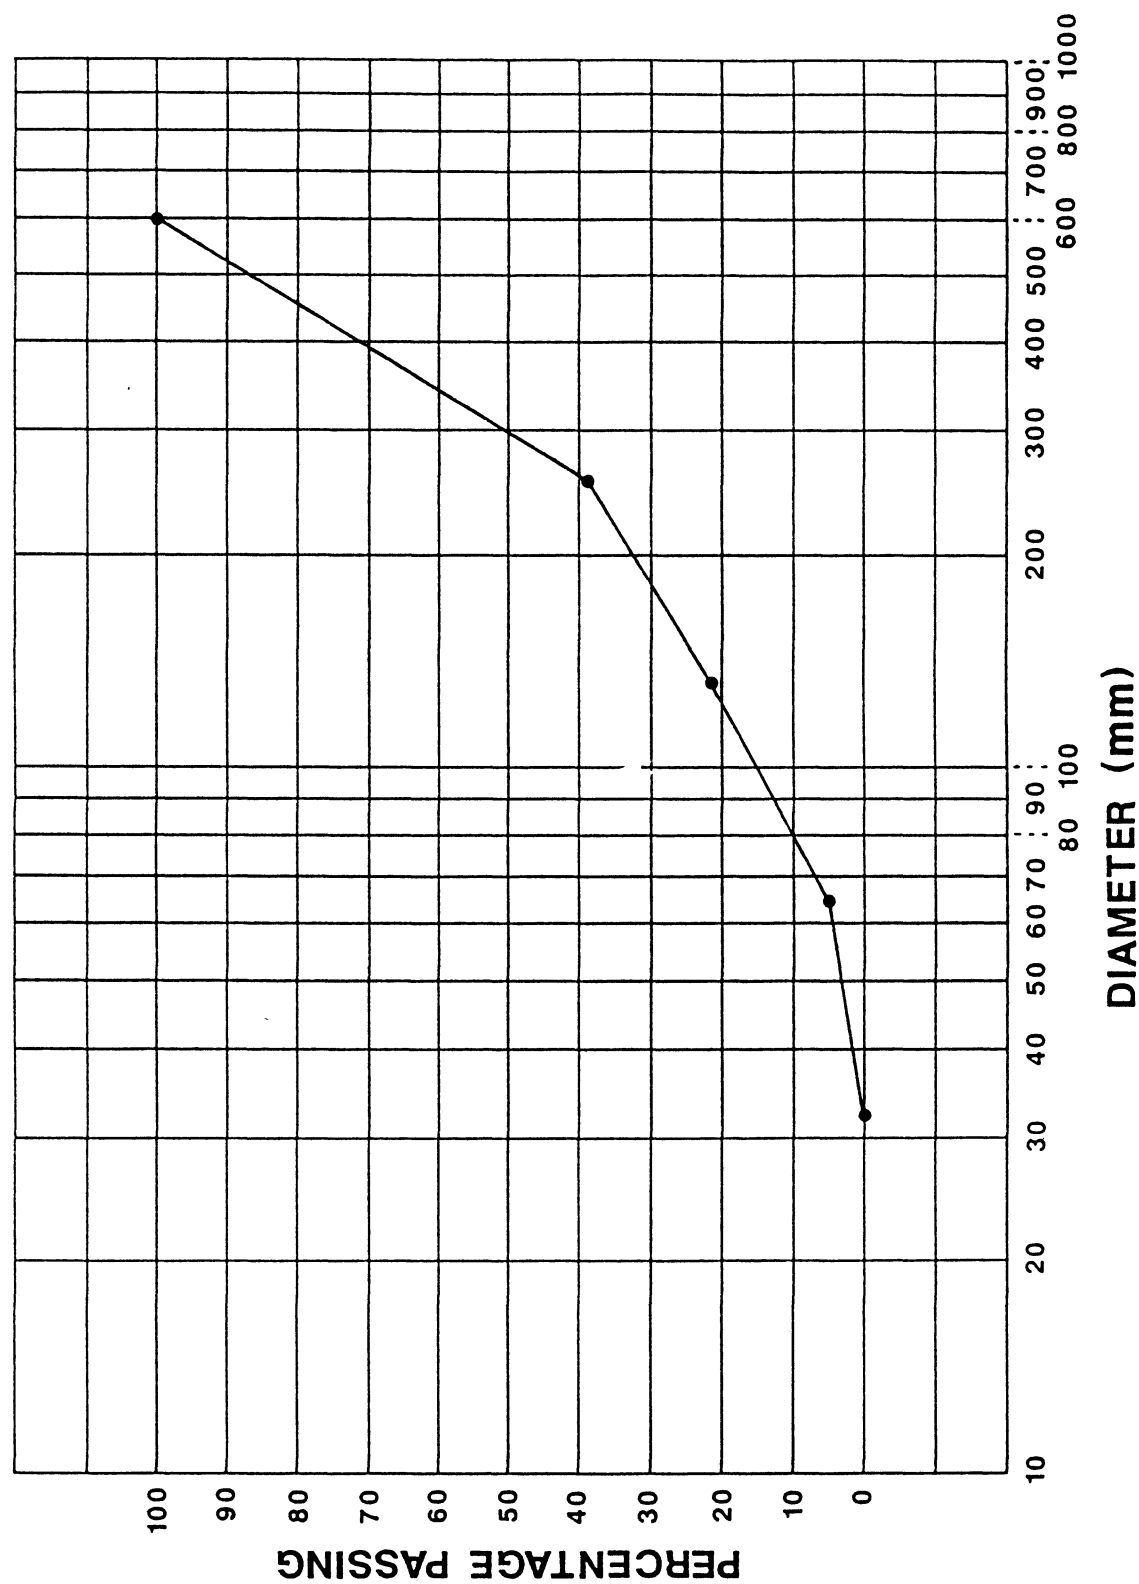
Figure 2. Grain size distribution for the upstream square yard, Dry River and Route 613.

Earlier in the fall while the streambed was still dry, areas of 1 sq yd were delineated with orange paint at three locations. Thus, those portions of the particles that were exposed received some orange paint. Each particle with orange paint on it was measured by hand in three dimensions. Using the field measurements, the approximate volume of each particle and then the nominal diameter of a sphere of that volume were calculated. The particles were classified according to Wentworth's particle size classification (cited in 5), using their nominal diameters, as boulders, large cobbles, small cobbles, very large pebbles, and large pebbles. The grain size distributions for these three samples are shown in Figures 2, 3, and 4. The size for 100 percent passing was determined by taking the size of the largest boulder and rounding up to the next hundred. As is frequently the case with extremely coarse particles, the number and size of the boulders strongly affect the skew of the distributions. Removing the boulders from the samples and recalculating the distributions (see Table 5) show that with respect to the remaining particles the distributions are quite similar.

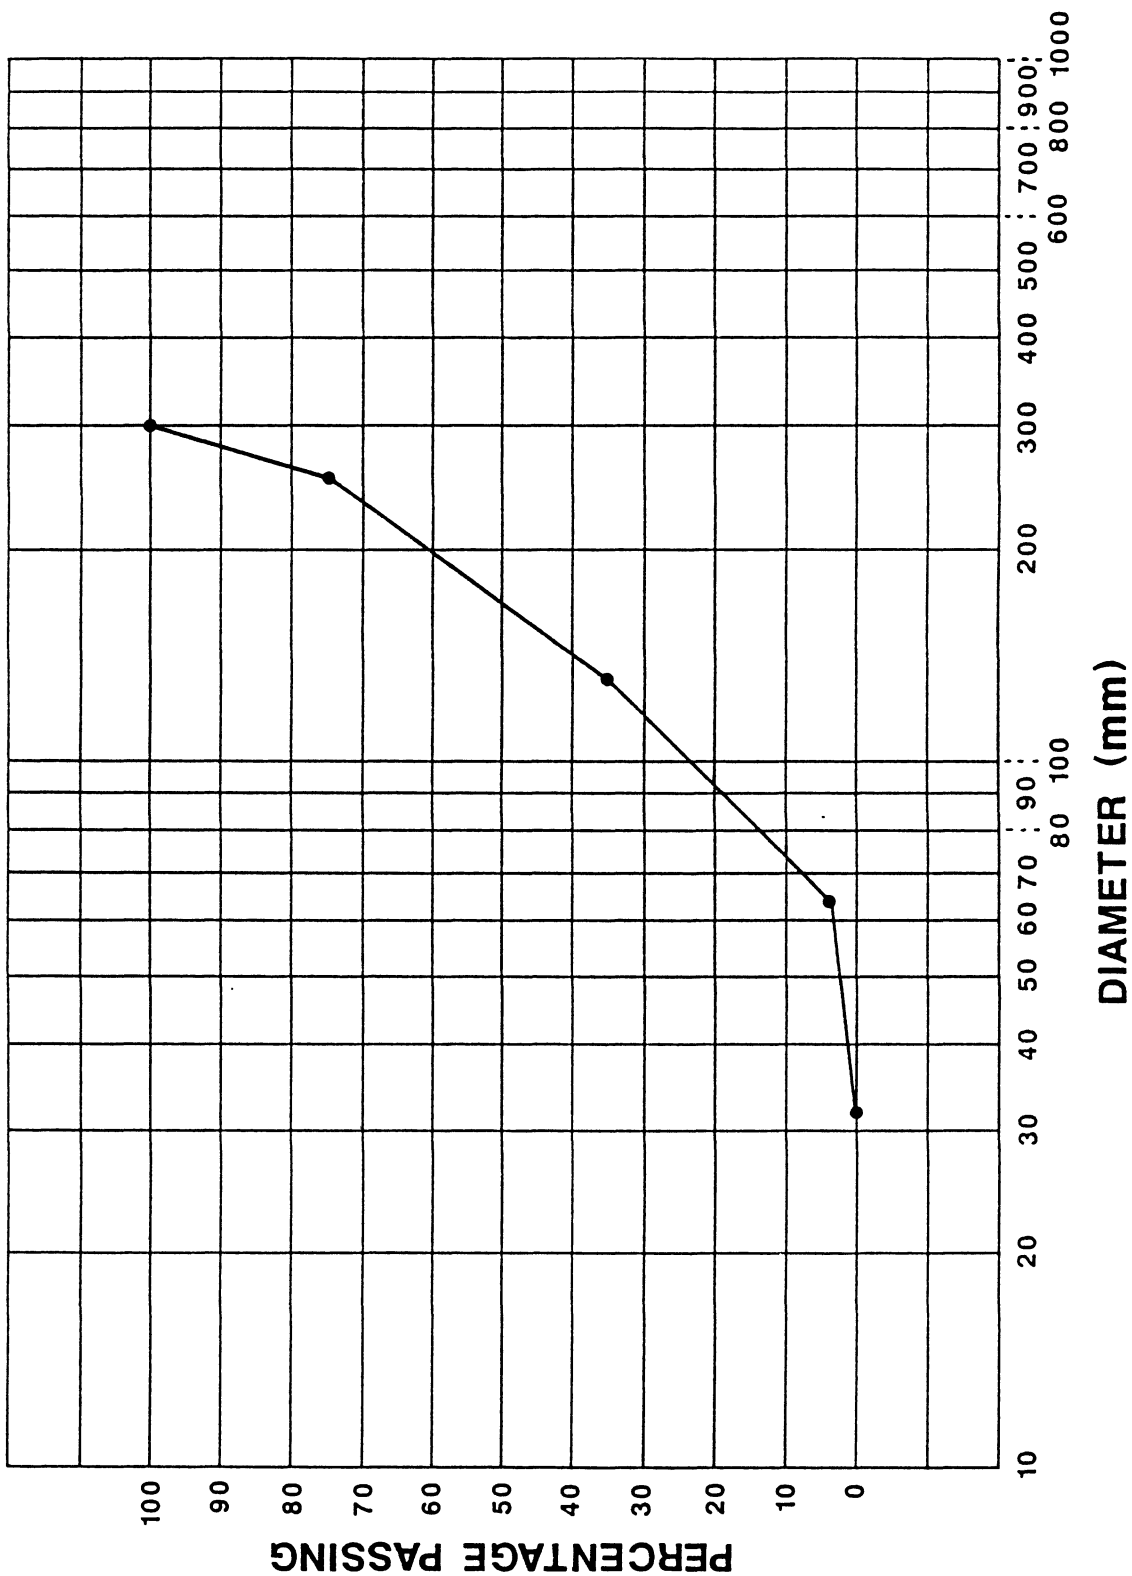
Figure 3. Grain size distribution for the northern downstream square yard, Dry River and Route 613.

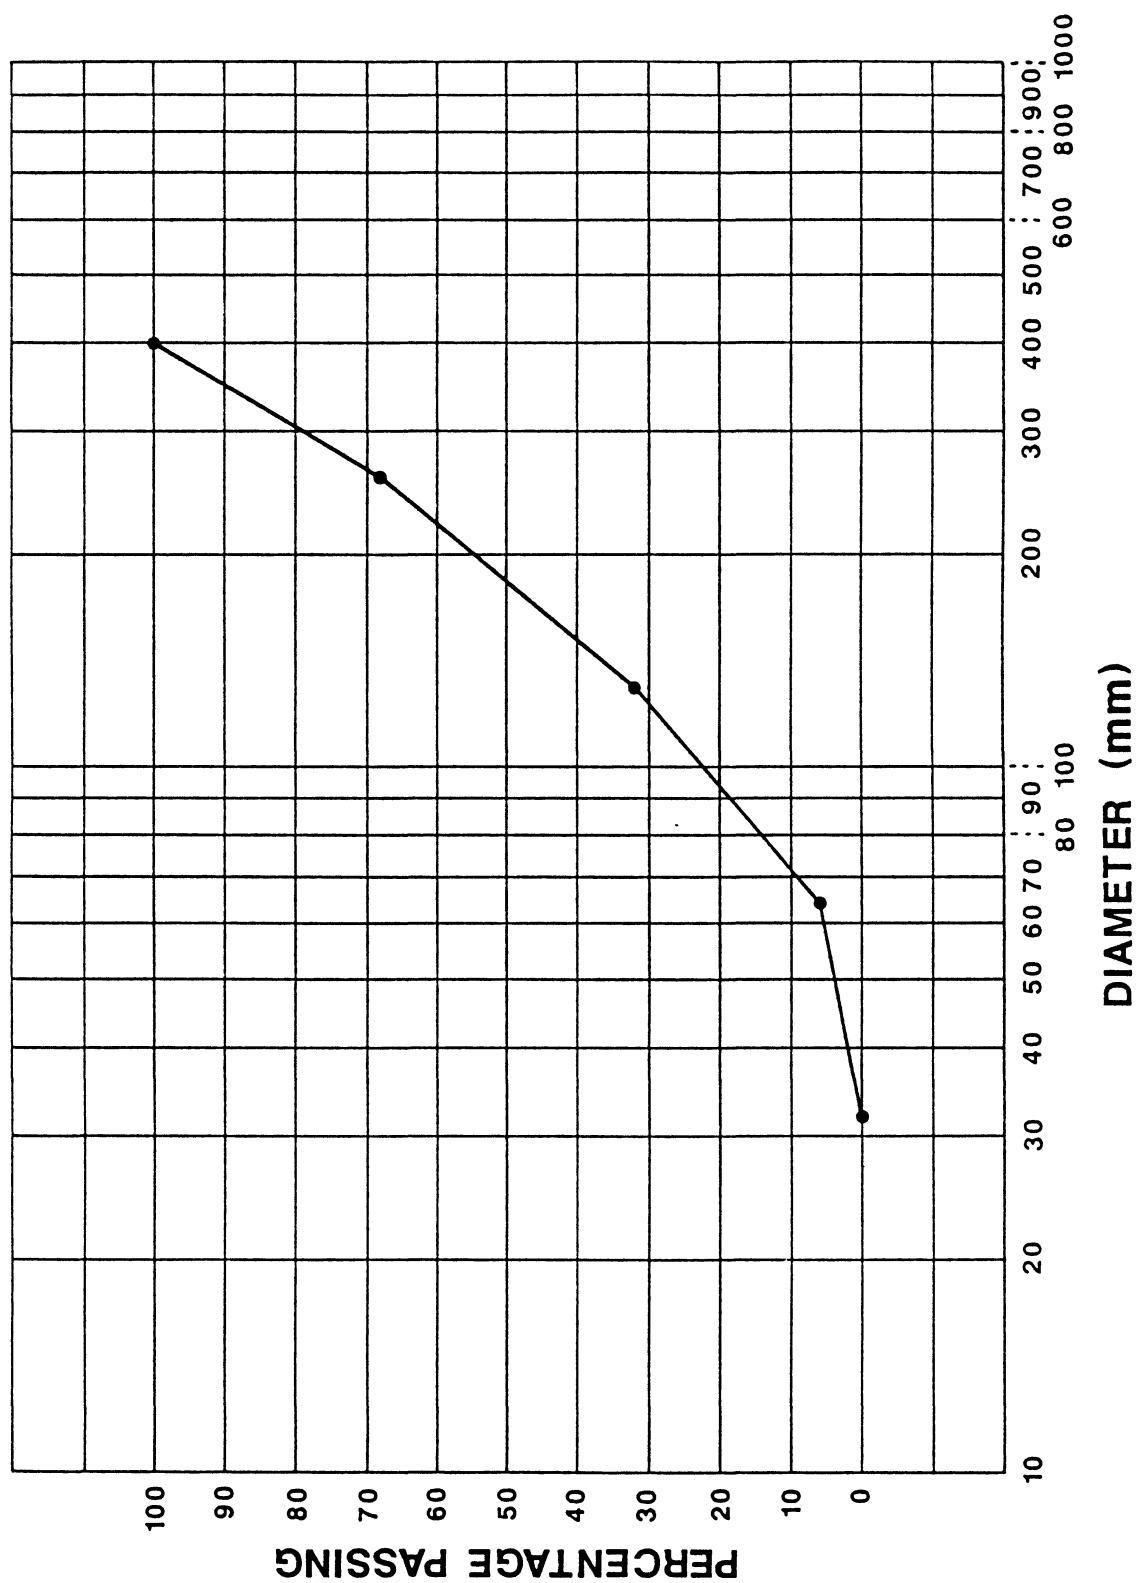
Figure 4. Grain size distribution for the southern downstream square yard, Dry River and Route 613.
