research report

Evaluation of the Cargill SafeLane™ Surface Overlay

February 2009
VTRC 09-R8

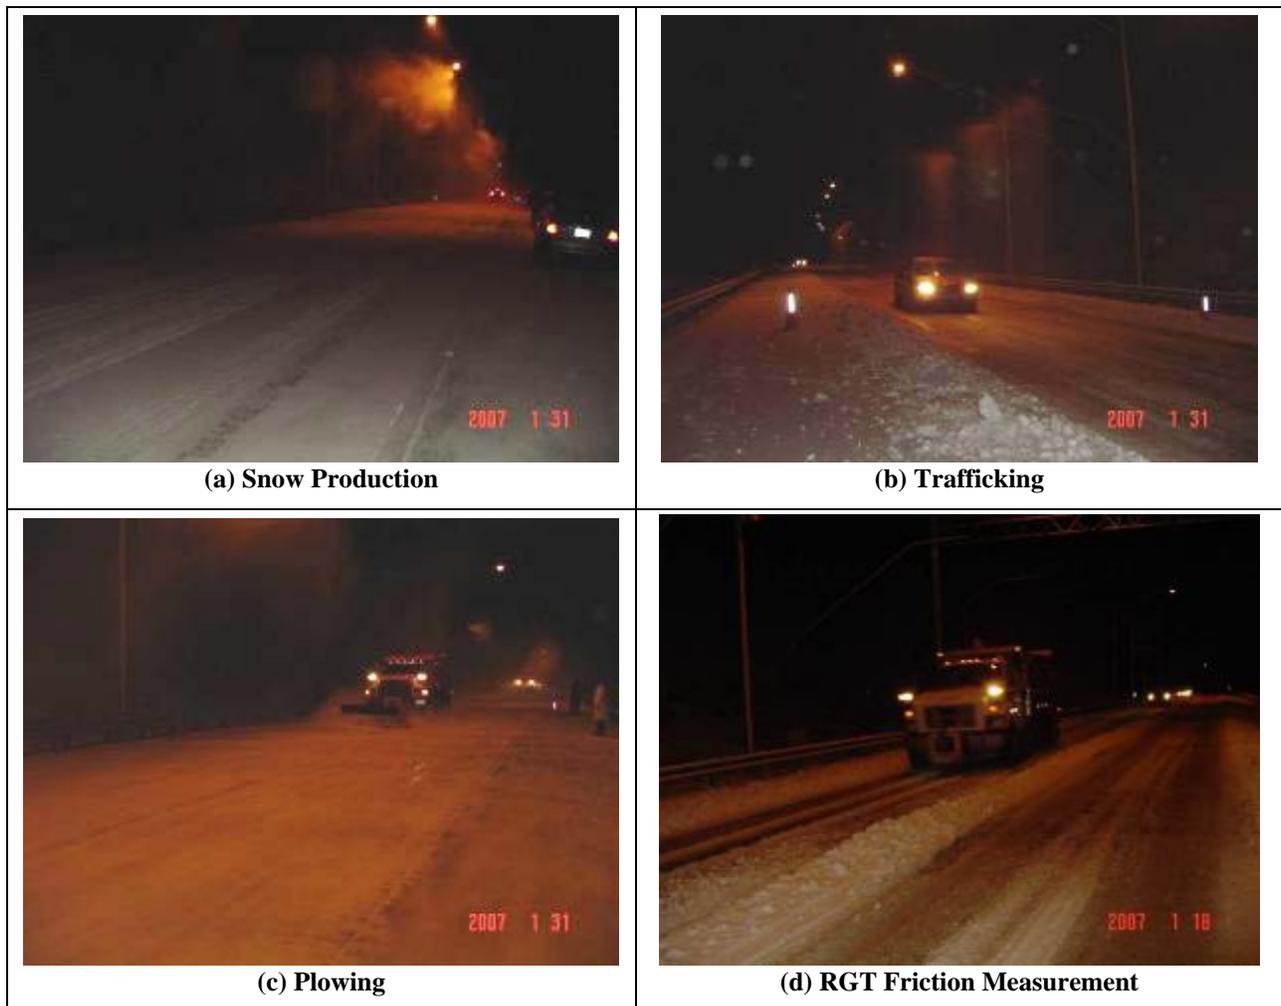
Figure 1. Selected Activities During Testing at Smart Road. RGT = Road Grip Tester.

Photographs of Steps 3 and 4 are provided in Figure 1.

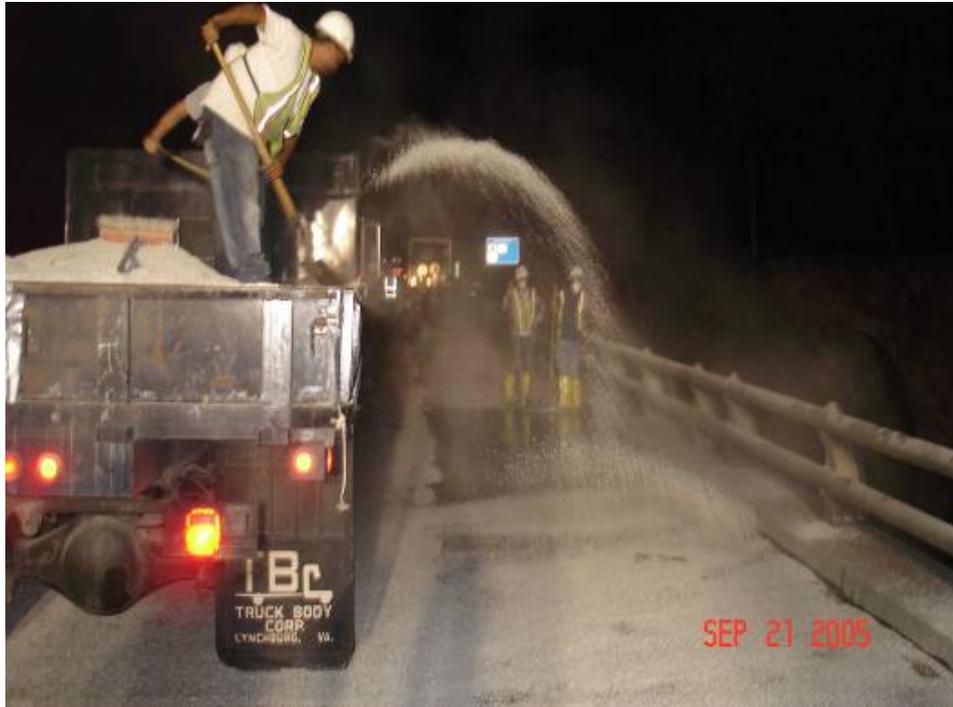
Figure 2. SafeLane Overlay Being Placed on Shoulder of I-81 Structure 2037

As discussed previously, the standard SafeLane overlay was placed on both lanes of Structure 2037 SB, as indicated in Tables 1 and 2. For Structure 2024 NB, placed in October 2005, all four spans of the passing lane were done with the standard SafeLane aggregate; Spans 1 and 2 of the travel lane were done with 25% of the SafeLane aggregate replaced with silica aggregate slightly larger than that used in VDOT overlays; and Spans 3 and 4 of the travel lane were done with 50% of the SafeLane aggregate replaced with the silica aggregate. The silica aggregate was substituted for a portion of the SafeLane aggregate to determine the impact on skid resistance and ice and snow melting performance. Figure 2 shows the SafeLane overlay being placed on Structure 2037.

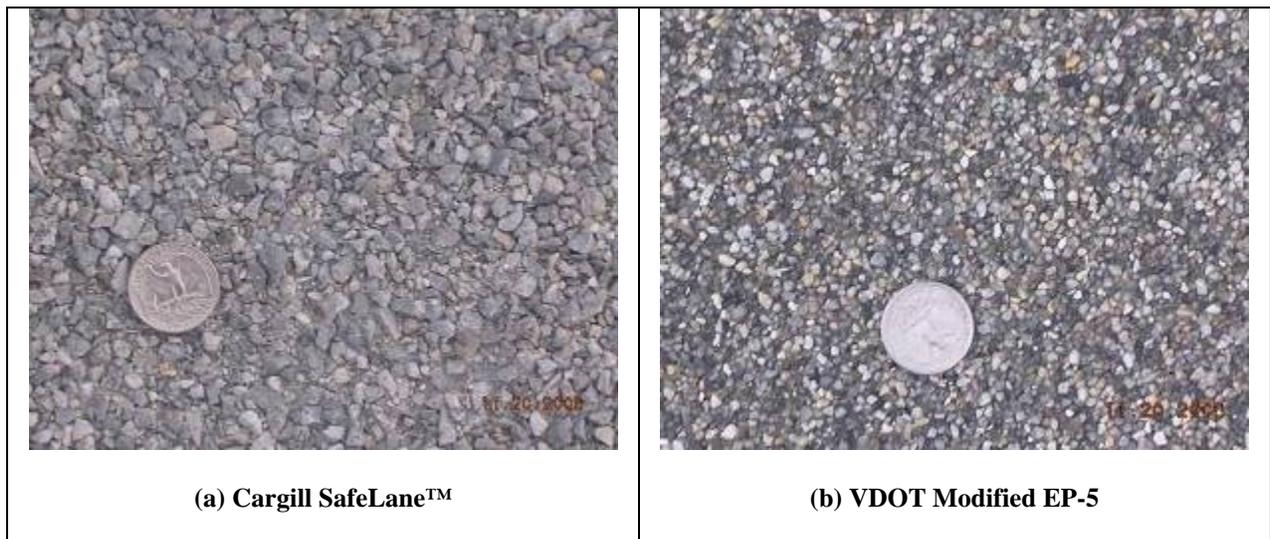
Figure 3. Comparison of Surface Texture of SafeLane and 2-Layer VDOT Modified EP-5 Overlays Constructed at Virginia Smart Road

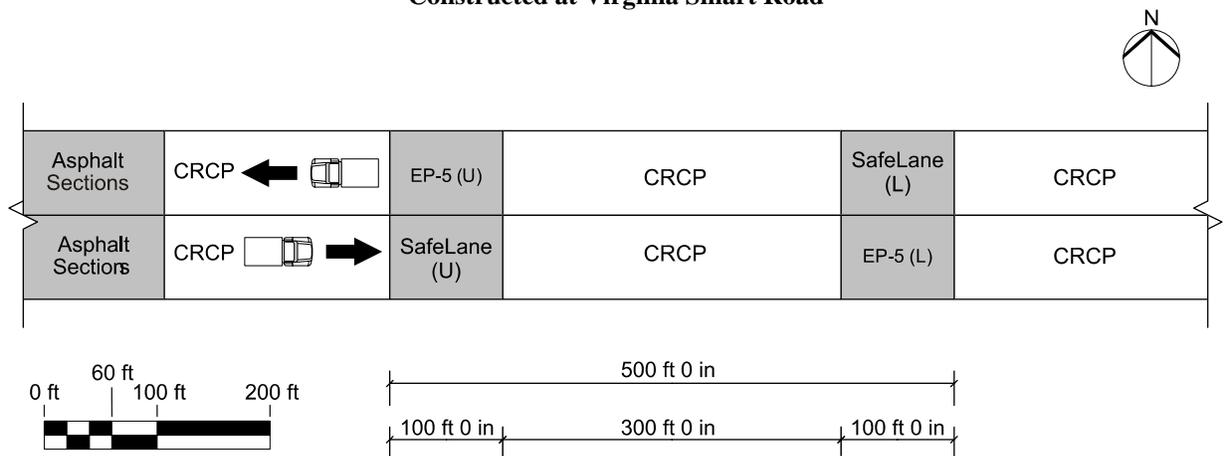
Figure 4. Layout of Experimental Sections at Virginia Smart Road. CRCP = continuously reinforced concrete pavement; EP-5 = 2-Layer VDOT modified EP-5 overlay; U = upper; L = lower.

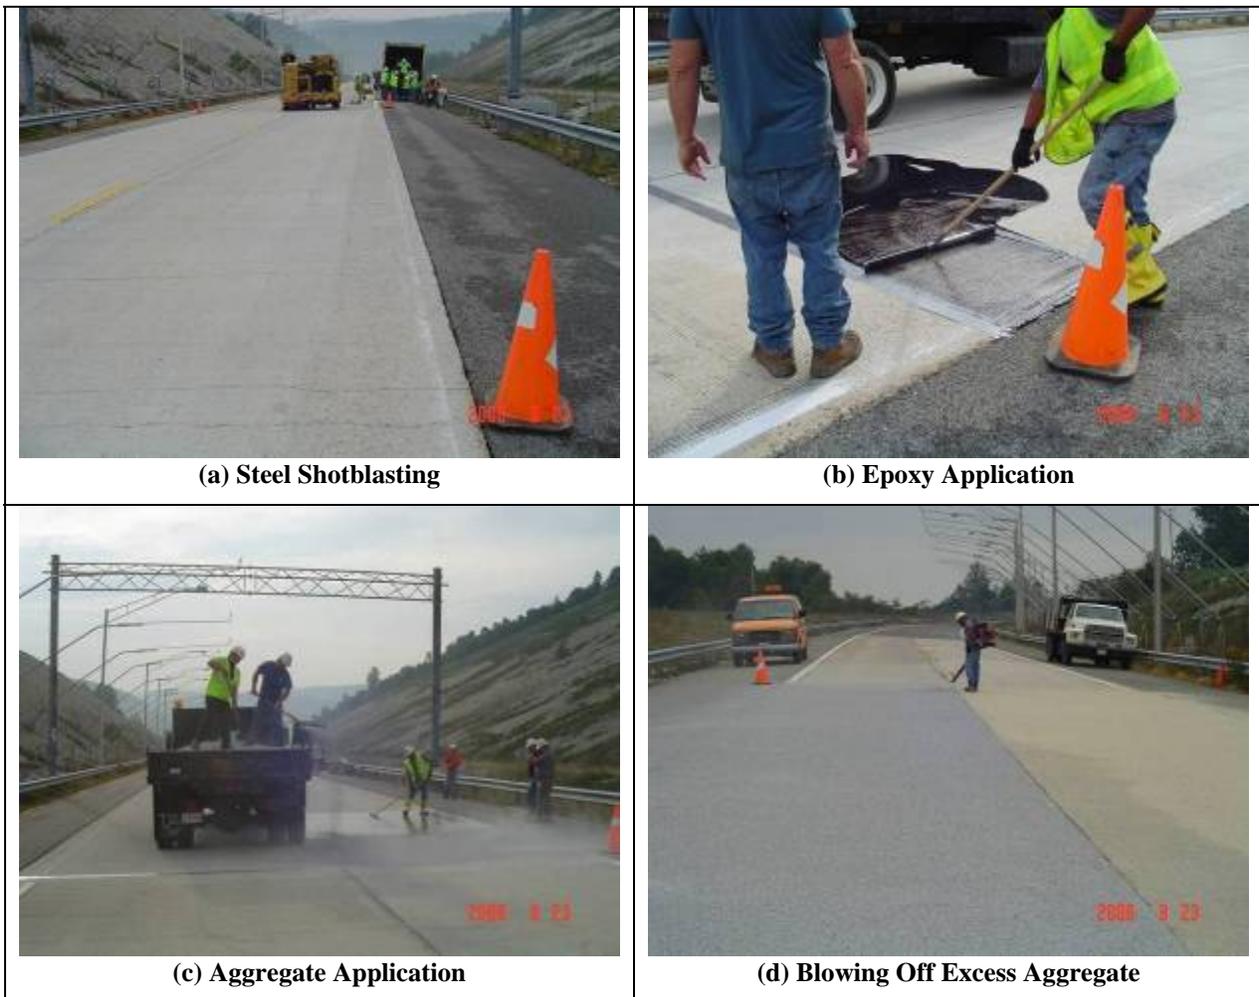
Figure 5. Summary of Construction Sequence at Smart Road

Prior to the installation of the overlays, the CRCP surfaces were thoroughly cleaned with a steel shot blasting process to remove pavement markings and/or oil spots and clean the concrete surface, as shown in Figure 5a.

After air blowing any leftover particles from the surface of the pavement, the epoxy was applied with a squeegee as shown in Figure 5b. Both types of overlays used the same type of epoxy. The aggregates were applied by manually shoveling them on the epoxy coat from dump trucks, as can be seen in Figure 5c. After the epoxy was cured, loose aggregate was removed

with a power broom and/or air blowers as shown in Figure 5d and the second application of epoxy and aggregates was done.

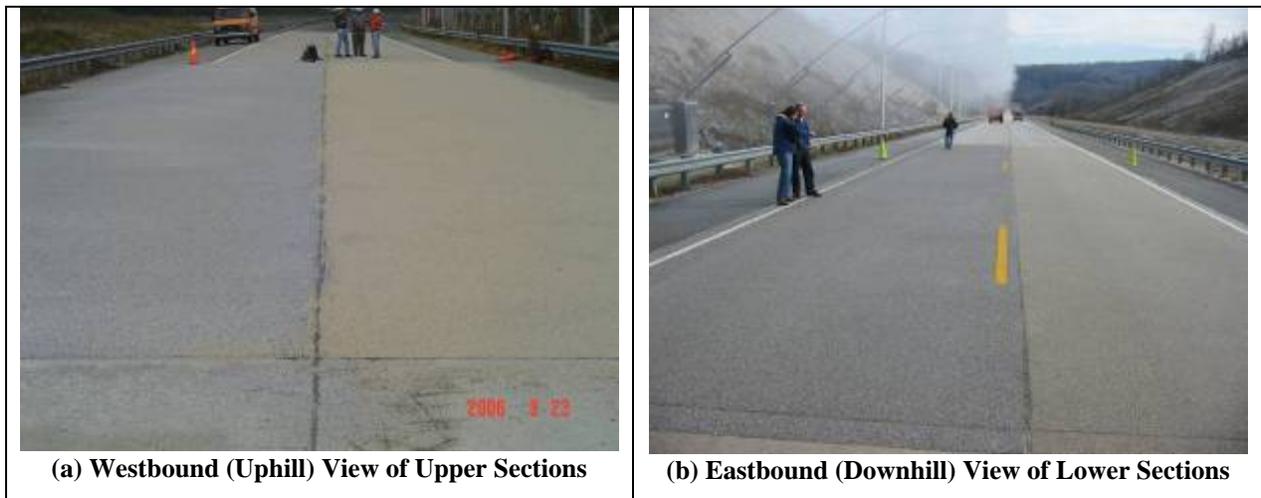
Figure 6. Side-by-Side Comparison of Overlay Systems at Smart Road. (a) VDOT Modified EP-5 overlay, (b) SafeLane overlay.

Photographs of the overlaid sections are provided in section in Figure 6. The application rates were as follows:

- *VDOT Modified EP-5*: 2.5 gal/100 ft² (Layer 1) and 5 gal/100 ft² of epoxy (Layer 2) with aggregate placed to excess.
- *SafeLane*: 4 gal/100 ft² (Layer 1) and 8 gal/100 ft² (Layer 2) of epoxy with aggregate placed to excess.

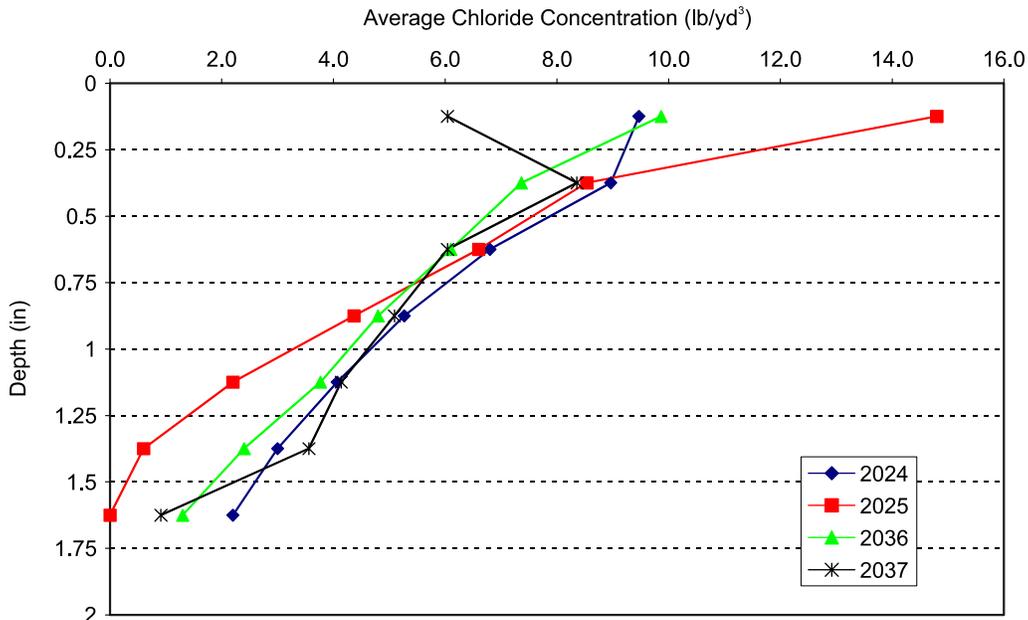
Figure 7. Chloride Content Profiles for I-81 Decks Based on Cores Taken February 15, 2006. Numbers in box = structure numbers; 2-layer SafeLane structure numbers = 2024, 2037; 1-layer VDOT modified EP-5 structure numbers = 2025, 2036.

Chloride content profiles based on the average of tests on the samples from the four bridges are shown in Figure 7. The chloride profiles were similar. The average chloride content

at the top level of reinforcement (approximately 1.75 in from the surface) ranged from 0 to 2 pcy. As a consequence, corrosion of the reinforcement and spalling of the deck under the overlays should not be a problem. Corrosion would likely initiate at locations with higher chloride contents with further ingress of chlorides. The epoxy overlays were applied at a good time to preserve the decks. Fortunately, a second layer was placed on the one-layer overlays before they failed so that protection was maintained. It is anticipated that the overlays will prevent further intrusion of chloride ion and the life of the decks will be extended by the life of the overlays.¹⁻³ Chloride profiles prepared in the future can be compared to the ones in Figure 7 and Appendix F to determine if chloride from the pretreatments of the overlays or from routine winter maintenance applications penetrated the overlays.

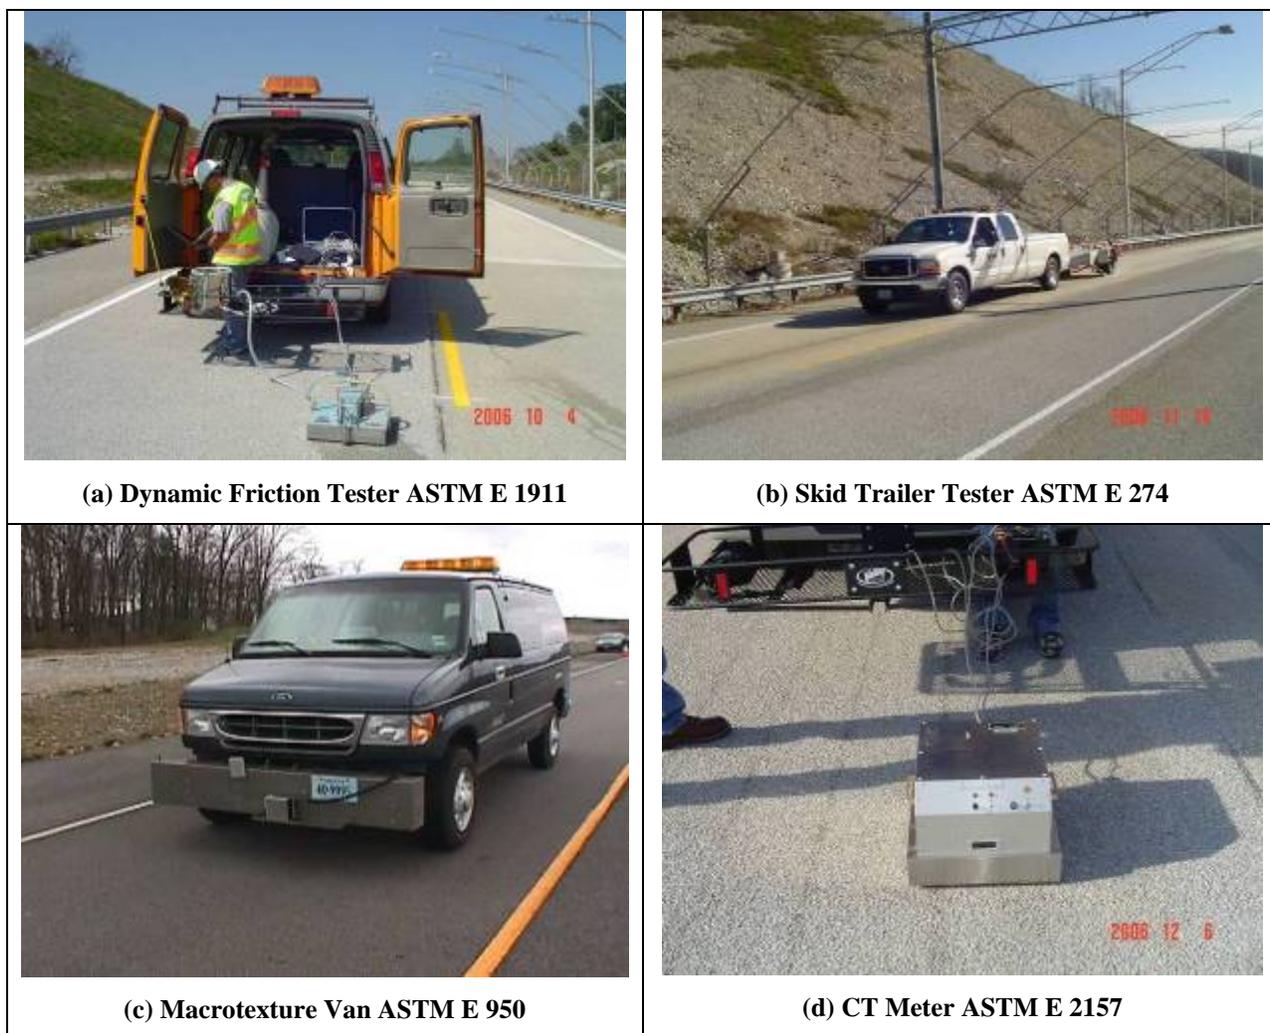
Figure 8. Friction and Macrotexture Measuring Devices Used

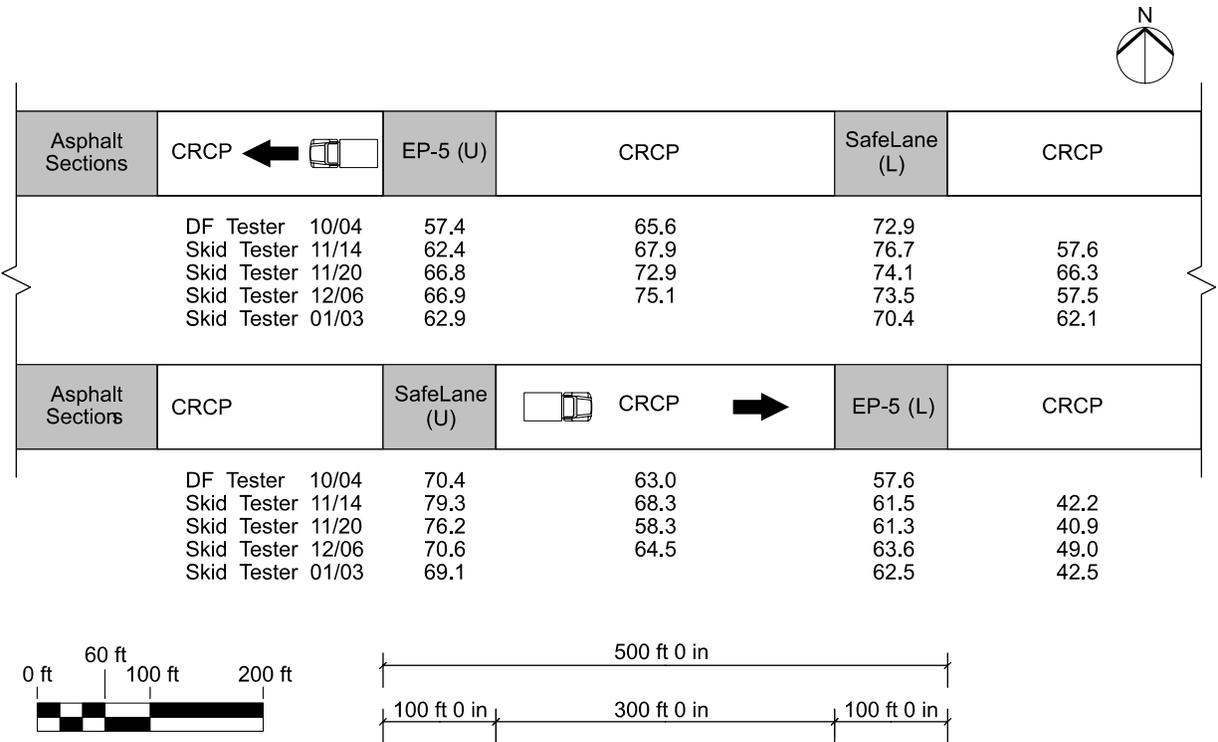
Figure 9. Initial Friction Test Results at Smart Road. CRCP = continuously reinforced concrete pavement, U = upper, L = lower.

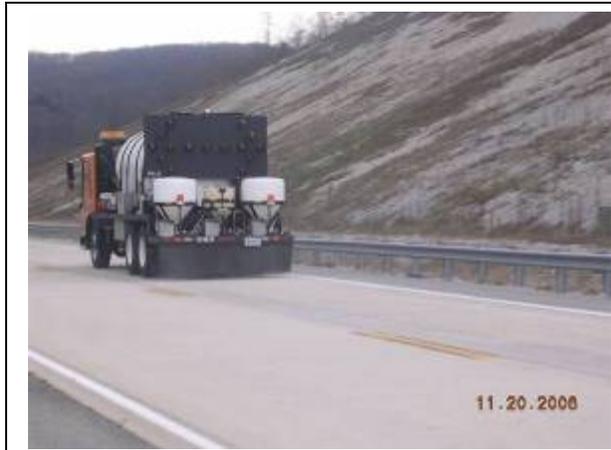
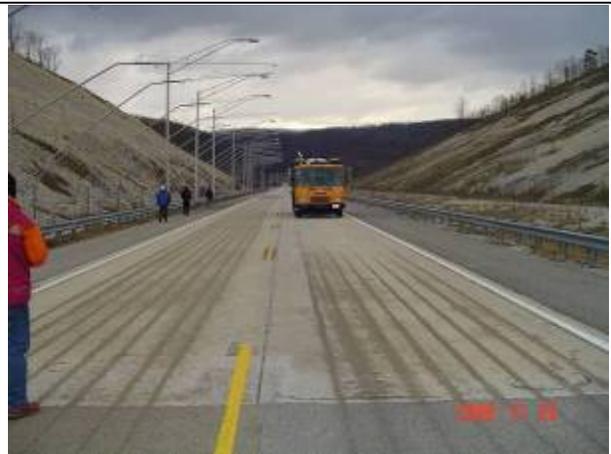
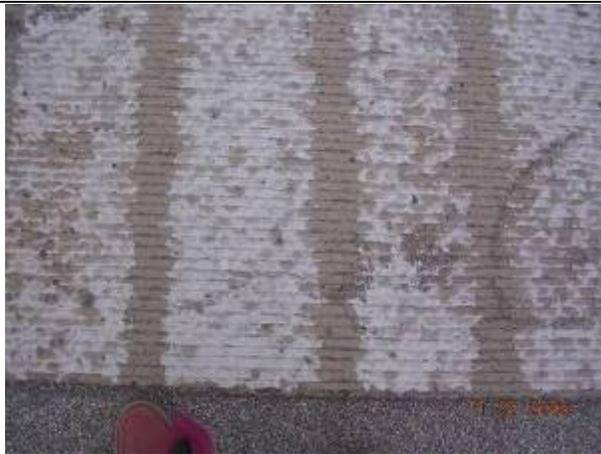
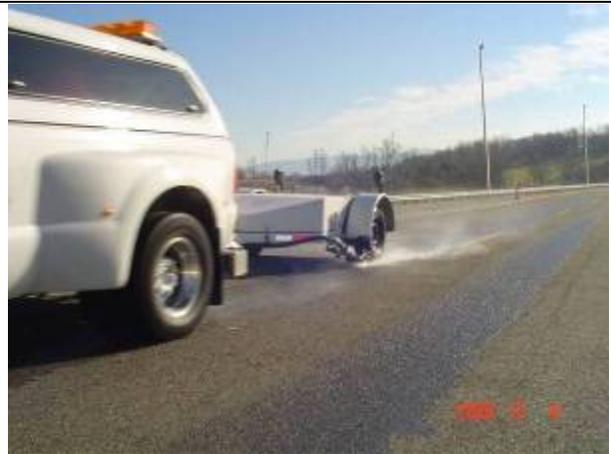
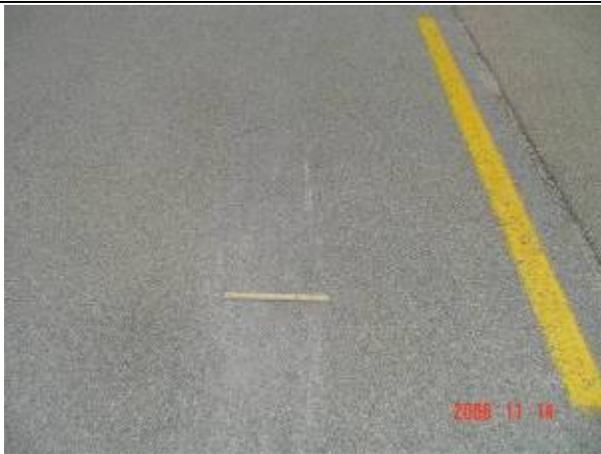
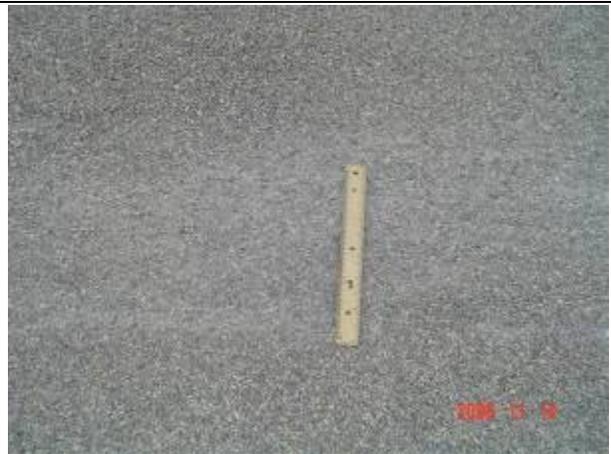
(a) Brine spreader

(b) Brine application marks

(c) Close-up of application marks

(d) Skid test

(d) Skid mark

(e) Close-up of skid mark

Figure 10. Brine Application, Initial Friction Testing, and Skid Marks at Virginia Smart Road

Better results were obtained with the revised procedure, which produced a more uniform coverage of the treated sections. After the surfaces were dry, the skid trailer tester measured friction on these sections again. Figure 10 shows photographs taken during the application of the brine and the skid marks left after the ASTM E204 friction tests. The schedule of subsequent applications and friction tests is presented in Table 10. No friction tests were conducted during the second set of treatments during the winter of 2007-08.

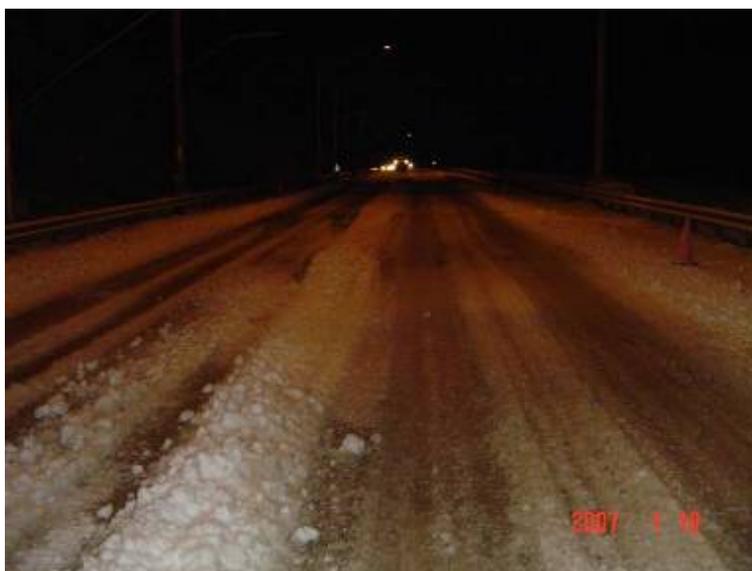
Figure 11. Snow Accumulation During First Snow Experiment (January 18, 2007) at Virginia Smart Road

The first experiment was used to refine the testing protocol. The snow accumulated faster than natural snow would accumulate (Figure 11) and, thus, did not represent typical conditions under natural snow. As a result of this preliminary test, the snow nozzles were replaced before the final two tests in February to slow down the rate of snow accumulation.

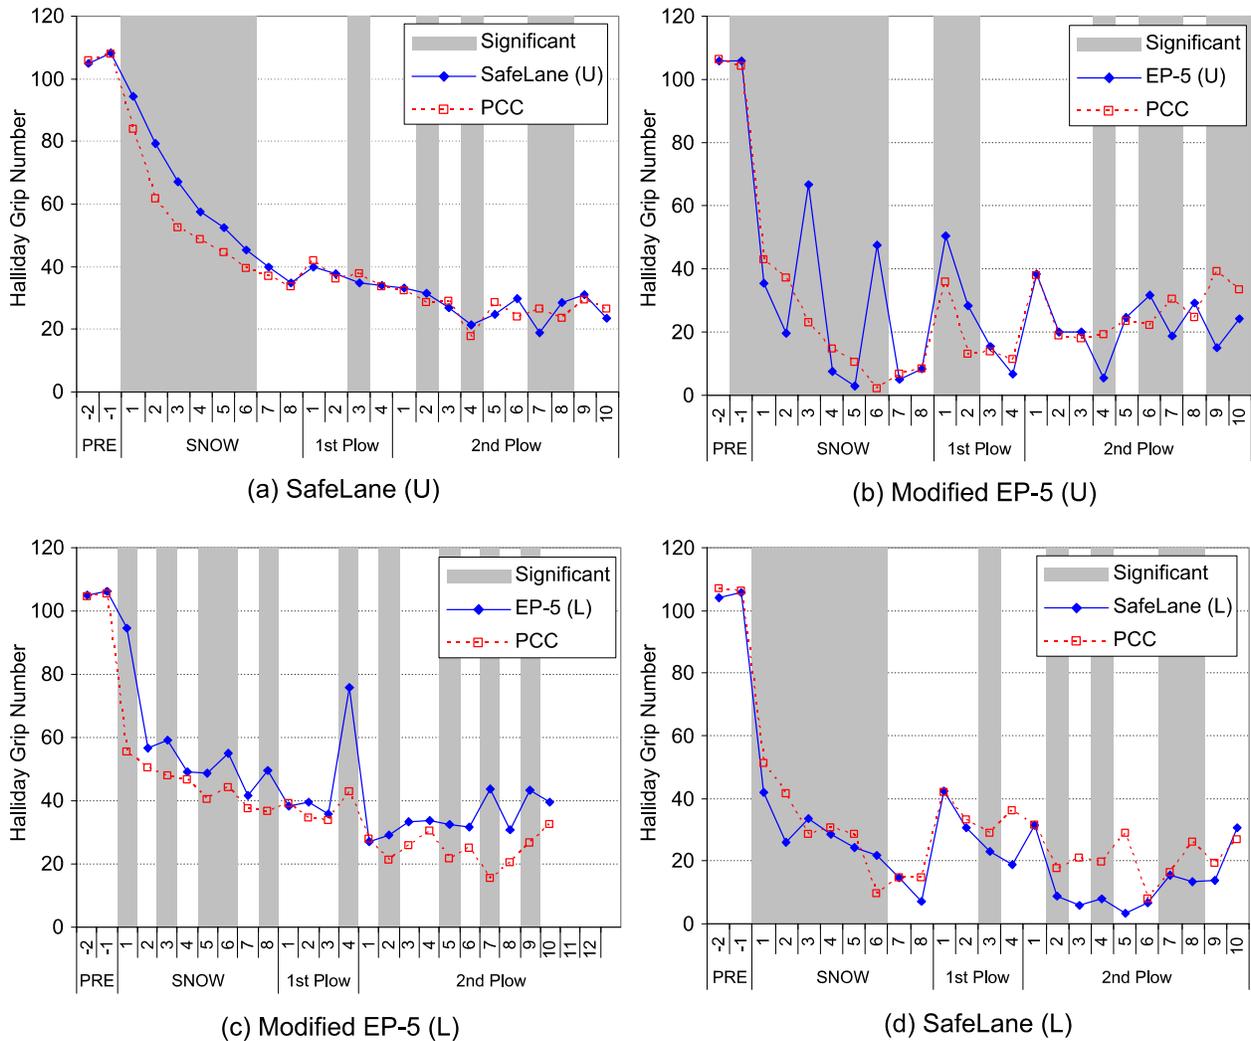
Figure 12. Friction Comparison for First Snow Experiment (January 18, 2007) at Smart Road. Significant = passes for which results were statistically significant using a *t*-test with a 5% level of significance; U = upper; PCC = portland cement concrete; L = lower.

The friction measurements are summarized and presented in Figure 12. The various plots compare the average friction results (measured every 0.1 sec) on the overlays with those of the closest bare-tined CRCP section. The shaded areas indicate the passes for which the results were found to be statistically significant using a *t*-test with a 5% level of significance. The results presented in Figure 12 show a statistically significant positive effect of both overlay treatments before the first plowing in the EB (downhill) direction. Both sections provided higher friction at the beginning of the experiment, which simulates the beginning of the precipitation storm before the snow-fighting crews begin treating the road. After the plowing, the friction values were similar. A consistent difference in friction was not found in the WB (uphill) direction. It is

hypothesized that this could be due to the very fast accumulation of snow on this WB lane, which was closer to the snow-making towers. This was one of the factors prompting the decision to replace the nozzles to reduce the rate of snow generation as discussed previously.

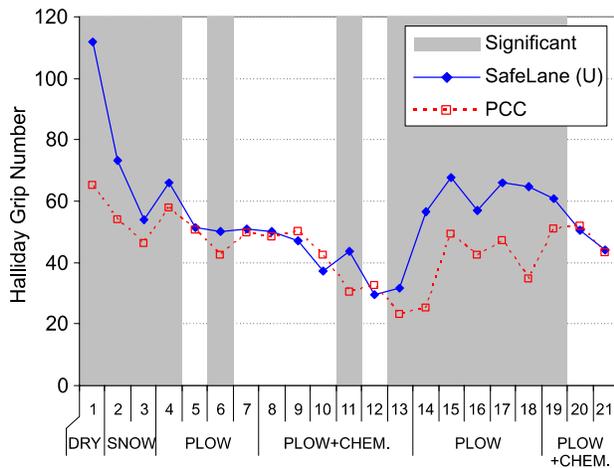
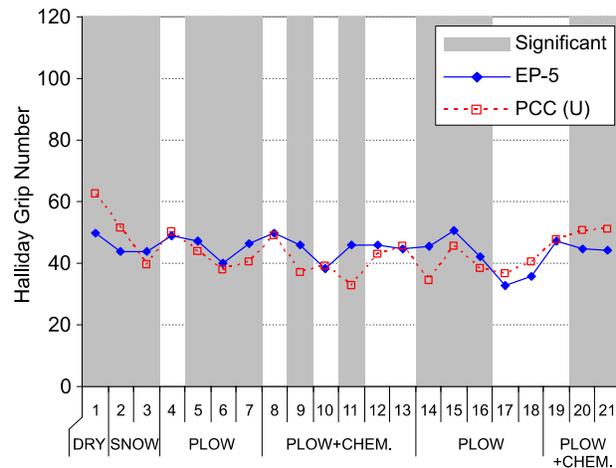
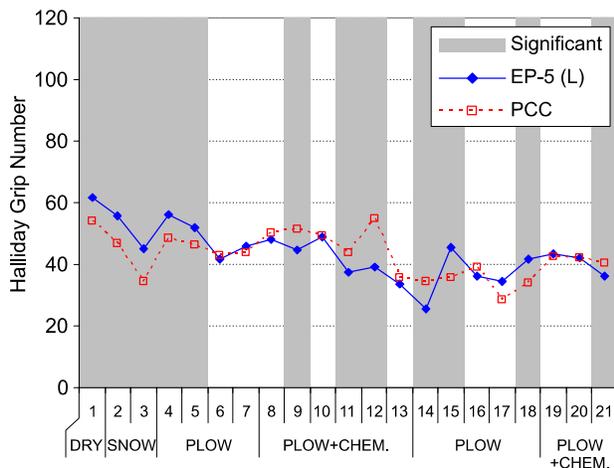
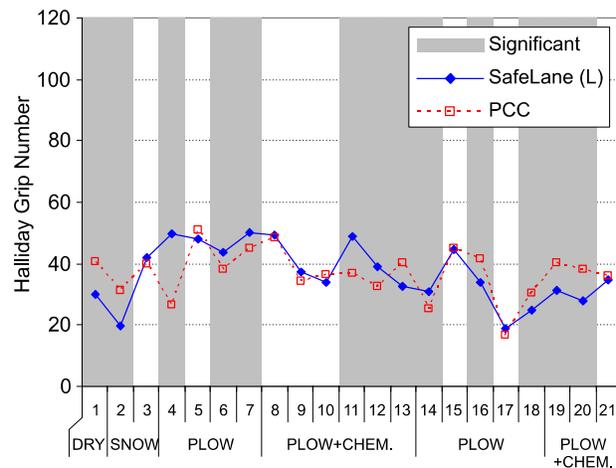
Figure 13. Friction Comparison for Third Snow Experiment: January 31, 2007 (P.M.). Significant = passes for which results were statistically significant using a *t*-test with a 5% level of significance; U = upper; PCC = portland cement concrete; L = lower.

The friction measurements collected are summarized in Figure 13. The results are similar to those obtained in the first experiment; the SafeLane and VDOT modified EP-5 sections in the EB (downhill) direction maintained higher friction than their respective adjacent bare-tined

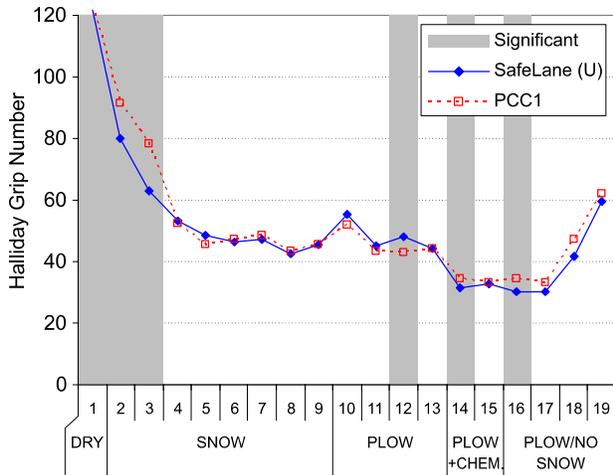
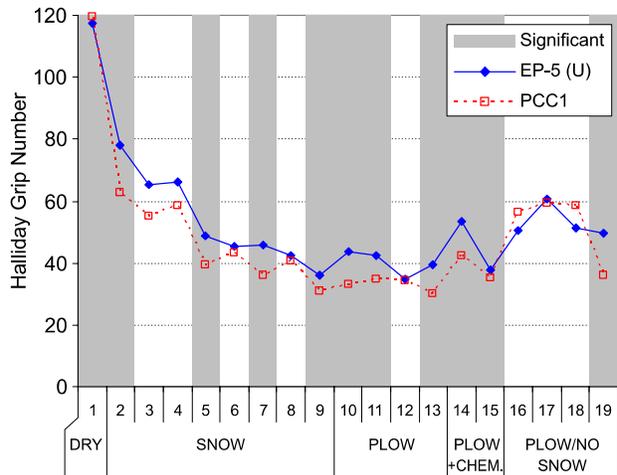
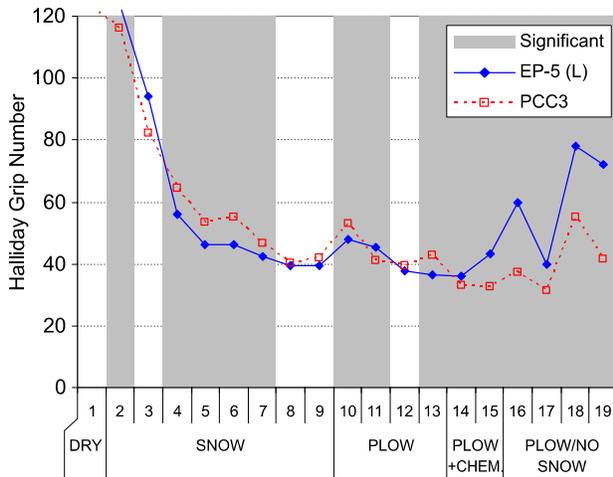
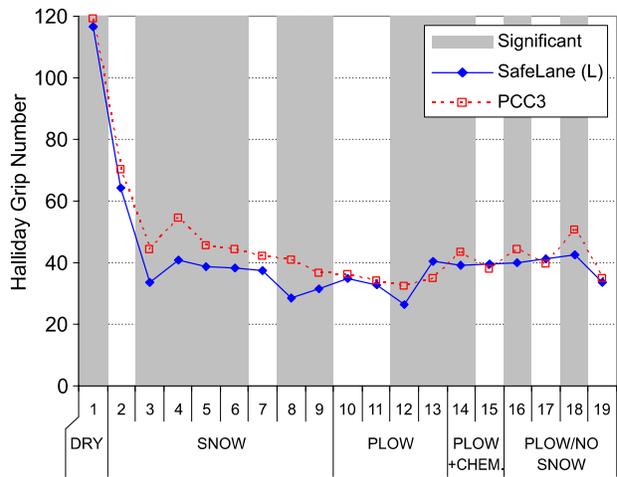
Figure 14. Friction Comparison for Fourth Snow Experiment on Smart Road: February 17, 2007 (P.M.). Significant = passes for which results were statistically significant using a *t*-test with a 5% level of significance; U = upper; PCC1 = PCC adjacent to upper SafeLane section; PCC3 = PCC adjacent to lower SafeLane section, L = lower.

These tests were conducted using the smaller nozzles (No. 5005) and the final experimental protocol that called for the plowing to be triggered by the friction number (see Appendix D). Table 13 summarizes the experiment, and Figure 14 presents the friction measurements. No consistent significant skid resistance benefit in snow from the two-layer SafeLane or two-layer VDOT modified EP-5 overlay was found in this experiment.

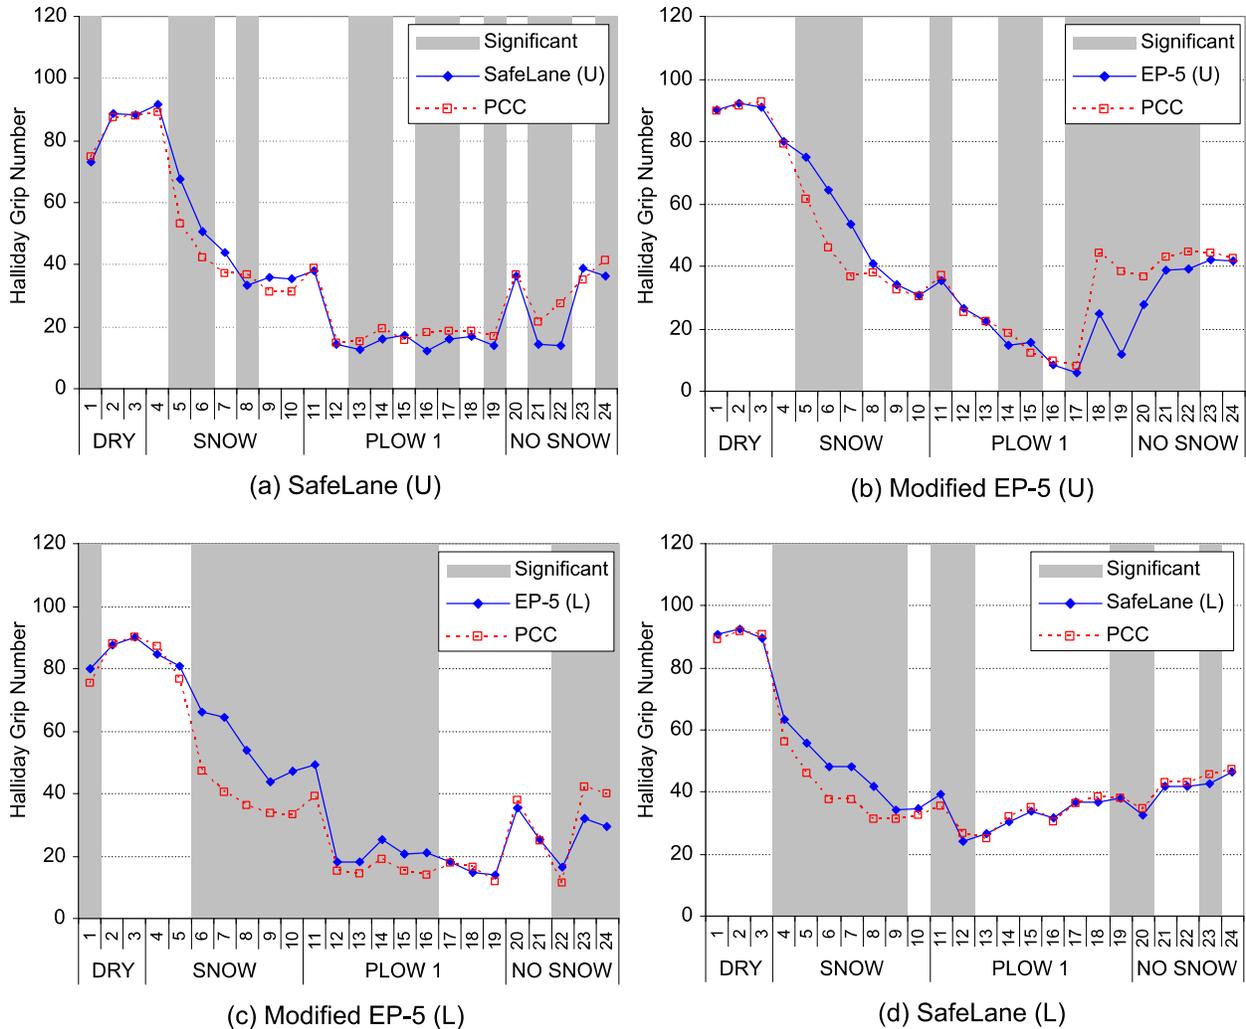
Figure 15. Friction Comparison for Fifth Snow Experiment on Smart Road: February 19, 2007. Significant = passes for which results were statistically significant using t -test with 5% level of significance; U = upper; PCC = portland cement concrete; L = lower.

In the final test, the snow was of good quality, but, unfortunately, once more, not all towers were working and the snow coverage was not uniform. In this case, the downhill (WB) sections were getting more snow cover because of the wind. The measured friction values are presented in Figure 15, and the log with the main events of the test is summarized in Table 14. The friction measurements showed either no difference or a statistically significant improvement in the friction values before the first plowing in the four overlay sections investigated with respect to the corresponding adjacent bare-tined concrete sections. On the other hand, it is interesting to note that the first plowing was not effective on any of the surfaces as the friction values measured were lower after the plowing. Friction started to improve after the snow was stopped.

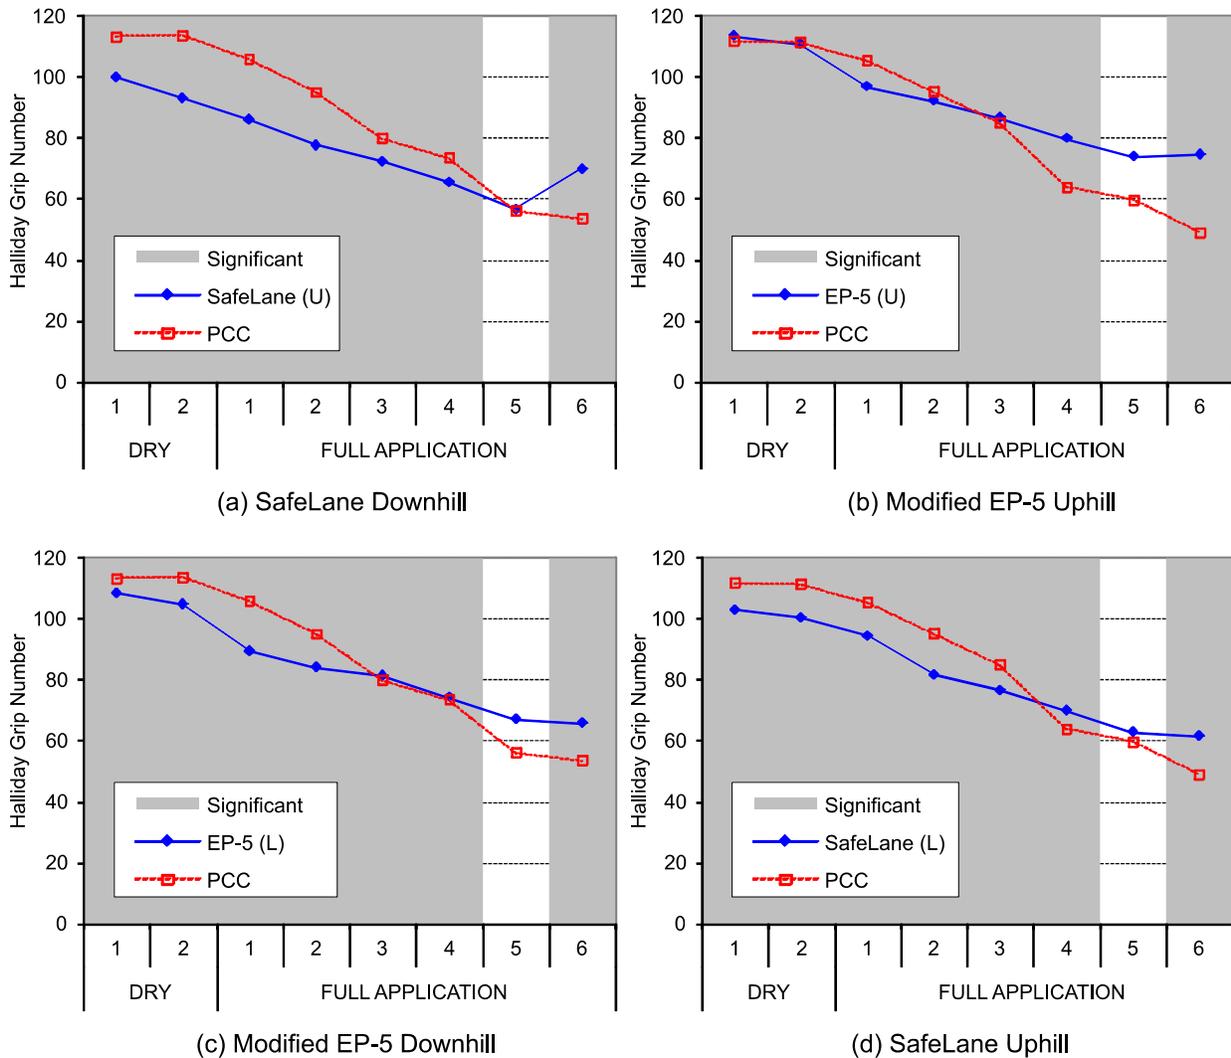
Figure 16. Friction Comparison for Ice Experiment, First Phase, 2/27/08. Significant = statistically significant; PCC = portland cement concrete; U = upper; L = lower.

A final testing event was performed to simulate the formation of ice on a road . For this purpose, a tractor with a liquid sprayer was retrofitted with small nozzles to spray a very fine mist of water that upon contact with the surface at freezing temperatures formed a very thin layer of ice on the road. Testing started when the pavement temperature reached 28° F. Two measurements were conducted on dry pavement before water was turned on to form the ice. Six passes with the water sprayer were made on the entire length of the testing sections (referred to as Full Application), which covered the four overlaid sections and the concrete pavement in between them. The continuous friction measurements (RGT) obtained during this first phase are presented in Figure 16. These measures show that at the beginning of the experiment the overlaid sections had lower friction than the adjacent bare concrete pavement. After the fourth or fifth pass water sprays, the friction of both overlaid sections started to improve.

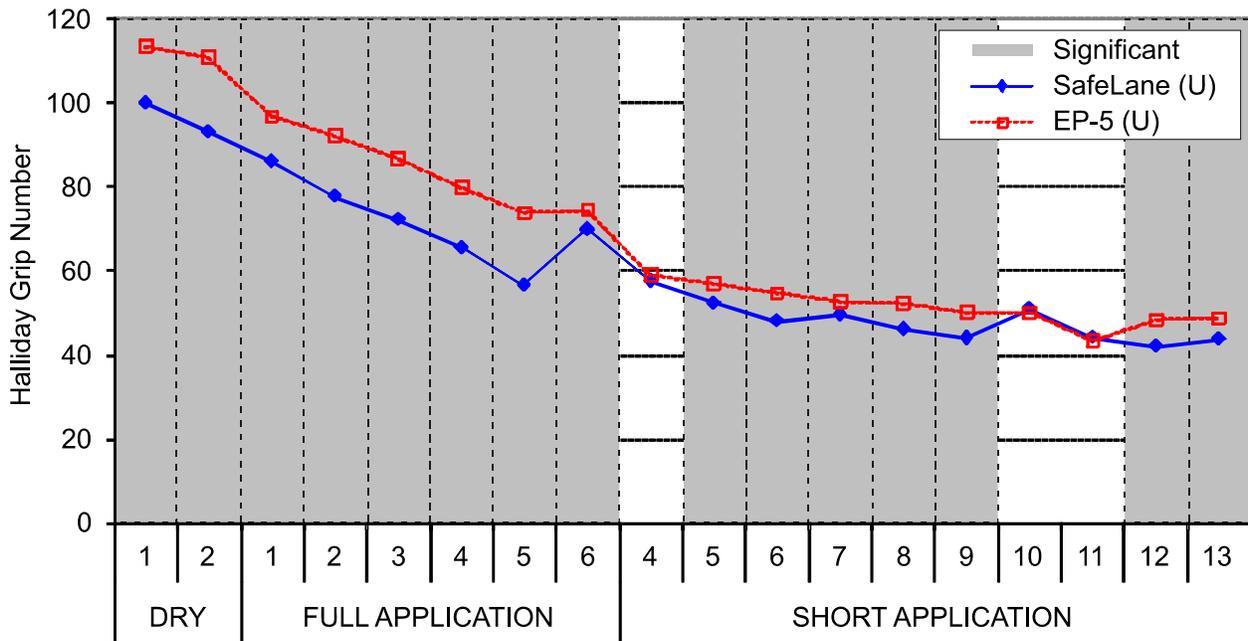
Figure 17. Friction Comparison for Ice Experiment, Second Phase, 2/27/08. Significant = Statistically significant, U = upper.

Unfortunately, all the water deposit on the tractor was used before a significant ice layer was formed on all the sections, thus forcing the experiment to be halted and continued after the tank was refilled. Because spraying all the sections was consuming too much time, a decision was made to spray only the adjacent top overlay sections in a shorter loop maneuver. This was done to form a thicker layer of ice on the road at a quicker rate. Figure 17 compares the continuous friction measurements on the two top overlay sections for both phases (Full/Short Applications). No comparison was made with the adjacent concrete sections since they were not sprayed with water in the second phase of the experiment. The first three passes of the Short Application were not measured. The shaded areas indicate a significant difference among the average measurements. All statistical tests were performed using a two-tailed *t*-test with different standard deviations of the samples with a significance level of $\alpha=0.05\%$.

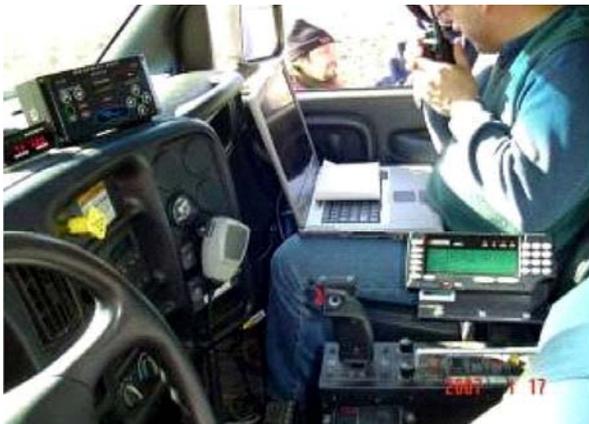
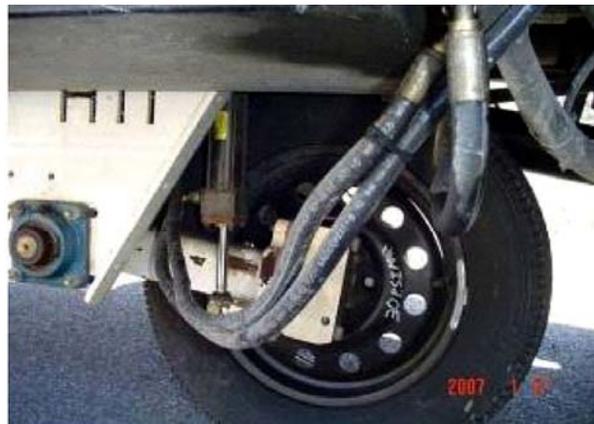
(a) Inside display units

(b) Fifth wheel

Figure B1. Road Grip Tester Installed in Plow Truck

Both methods produced abundant data. On a typical test day, about 3,000 records of 2-sec data and about 40,000 of the 0.1-sec data were recorded per hour. The RGT inside displays units are shown in Figure B1(a), and the friction wheel located under the truck in Figure B1(b).

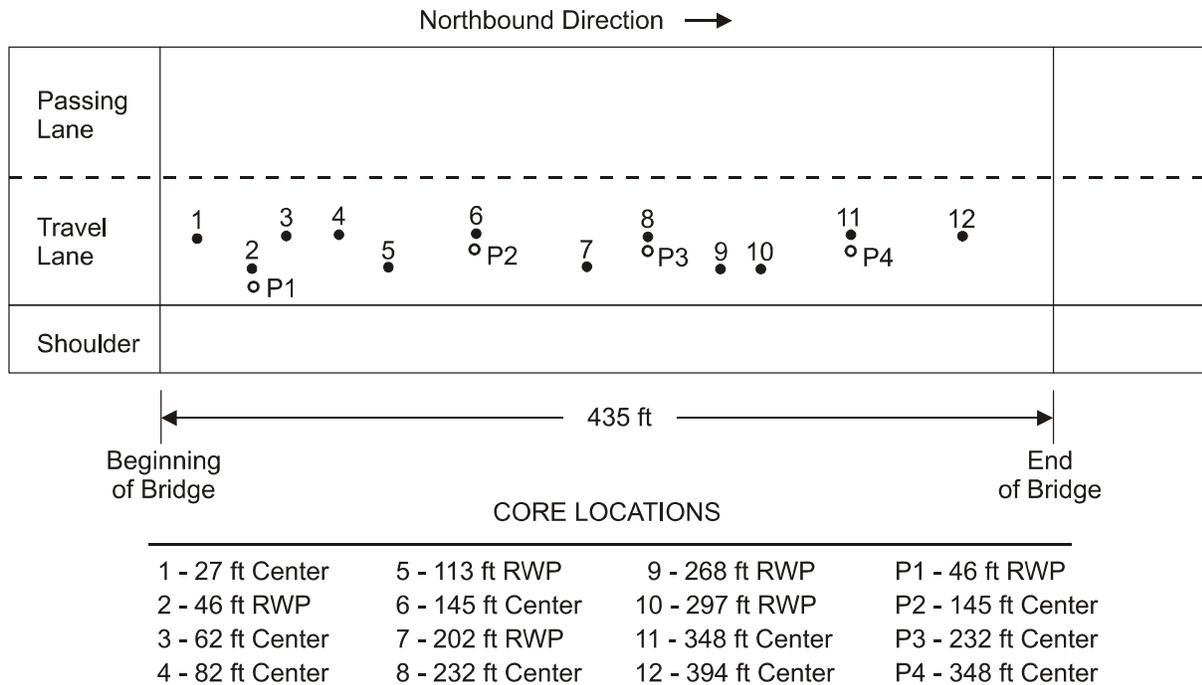
Structure Number: 2024

Cores 1 - 12 => 2 1/4 in diameter cores for tensile strength testing

Cores P1 - P4 => 4 in diameter cores for permeability to chloride ion testing

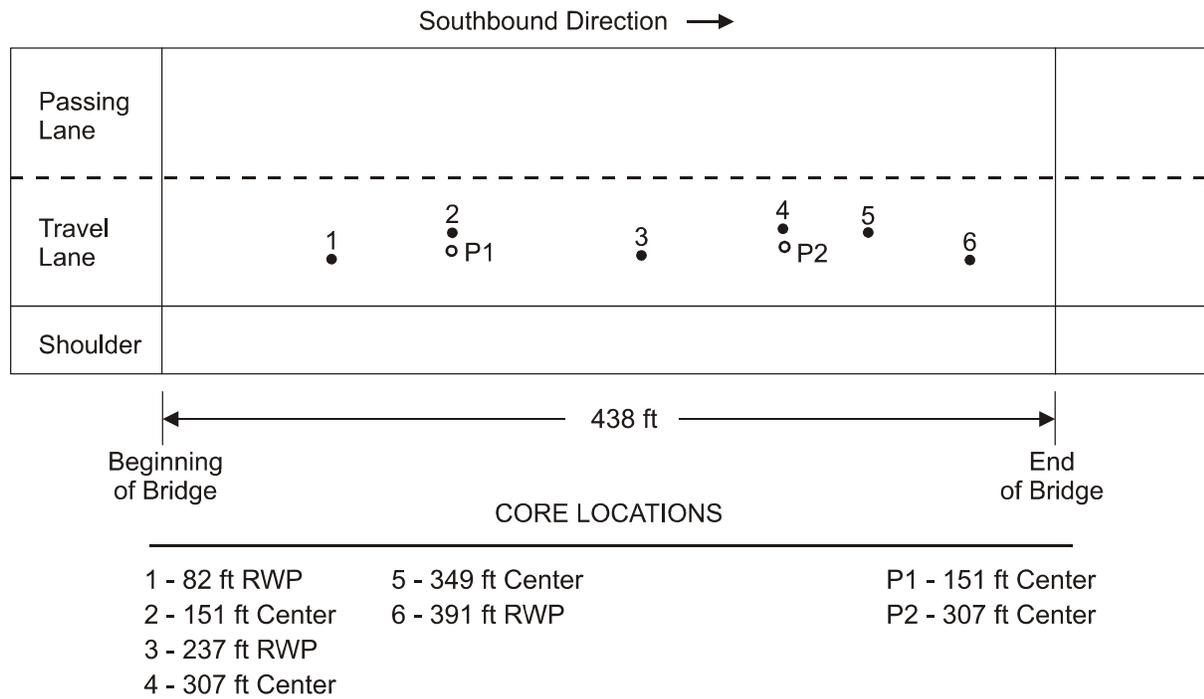
Structure Number: 2025

Cores 1 - 6 => 2 1/4 in diameter cores for tensile strength testing

Cores P1 - P2 => 4 in diameter cores for permeability to chloride ion testing
