research report

Evaluation of the Cargill SafeLane™ Surface Overlay

February 2009
VTRC 09-R8

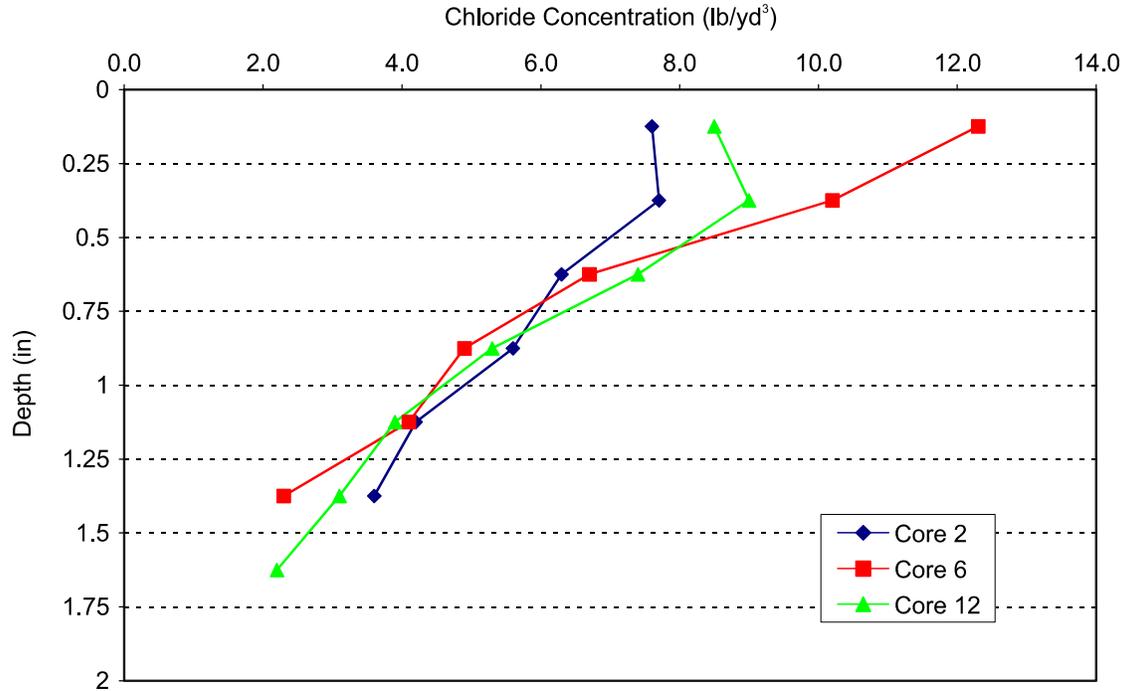
Figure F1. Chloride Profiles: I-81 NBL, Structure 2024, SafeLane with Blended Aggregate

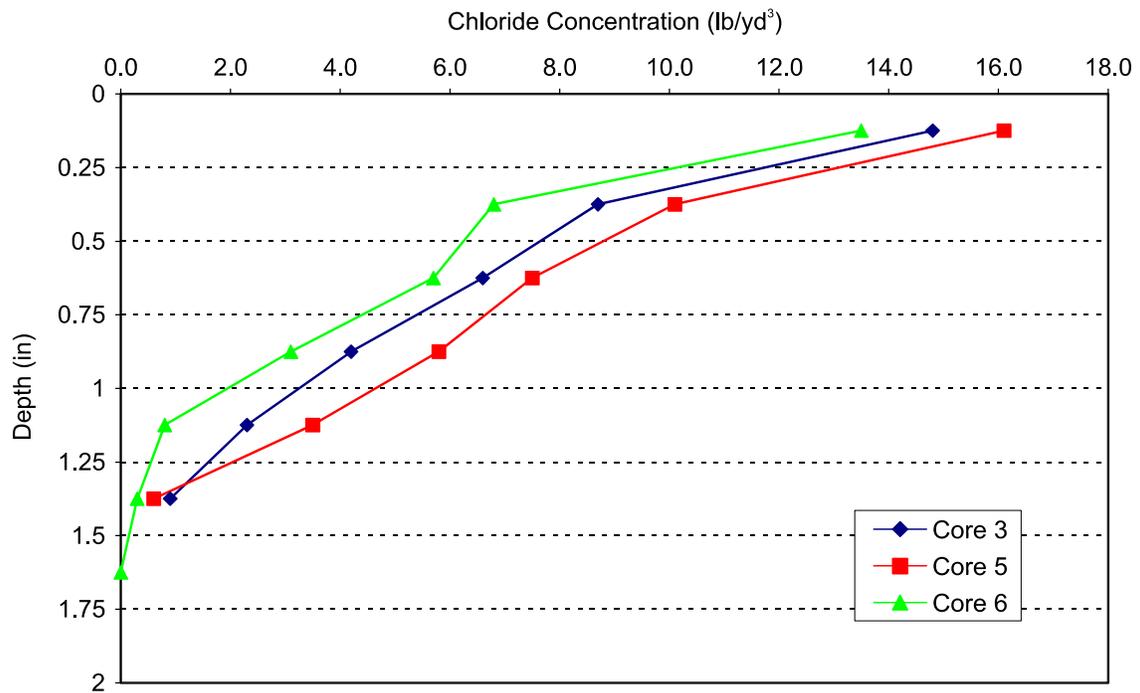
Figure F2. Chloride Profiles: I81 SBL, Structure 2025, One-Layer VDOT Modified EP-5

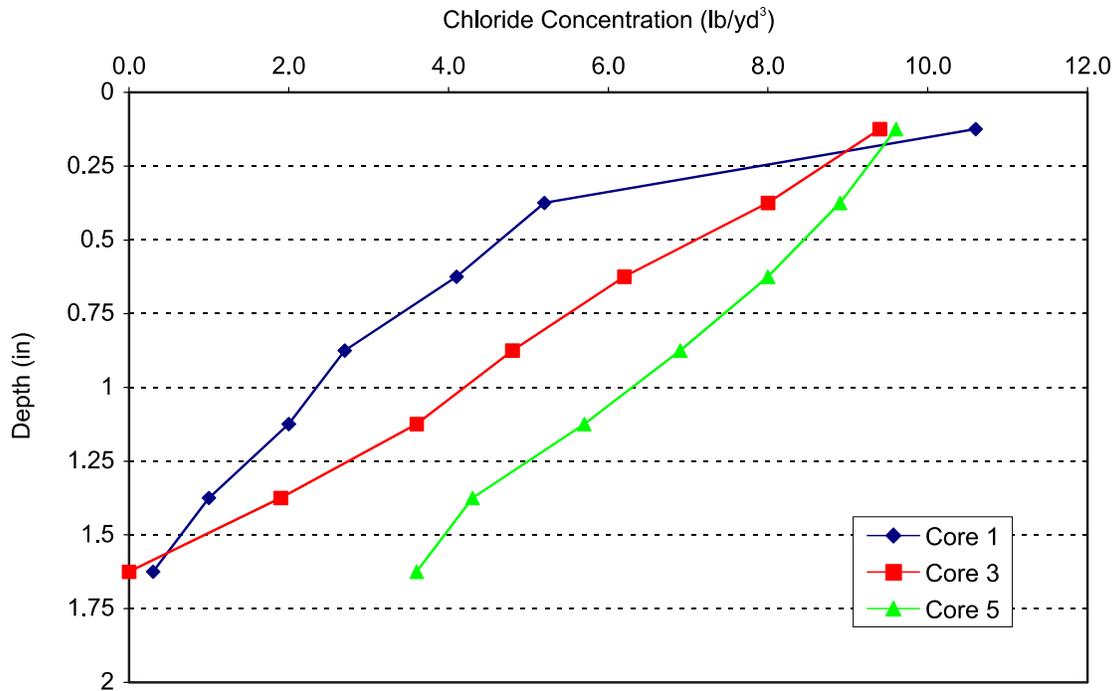
Figure F3. Chloride Profiles: I81 NBL, Structure 2036, One-Layer VDOT Modified EP-5

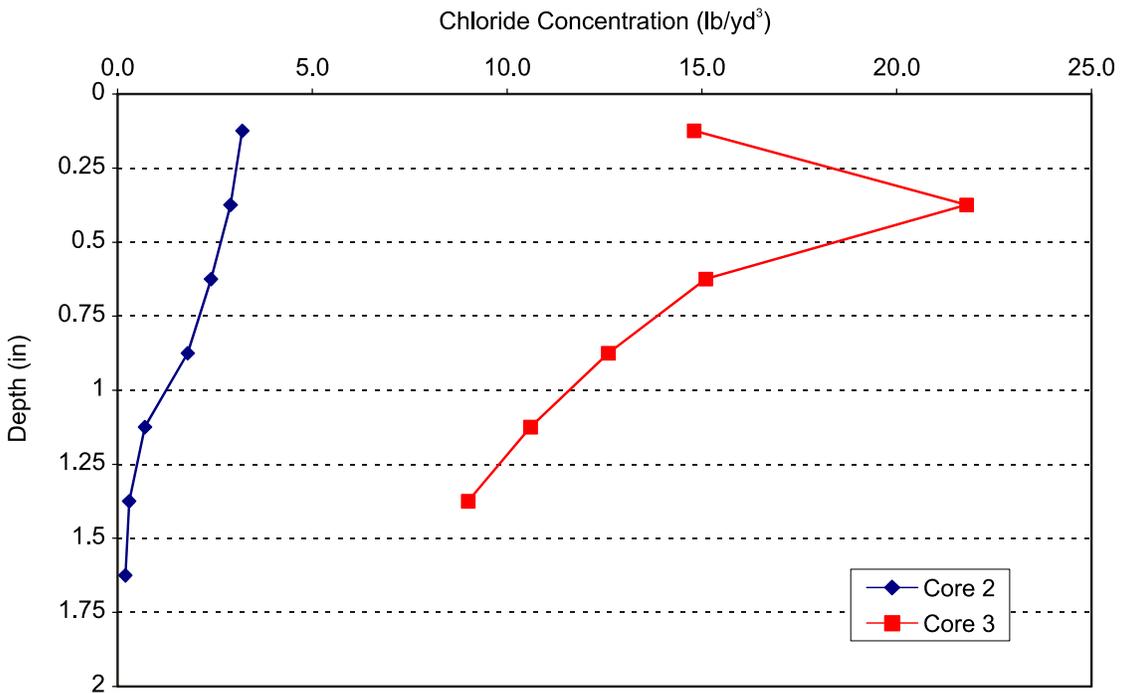
Figure F4. Chloride Profiles: I-81 SBL, Structure 2037, SafeLane
