Evaluation of Polypropylene Drainage Pipe

Final Report VCTIR 11-R14

FINAL REPORT
EVALUATION OF POLYPROPYLENE DRAINAGE PIPE

March 2011
VCTIR 11-R14

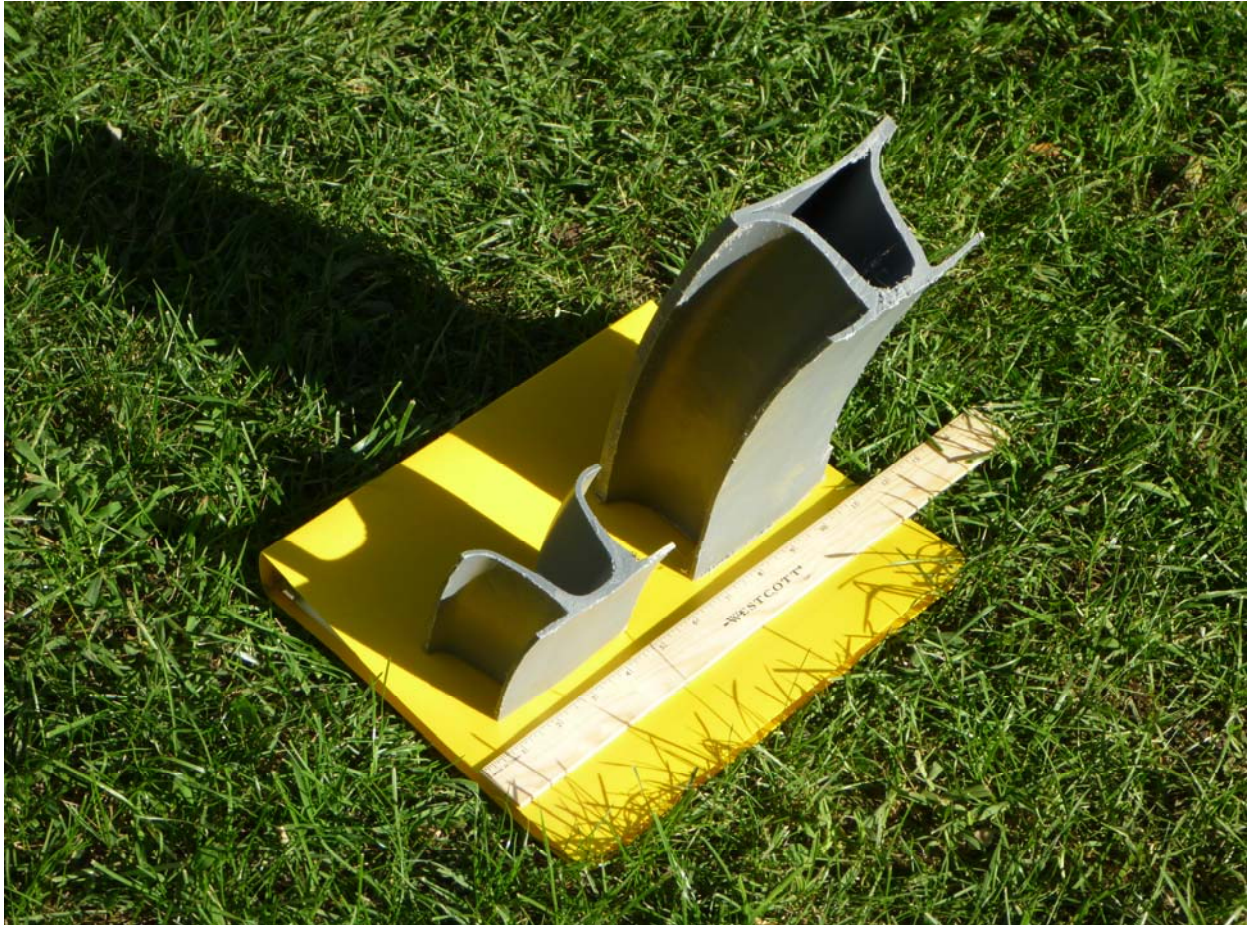
Two pipe runs were of 30 in nominal internal diameter, and three runs were of 48 in internal diameter. The corresponding outside diameters were 35.4 and 53.8 in, respectively. Pipes were delivered in standard 20-ft sections; 30-in pipes had a dual-wall profile, and 48-in pipes had a triple-wall profile design. Figure 1 shows sections of the ADS dual- and triple-wall pipe profiles.

Figure 1. Dual-Wall and Triple-Wall Profiles of ADS Polypropylene Pipes

The stiffness of the pipe, was 46 psi at 5 percent deflection. Manning's n value was 0.012. Pipe joints were rated at 15 psi internal pressure. Extensive product data and design guidelines are available from ADS.²⁻⁸

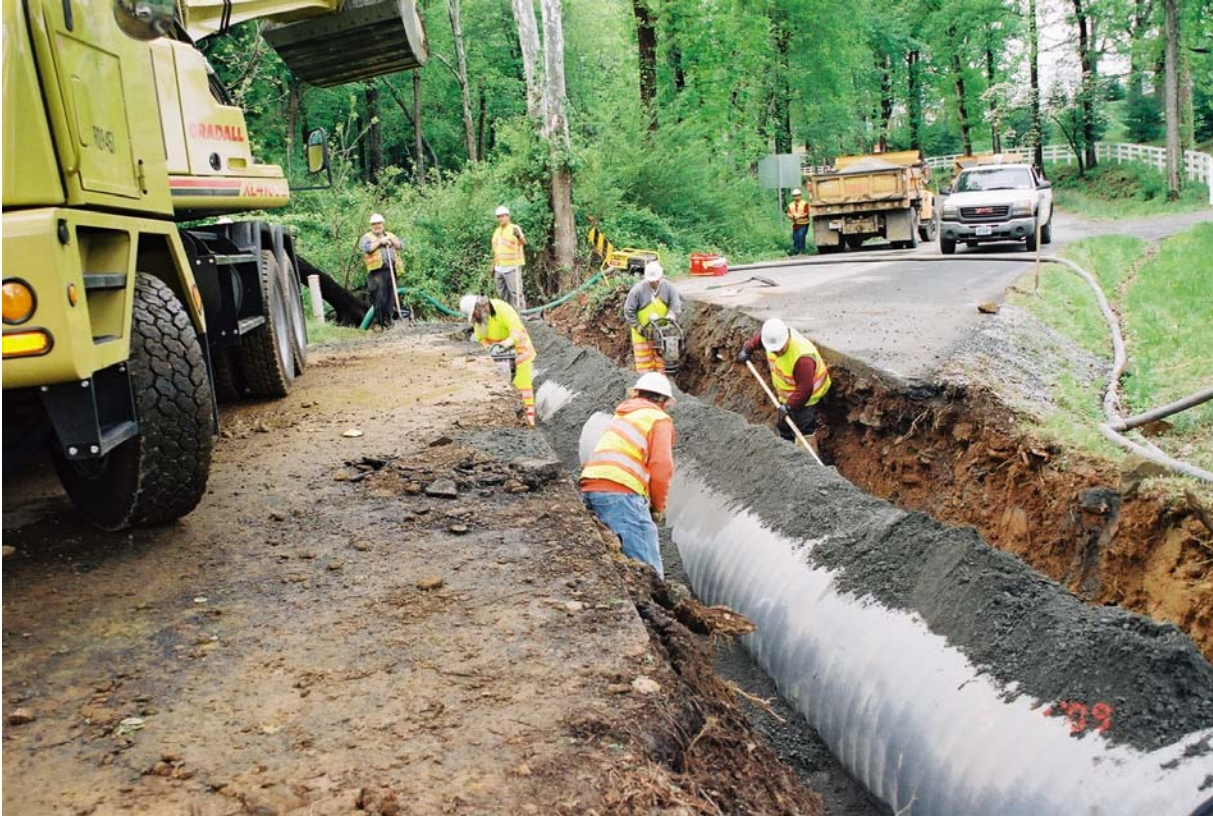
1. Route 684: 48-in-diameter, triple-wall pipe, 55 ft long (Figure 3)

- There was no backfill compaction from the bedding to the spring line. The crew superintendent stated that it is the standard practice with CMP pipe to prevent pipe lift and misalignment.

Figure 3. Installation of 48-inch Pipe at Route 684

- Compaction was performed in 8- to 10-in-deep lifts above the spring line using hand-operated compactors.
- The entire 55-ft-long pipe run was assembled outside the trench and then lowered in position using multiple supporting chains attached to a Gradall bucket.
- Backfill stone was piled on top of pipe to hold it in place.
- Riprap stone was hand placed around the pipe at each end.
- Approximately 10 in of mud and stone accumulated at the bottom of the pipe, making vertical measurements impossible. There was partial flow through at all times.
- The following defects were observed: inner liner dent at 50 ft upstream caused by the forklift, stress whitening at 40 ft upstream at the second joint (noted prior to pipe placement).

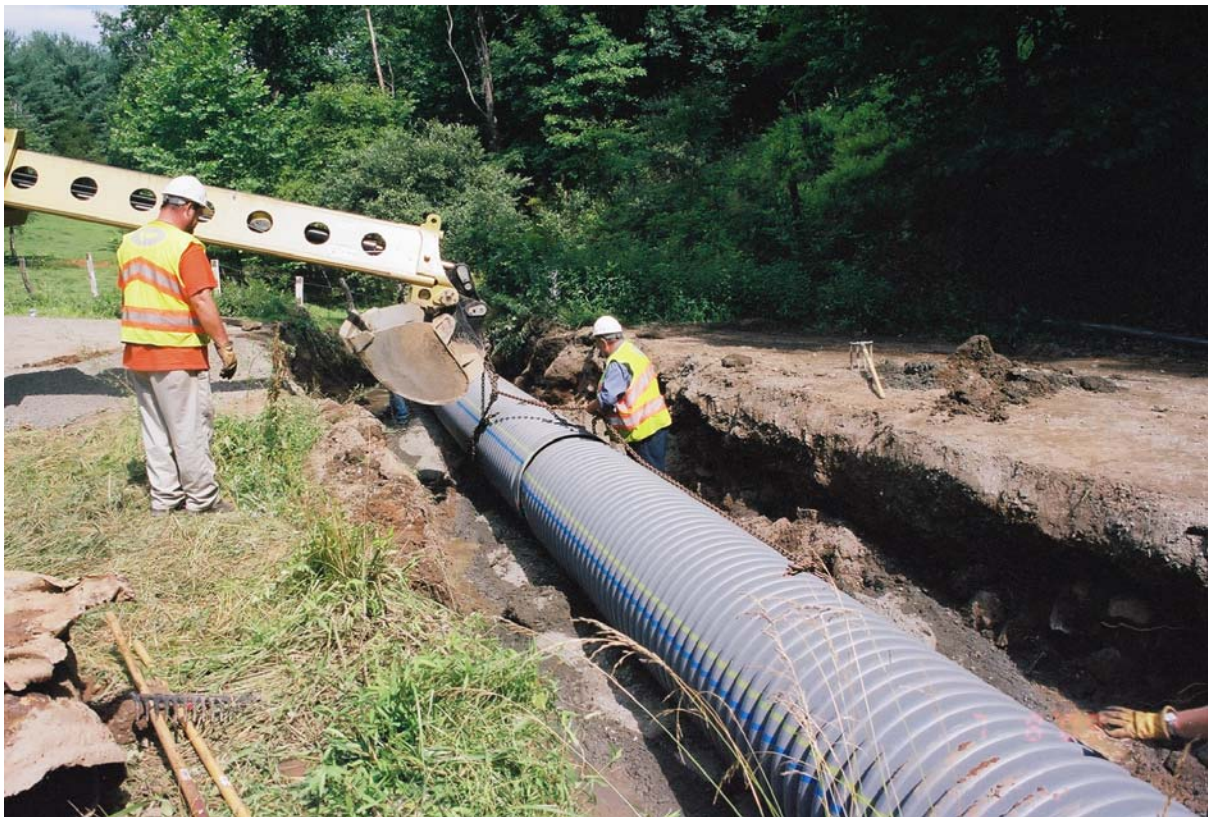
2. Route 736: 30-in-diameter, dual-wall pipe, 50 ft long (Figure 4)

- There was no backfill compaction. Hand-operated compactors were not used.
- Surface compaction was carried out using Gradall Series 4100 excavator with rubber tires.
- The entire 50-ft-long pipe run was assembled outside the trench and then lowered in position using multiple supporting chains attached to a Gradall bucket.
- Backfill stone was piled on top of the pipe to hold it in place.
- Riprap stone was hand placed around the pipe at each end.
- No defects were observed.

Figure 4. Installation of 30-inch Pipe at Route 736

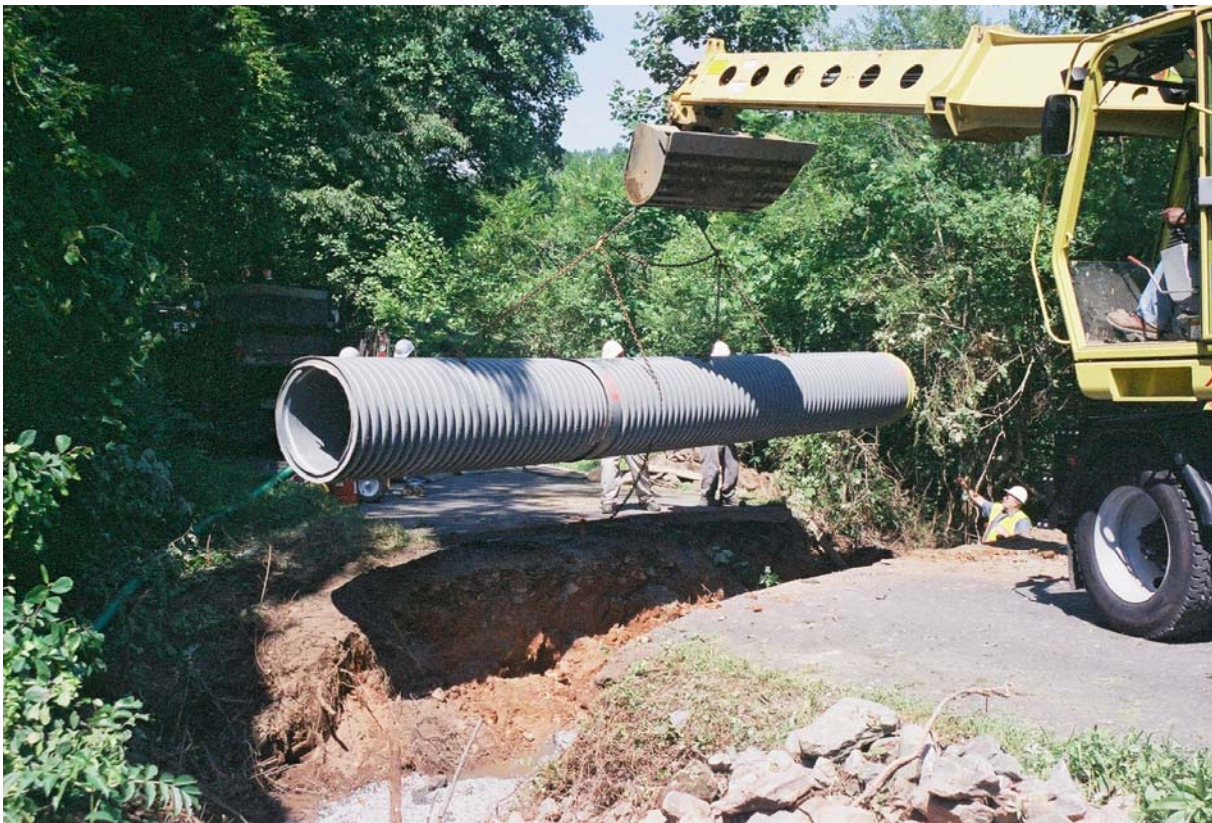
3. Route 635: 30-in-diameter, dual-wall pipe, 30 ft long (Figure 5)

- There was no backfill compaction. Hand-operated compactors were not used.
- Surface compaction was carried out using Gradall Series 4100 excavator with rubber tires.
- The entire 30-ft-long pipe run was assembled outside the trench and then lowered in position using multiple supporting chains attached to a Gradall bucket.
- Backfill stone was piled on top of the pipe to hold it in place.

Figure 5. Installation of 30-inch Pipe at Route 635

- Riprap stone was hand placed around the pipe at each end.
- Observed defects were minor forklift indentations inside the pipe.

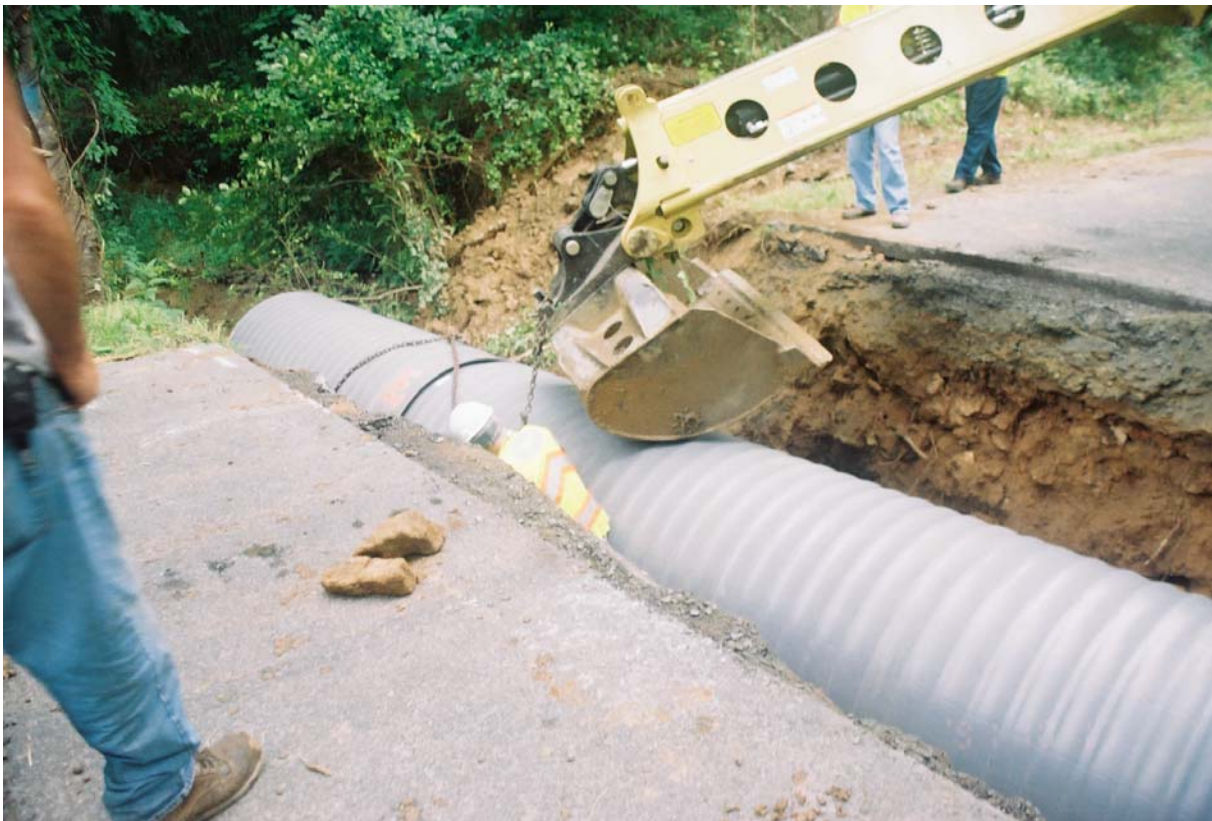
- There was no backfill compaction. Hand-operated compactors were not used.
- Surface compaction was carried out using Gradall Series 4100 excavator with rubber tires.

Figure 6. Installation of 48-inch Pipe at Route 635

- The entire 33.5-ft-long pipe run was assembled outside the trench and then lowered in position using multiple supporting chains attached to a Gradall bucket.
- Backfill stone was piled on top of the pipe to hold it in place.
- Riprap stone was hand placed around the pipe at each end.
- Observed defects were two puncture marks at 20 ft downstream caused by handling.

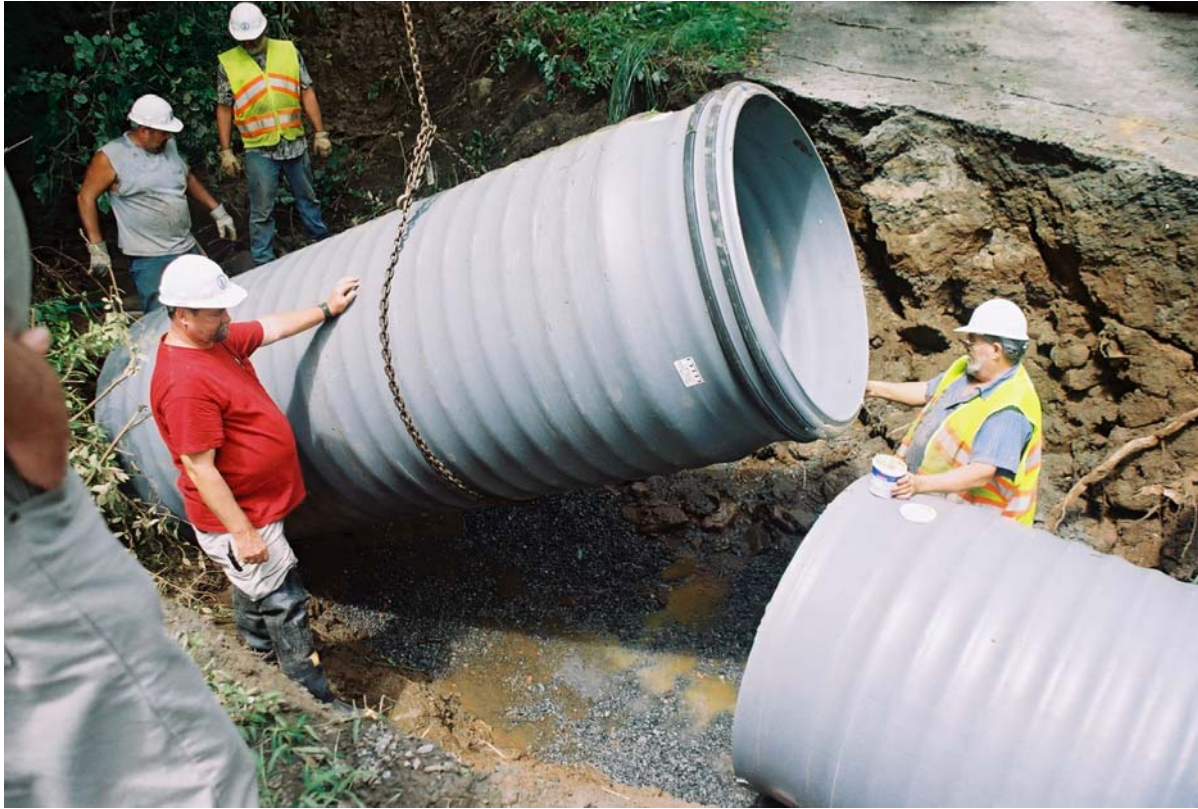
- There was no backfill compaction. Hand-operated compactors were not used.
- The trench was very wet and difficult to de-water.
- There were some large rocks in the trench soil approximately 12 in away from the pipe.
- Initially, compaction was carried out using Gradall Series 4100 excavator. It broke down during construction. The remaining backfill was compacted with a rubber tire backhoe.
- Pipes were joined in the trench. A pipe section was pushed into a partially backfilled pipe section with a Gradall bucket. Placement of pre-assembled pipes was not possible at this site because of the proximity of a telephone line).
- Backfill stone was piled on top of the pipe to hold it in place.
- Riprap stone was hand placed around the pipe at each end.
- No defects were observed.

Figure 7. Installation of 48-inch Pipe at Route 698

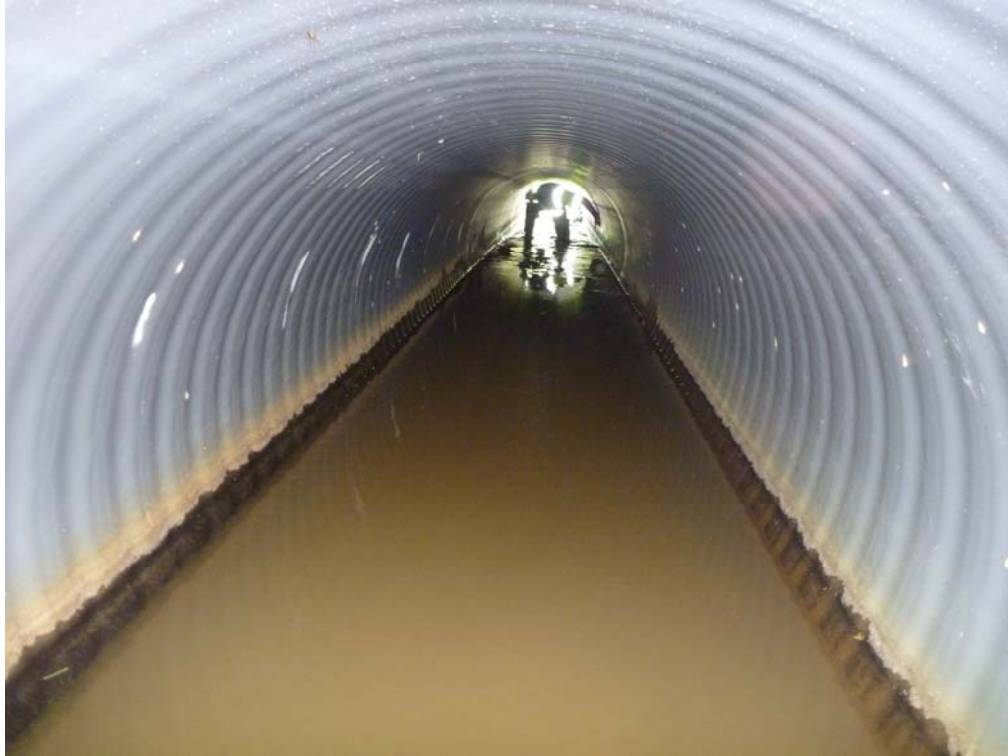
Figure 8. View of 48-inch Pipe at Route 684 After 1 Year in Service

No new defects were discovered, and no progression of the original defects was detected after 1 year of monitoring. In addition, no signs of joint infiltration were observed. Pipe alignment remained satisfactory. All pipes were fully functional. All pipes would satisfy current VDOT post-installation inspection requirements implemented in July 2010 through a revised Section 302 of VDOT's *Road and Bridge Specifications*. These requirements were not in place at the time of installation.

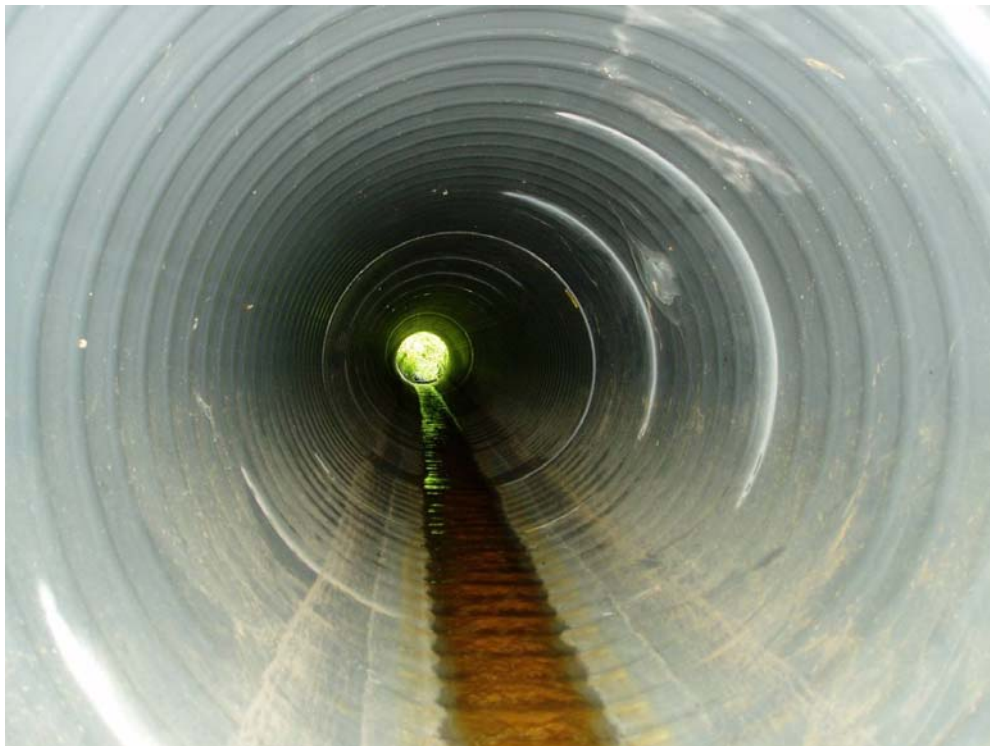
Figure 9. View of 30-inch Pipe at Route 736 After 1 Year in Service

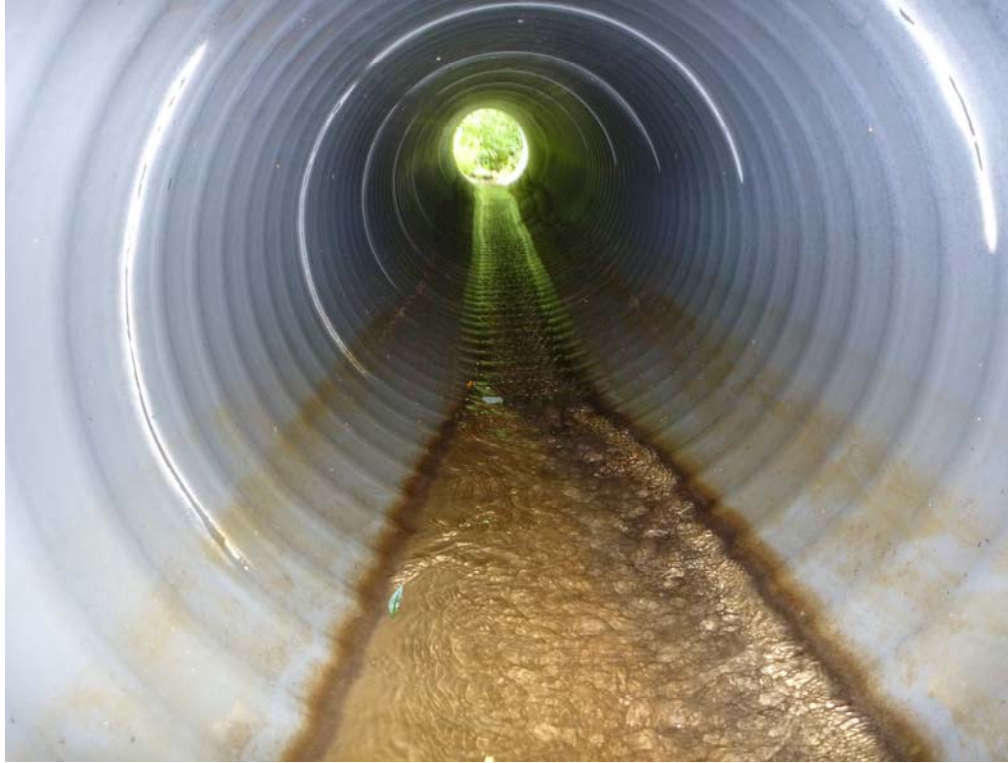
Figure 10. View of 30-inch Pipe at Route 635 After 1 Year in Service

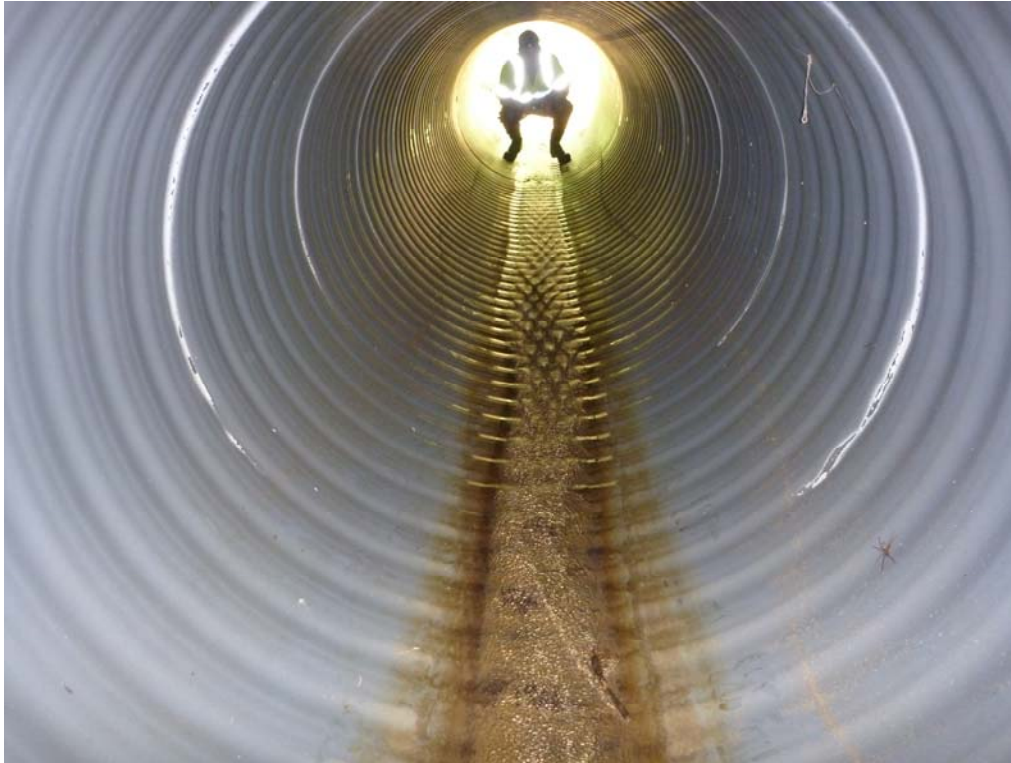
Figure 11. View of 48-inch Pipe at Route 635 After 1 Year in Service

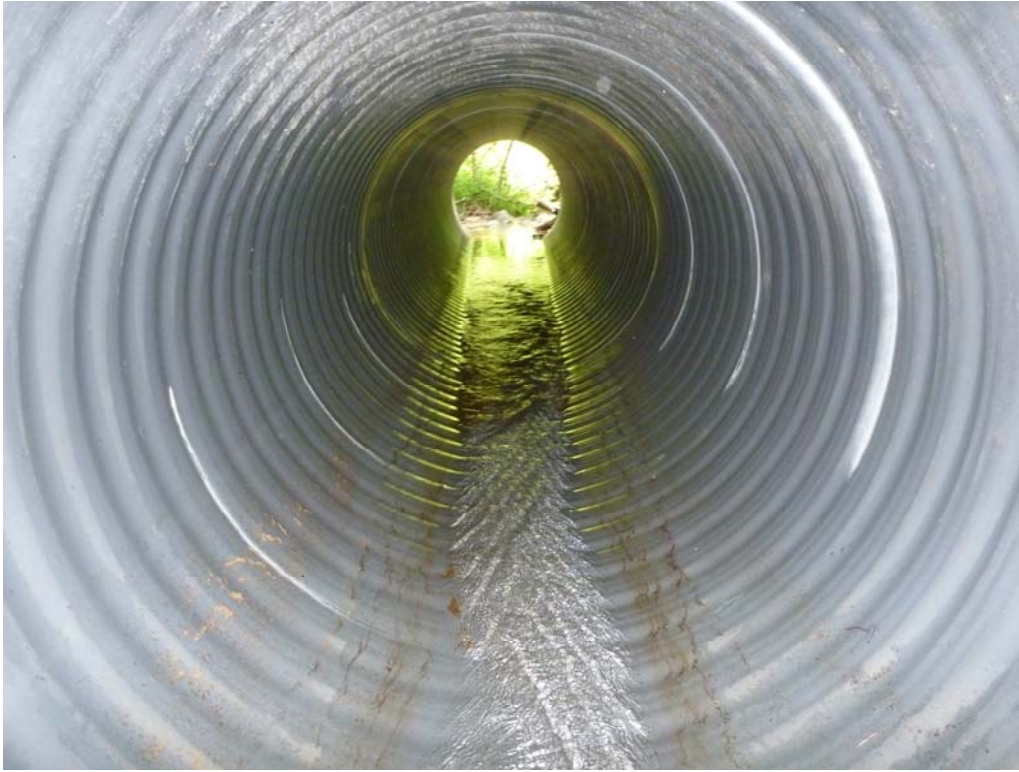
Figure 12. View of 48-inch Pipe at Route 698 After 1 Year in Service
